DATA SUMMARY

Date and time	31 October 2008; 07:15 UTC
Site	Lanzarote Airport

Registration	EC-HJQ
Type and model	BOEING 737-800 S/N: 28387
Operator	Air Europa

Aircraft	Damage to all landing gear tires
Third parties	Two approach lights on the opposite threshold

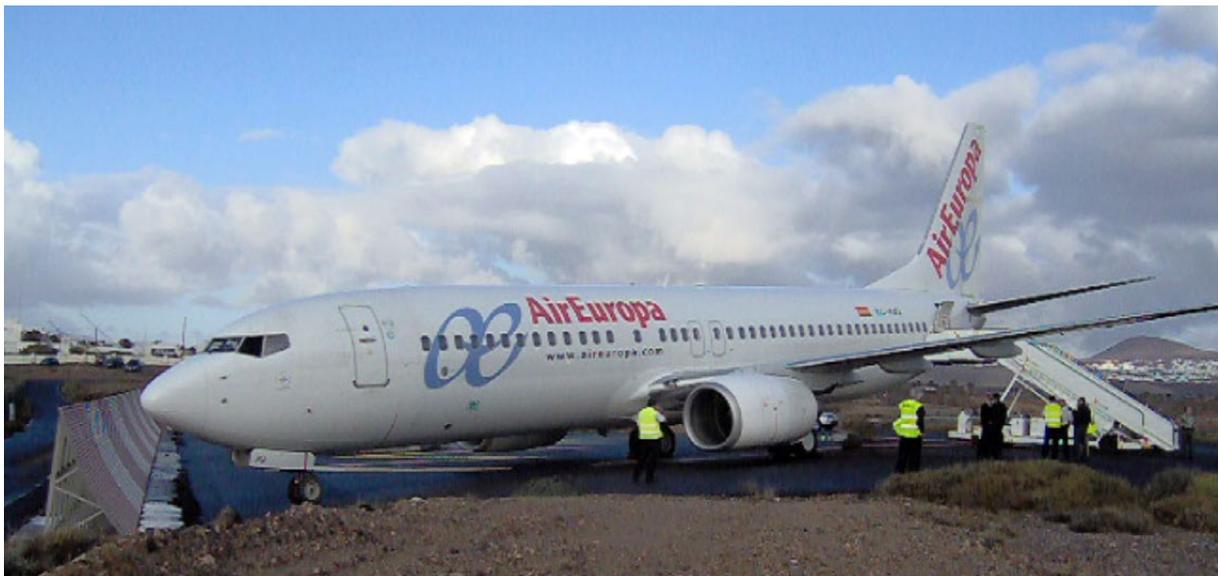
Figure 1. Final aircraft position

The airplane ran off the end of the runway at a ground speed (GS) of 51 kt and traveled over the 60 m of the stopway, before stopping approximately one meter away from the 03 threshold jet blast barrier, alongside the airport's perimeter fence.

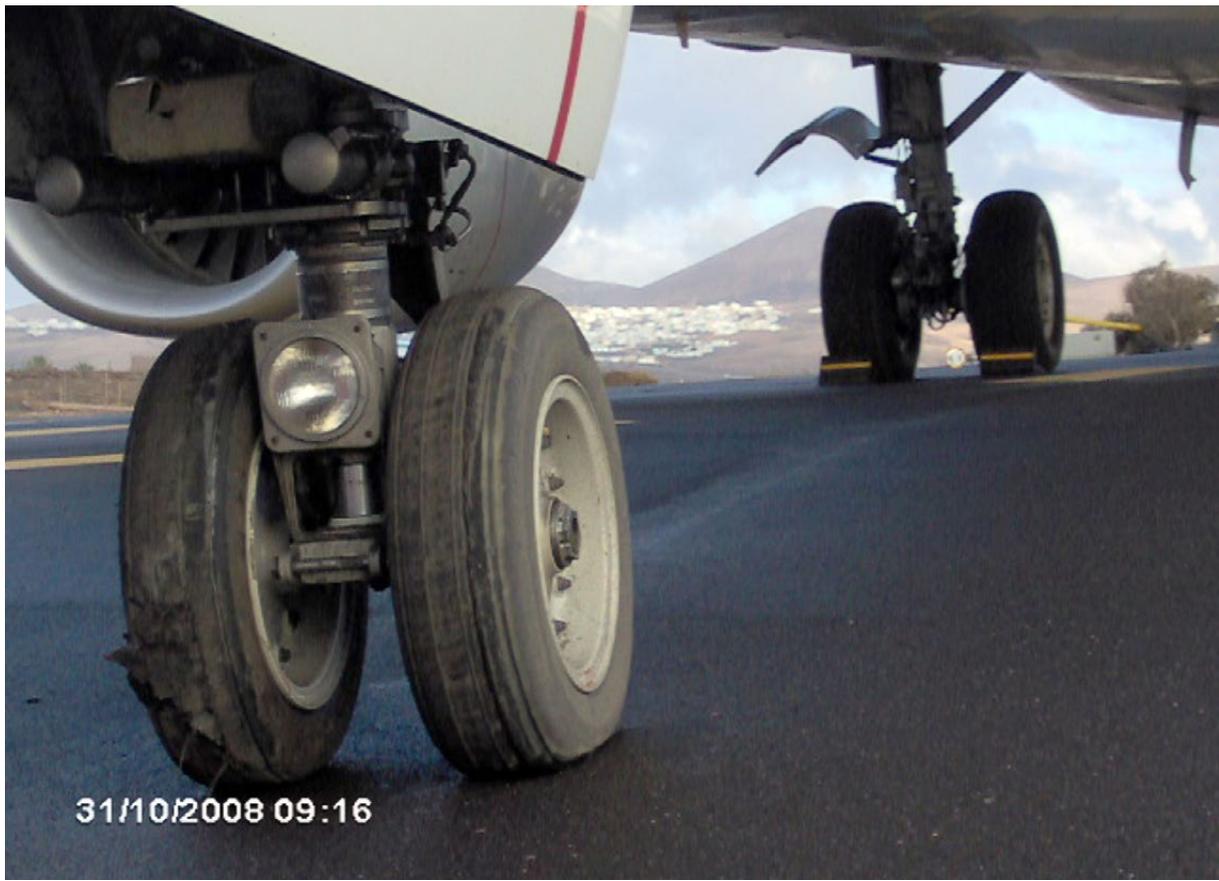
Figure 2. Damage to the nosewheel landing gear

The material damage was limited to the airplane's tires, which had to be replaced following an inspection by the airline's own maintenance personnel, and to two landing approach lights on the opposite threshold.

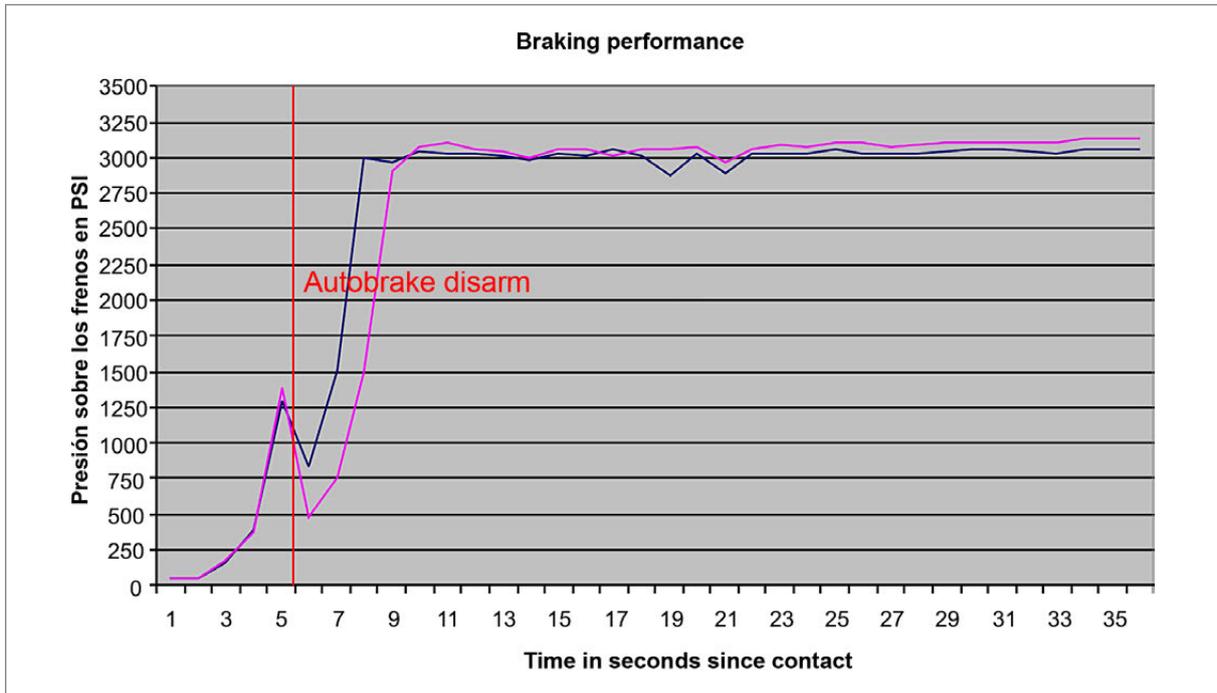
Figure 3. Braking performance during landing run

Figure 3 shows the pressure (in psi) reached in the brake system as commanded by both the autobrake and by the pilots via the brake pedals. The magenta line (bottom) represents the right brake and the blue line (top) the left.

The airplane stopped 28 seconds after the landing gear made contact with the runway surface.

Between 9 and 12 seconds after touchdown, the deceleration decreased almost by half, to -0.22 g, while maximum pressure (3,000 psi) was applied to the brakes. The most likely explanation is that the airplane was crossing the area of runway close to the 1,000 ft marks for runway 03 where the rubber buildup is extensive and the coefficient of friction lower, especially if the surface is wet or damp, as the crew had noted and as was verified during the investigation.

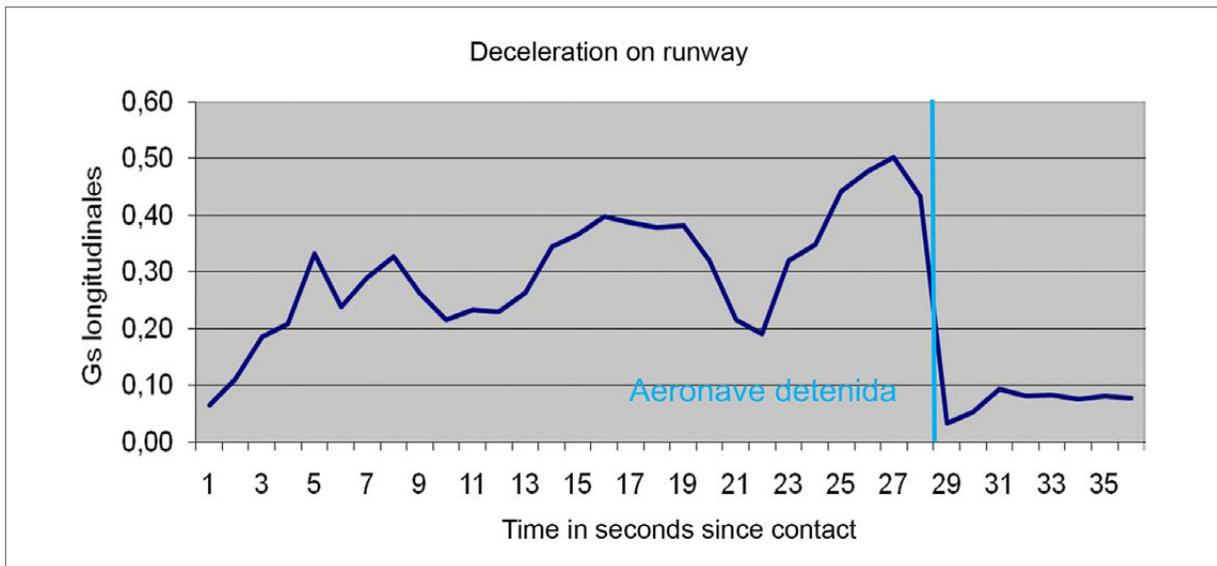
Figure 4. Deceleration during landing

Figure 4 uses positive values to represent the negative longitudinal acceleration (deceleration) attained as a result of the braking action, as recorded by the FDR at ¼ second intervals.

Experience and an analysis of flight recorder data shows that smooth braking yields values of up to 0.2 g. Between 0.2 g and 0.4 g is normal braking, with anything above 0.4 g being hard braking that is uncomfortable to the passengers. During the first 13 seconds of the landing run, while the airplane’s speed was still high, the braking efficiency varied between the low values typical of normal braking and values corresponding to smooth braking. It then increased, though it dropped during a 2 to 3 second period, reaching the highest values at the end of the run.

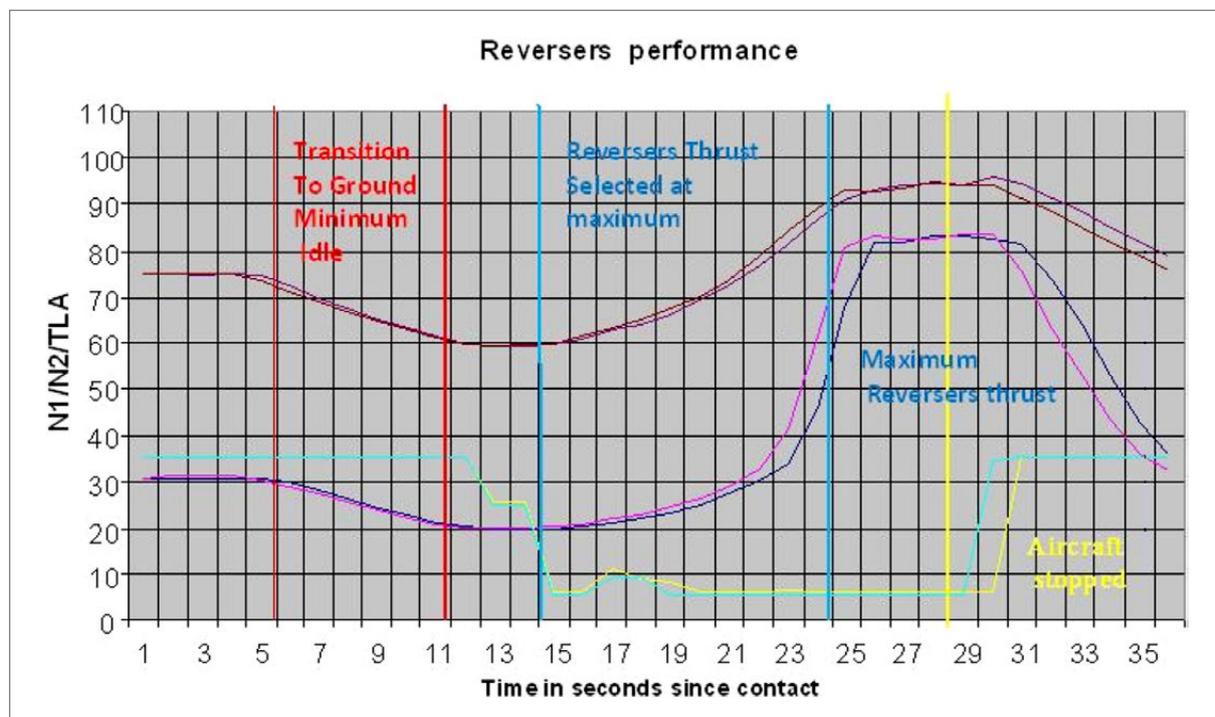
Figure 5. Engines performance during landing – reversers thrust

Figure 5 shows the values of N1 (bottom curves in magenta for the no. 1 engine and indigo for the no. 2), N2 (top curves in purple for the no. 1 engine and brown for the no. 2) and TLA (throttle lever position) (bottom curves in straight segments, yellow for the no. 1 engine and blue for the no. 2) from the moment of touchdown until the end of the landing run.

As shown in the graph, five seconds after contact was made with the runway surface, the N1 and N2 engine parameters start to decrease without any change to the position of the throttle levers (TLA). As noted in 1.3.2, this is because the engines transitioned from approach idle to ground minimum idle. This transition is complete six seconds later. When the crew selects maximum reverse thrust, it takes the engines on the order of ten seconds to achieve this commanded maximum reverse thrust.

The “approach idle” mode in the engines is selected automatically when the flaps are in a landing configuration, since the higher % RPM for N1 and N2 lowers the engine spin-up time in the event that a go around is required. The engine’s ability to respond is degraded, therefore, when they transition to “ground minimum idle”.

The degradation in the engine’s capacity to respond when the pilots delay either in engaging the reversers upon landing or in applying thrust to execute a go around must be known and taken into account by crews. A safety recommendation is issued to the manufacturer in this regard so that it emphasizes this fact in its manuals.

- REC 52/11.** It is recommended that the aircraft manufacturer include in the appropriate aircraft documentation (FCTM, AFM, etc.) a warning on how delaying an input to the throttles after landing, either to activate the reversers or to execute a go around, can result in a corresponding delay in engine response.
