Report A-035/2016

Accident involving a Robin DR-400-180 aircraft, registration EC-KFG, in Villanueva del Condado, municipality of Vegas del Condado (León, Spain), on 6 September 2016

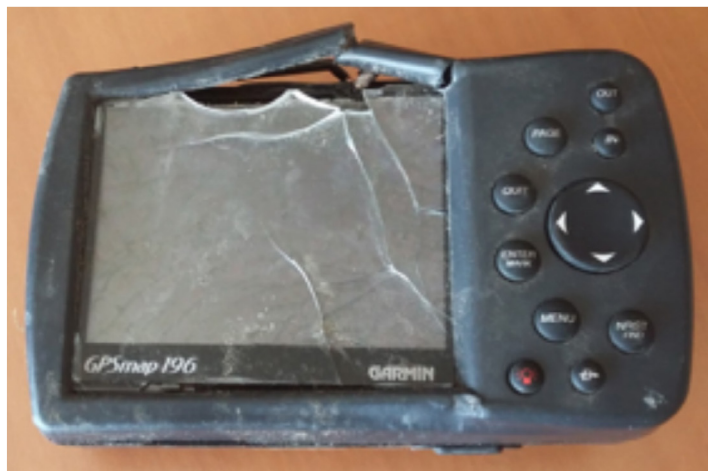
Figure 1. Photograph of the Garmin GPSmap196 unit

Two GPS units were recovered from the aircraft wreckage, both of them made by Garmin, a GPS150 and a GPSmap196 model. They were in bad condition as a result of the accident.

The unit was heavily damaged to the point that it did not even turn on. As a result, the CIAIAC requested assistance from the French accident investigation authority, the "Bureau d'Enquêtes et d'Analyses pour la sécurité de l'aviation civile", in whose laboratory the stored data were downloaded and verified to contain information from the accident flight.

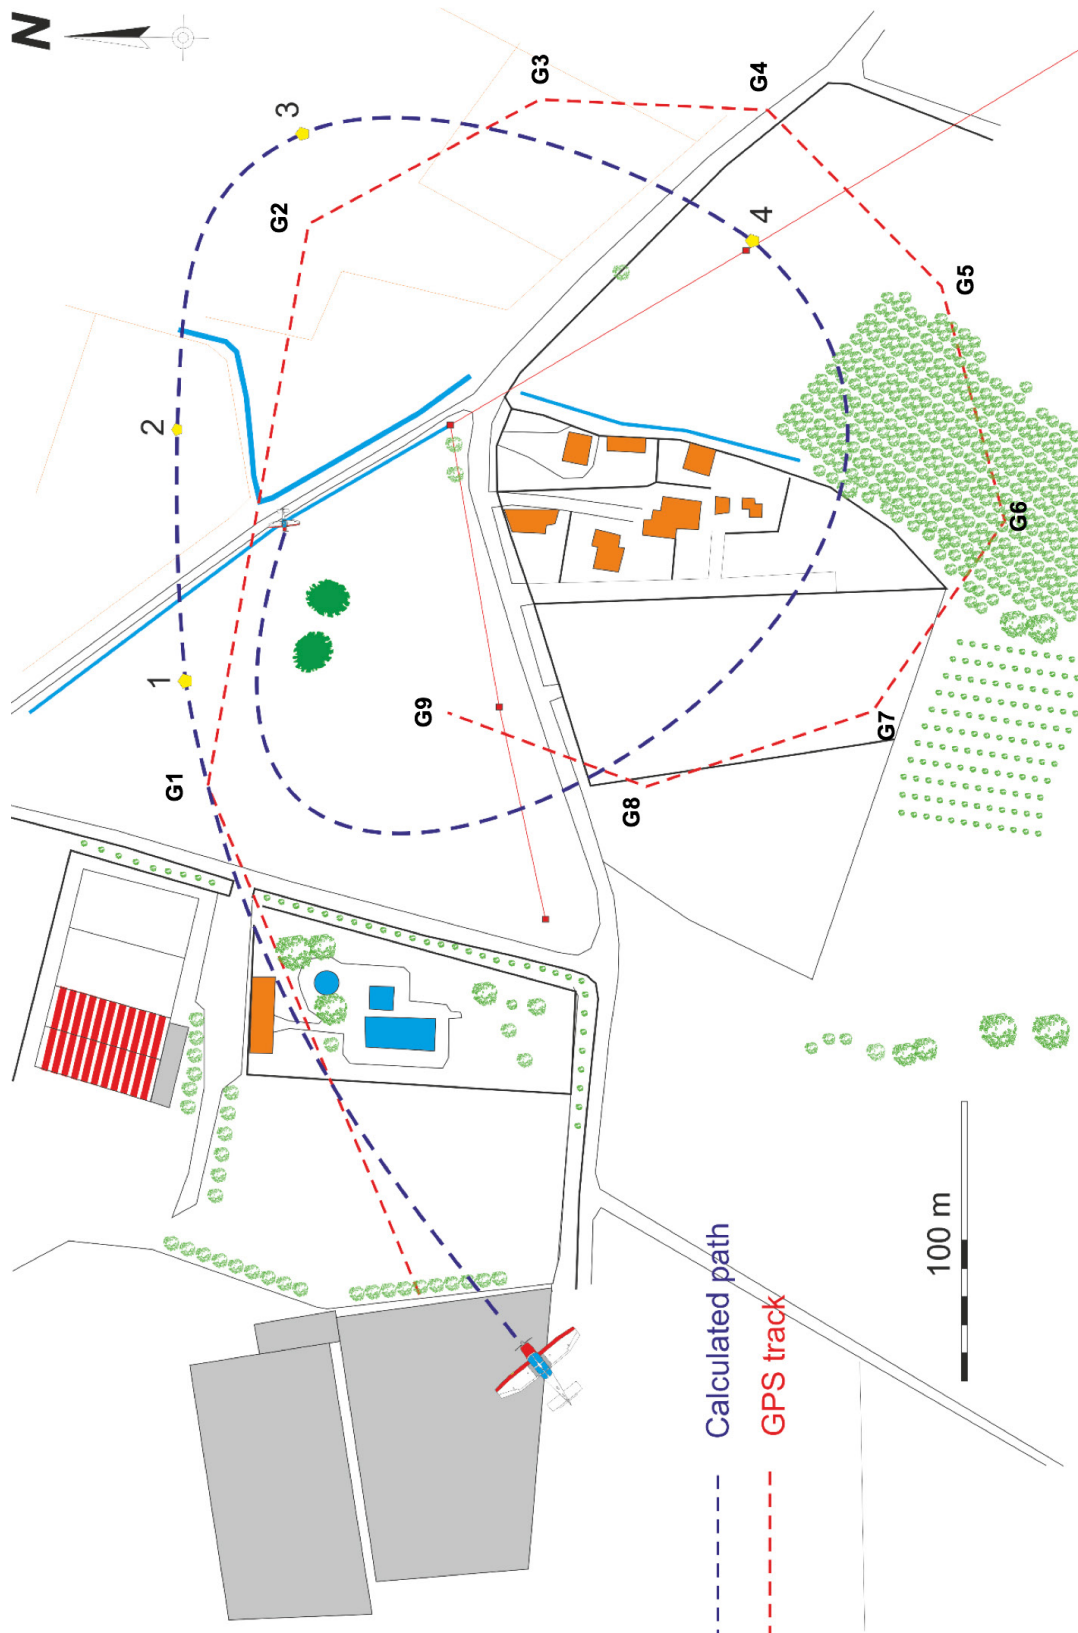
Figure 2. Map of the accident site, with the flight path obtained from the GPS unit (red line) and that determined from the photographs (blue line).

The GPS track contained in Figure 2 shows nine points, labeled G1 through G9. The table below contains time and altitude data from the GPS information on each of these points. The elevation of the terrain was obtained from information in IGN maps. The height, distance and speed values were calculated from the preceding data. The average radius of this circling maneuver was about 150 m.

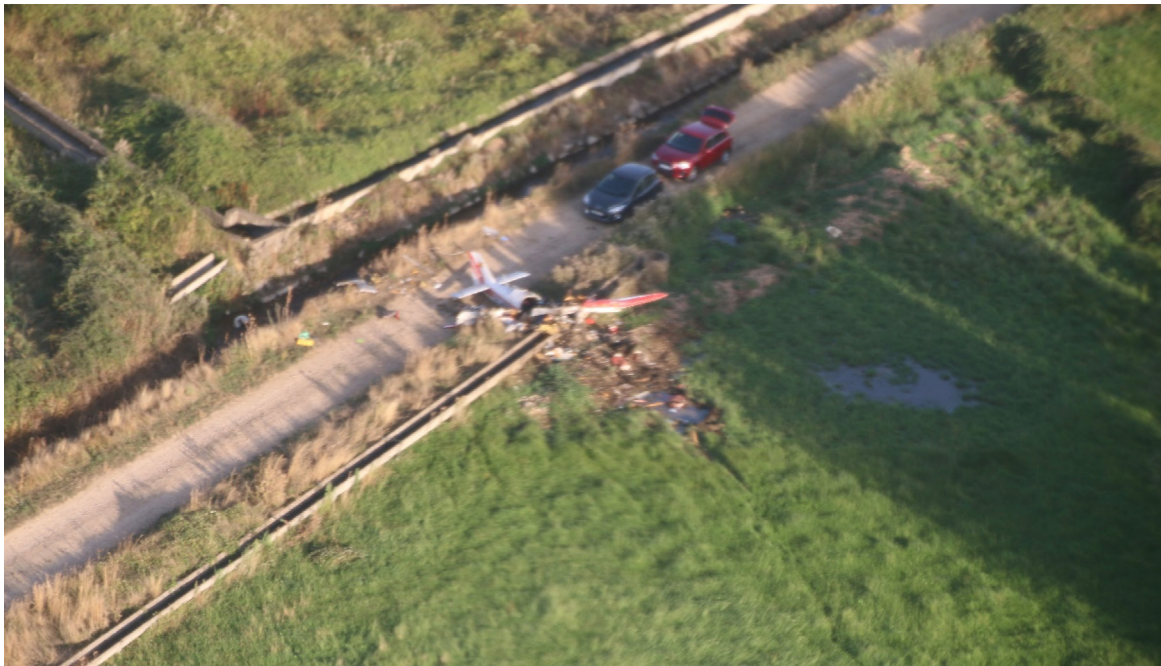
Figure 3. Aerial photograph of the aircraft wreckage and the marks it left on the ground

Figure 3 shows an aerial photograph of the aircraft wreckage.

As this photograph shows, the main wreckage was located at the edge of a crop field, with part of the wreckage located in the field and the rest on a road and a water trough that runs parallel to the road. The aircraft was facing in the approximate direction of 250°.

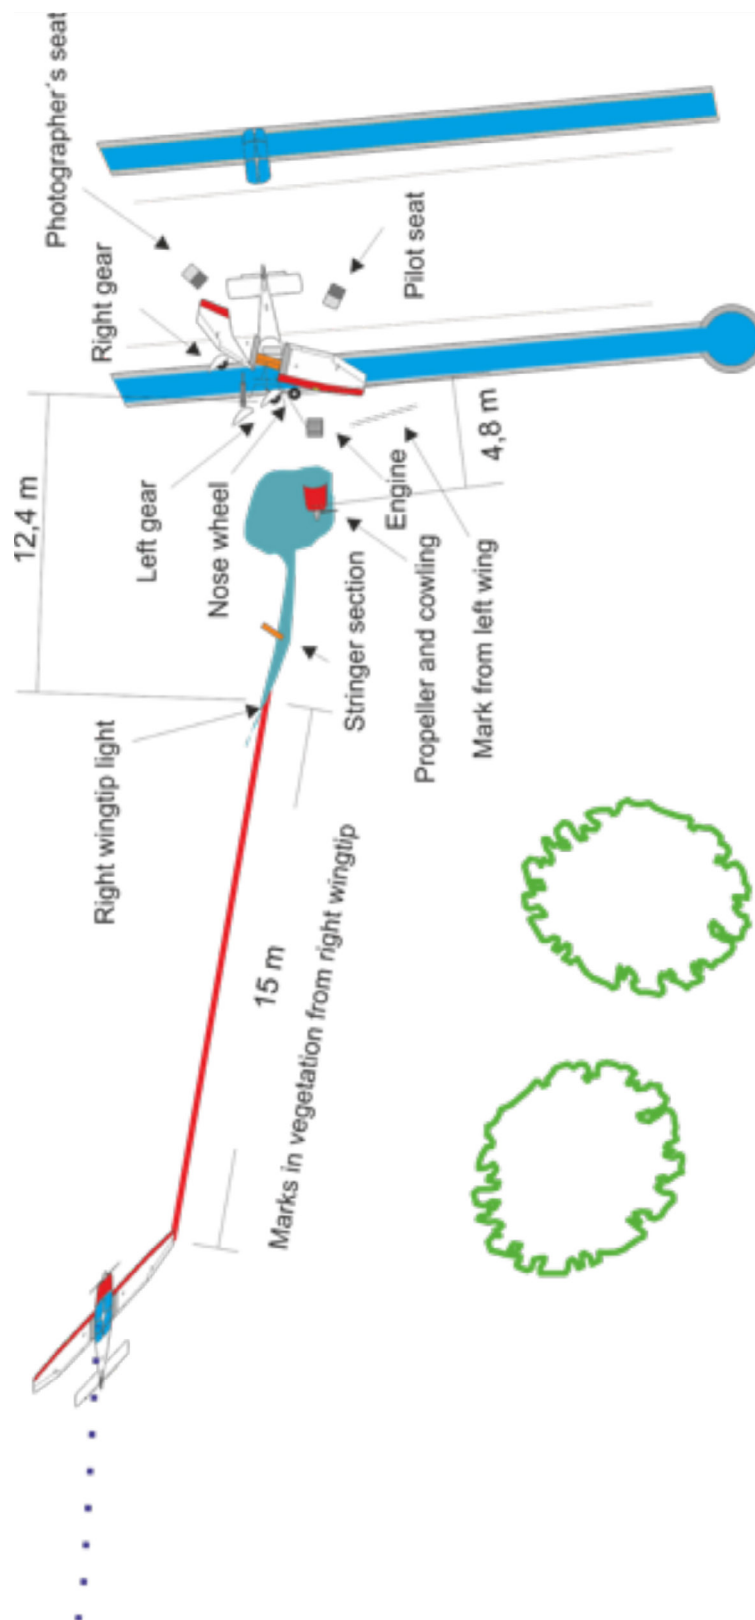
Figure 4. Diagram of the marks on the ground and location of aircraft wreckage

There was a mark on the ground that reached the hole and extended some 17 m in the opposite direction from where the aircraft wreckage was located (see diagram in Figure 4).

This mark had two different segments, one that extended from the hole until the point where a part of the wing stringer was found, located some 2 m away from the hole. This segment was very deep and wide (shown in blue in the diagram in Figure 4).

Debris from the aircraft were found inside this mark, including the right wingtip light.

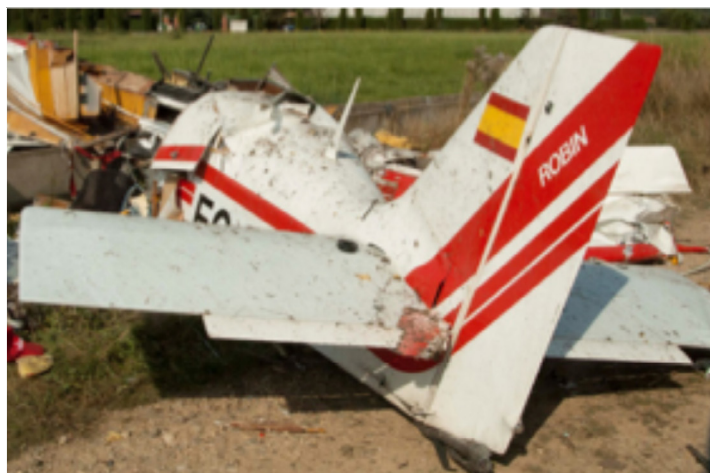
Figure 5. Photograph of the rear of the aircraft

The tail section was almost intact. There were no significant impact marks or damage. The only finding of note was the presence of mud that had been projected upward. The vertical stabilizer and the rudder were in their correct positions and moved freely. Continuity from the controls to the pedals could not be checked because the cables had been severed.

The horizontal part of the tail assembly consists of a single control surface that doubles as a horizontal stabilizer and elevator. It moved without any problem when the control stick in the cockpit was moved. Its motion reflected the input made to the control stick. The control stick could only be moved back and forth (pitch control), but was jammed in the side-to-side direction (bank control).

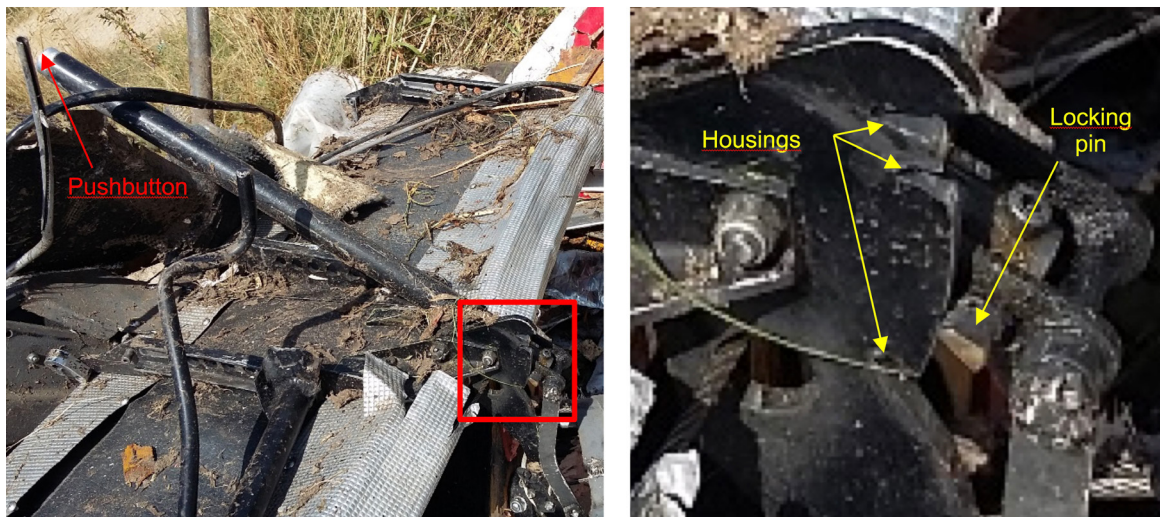
Figure 6. Photograph of the flap lever (left). At the right, close-up of the area shown in the red box in the figure on the left, providing a better view of the locking pin and the three control housings

Both the aileron and the flap were still attached to the wing through their fittings. The aileron control cables were jammed, causing the aileron to be stuck in its neutral position and making it impossible to move by hand. As noted earlier, the control stick for this surface was stuck. In contrast, the flap pivoted freely about its fittings since its control linkage was broken.

The pin and housings are designed so that the pin cannot leave the housing unless the pilot presses the release button. The fact that neither the pin nor any of the three housings present in the flap system exhibited any significant damage indicates that the pin did not leave the housing during, and as a result of, the impact, in which case the only possibility is that the pin was not in any of the housings.

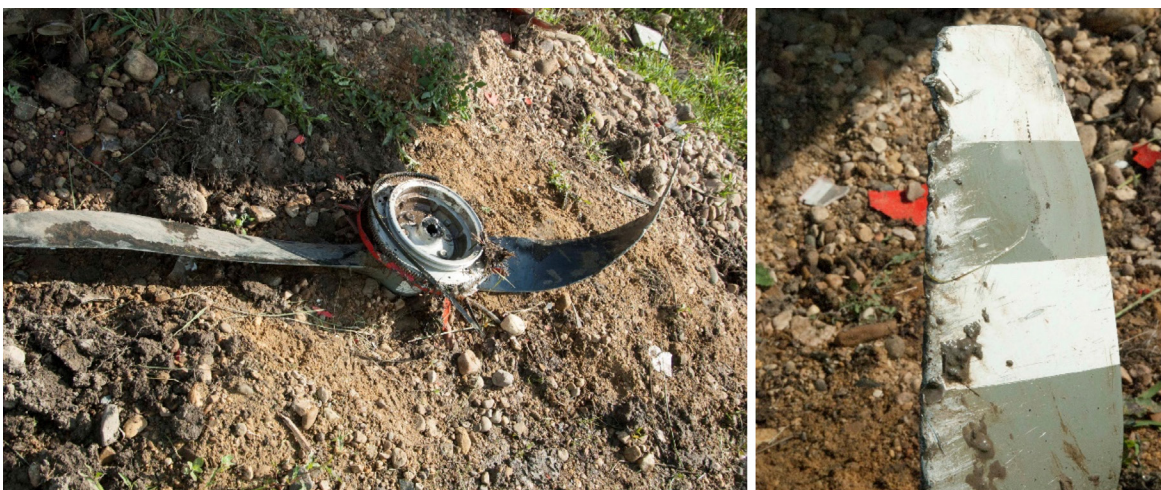
Figure 7. Photograph of the propeller (left) and close-up of the top surface of one of the blades (right)

Of the propeller's two blades, one had little impact damage and exhibited no appreciable plastic deformation. The other, in contrast, exhibited considerable warping and had multiple strong impact marks on the leading edge, as well as rotation marks on both the top and bottom surfaces.

The damage and deformations exhibited by the two propeller blades clearly indicate that when they impacted the ground, the engine was under power.

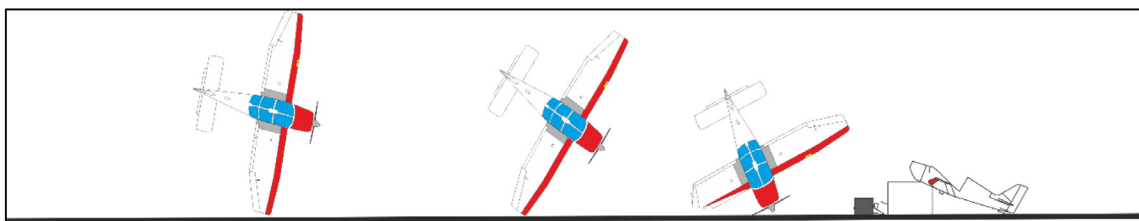
Figure 8. Aircraft impact sequence

The right wing's contact with the ground in turn caused the aircraft to start to pivot about the outer edge of the wing, making the nose of the aircraft plunge to the ground (see Figure 8).

This was a high energy impact that caused the destruction of the front part of the airframe and created the hole inside of which the engine and propeller were found.

The left wing then impacted the ground. Both the damage to this part of the aircraft and the marks left on the ground by this impact were considerably less significant than those produced by the previous impact. This implies that the initial impact absorbed most of the aircraft's energy.

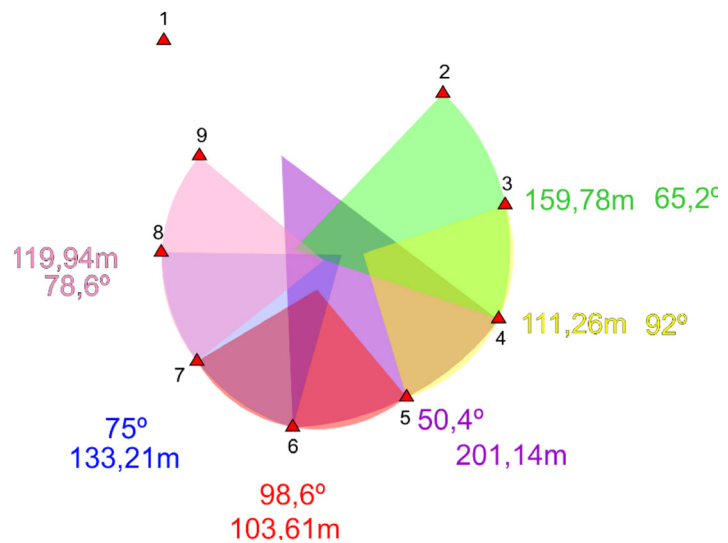
Figure 9. Sectors created from points of last circling maneuver. Radius and angle spanned by each sector

The smaller the turn radius, the higher the aircraft's bank angle has to be in order to execute the turn.

Figure 9 shows the final 9 points of the turn, though point 1 will not be used. Each point is separated by 2 s.
