Appendix A

Record of flights crewed by the Commander or Co-pilot from 6 February 2011

FINAL REPORT

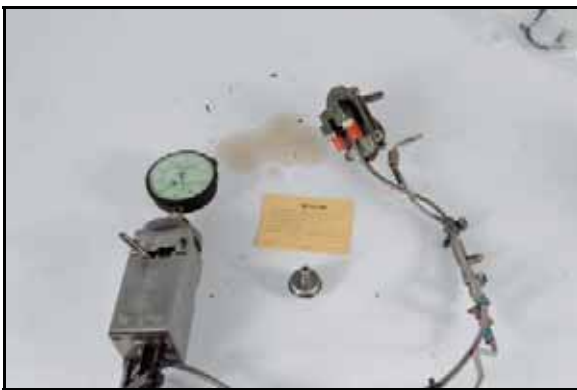
Photo No. 1:

According to the component manufacturer, the P_{T2}/T_{T2} Sensor was produced in August 1999 and was not returned to the manufacturer for any subsequent maintenance. The P_{T2}/T_{T2} sensor bellows displacement was measured using measuring tool WT-51467 # 1 (**Photo No. 1**). The height of the bellows was measured from the inside of the outer flange to the center of the bellows stem measured was 0.947 inches at a room temperature of approximately 75°F (specification is 1.023 ± 0.002 inches at 75°F). This is consistent with the sensor reading a lower temperature value than actual. The height of the bellows being considerably shorter than required would be consistent with a breach within the system (**Photo No. 2**).

Bellows displacement measuring tool

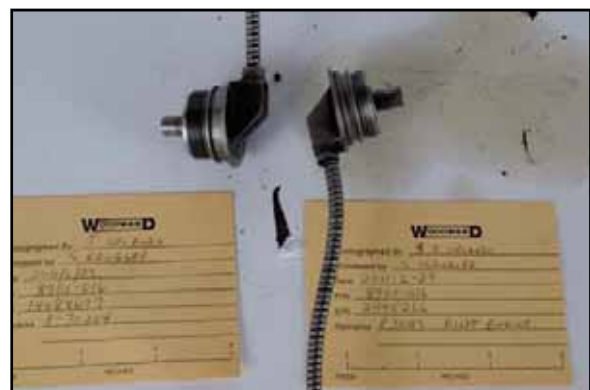
Photo No. 2:

Bellows height comparison

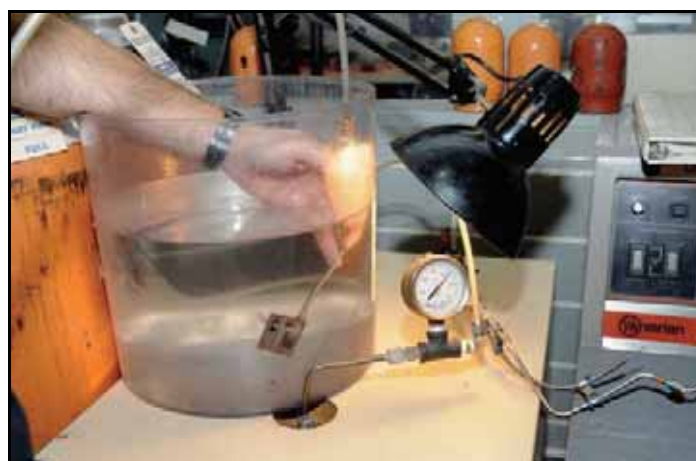
The P_{T2}/T_{T2} sensor was cut midway in the capillary tube to isolate the bellows from the probe to determine which end may be breached. Each half was pressured using helium, then dunked into a tank of Stoddard Fluid (MIL-F-7024 type II) (**Photo No. 3**).

Photo No. 3: P_{T2}/T_{T2} leak check test

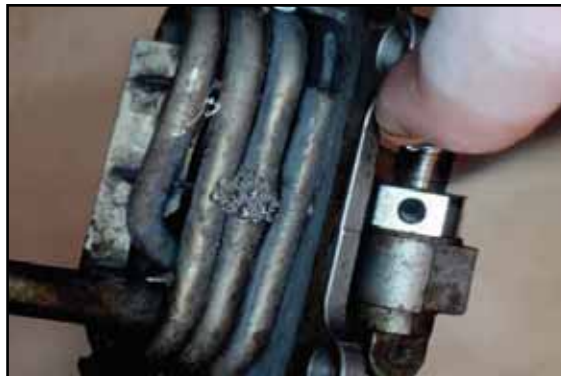
No leak (bubbles) was noted coming from the bellows but a streak of bubbles was noted coming from the sensing tube (**Photo No. 4 & Photo No. 5**). The sensing tube was marked where the bubbles appeared to have been coming from (**Photo No. 6**). Additional examination will be needed to determine the exact location and cause of the breach.

Photo No. 5: Sensing tube leak

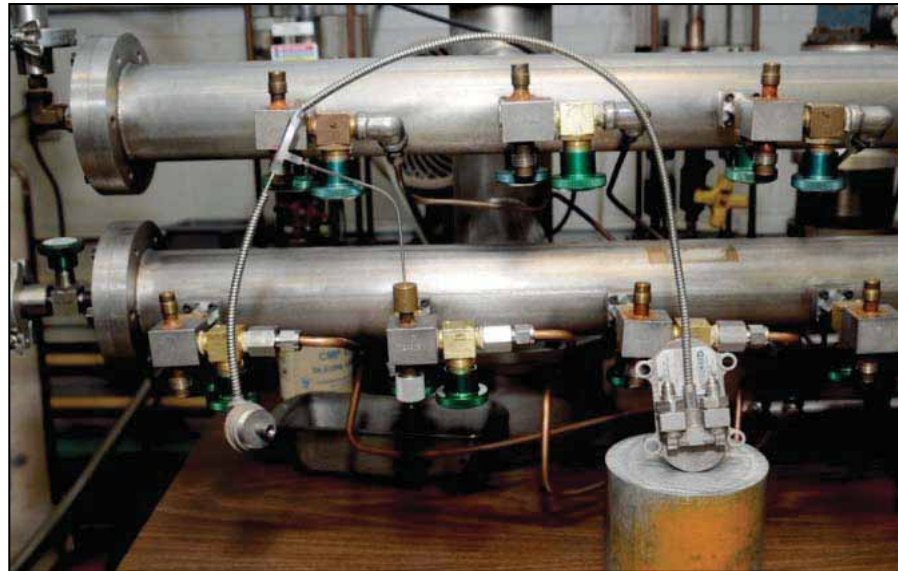
The modified P_{T_2}/T_{T_2} sensor was then put under vacuum to draw any air trapped out the system and then it was filled with N-butyl alcohol (**Photo No. 7**).

Photo No. 7: pressurizing the P_{T_2}/T_{T_2} sensor to determine leak rate

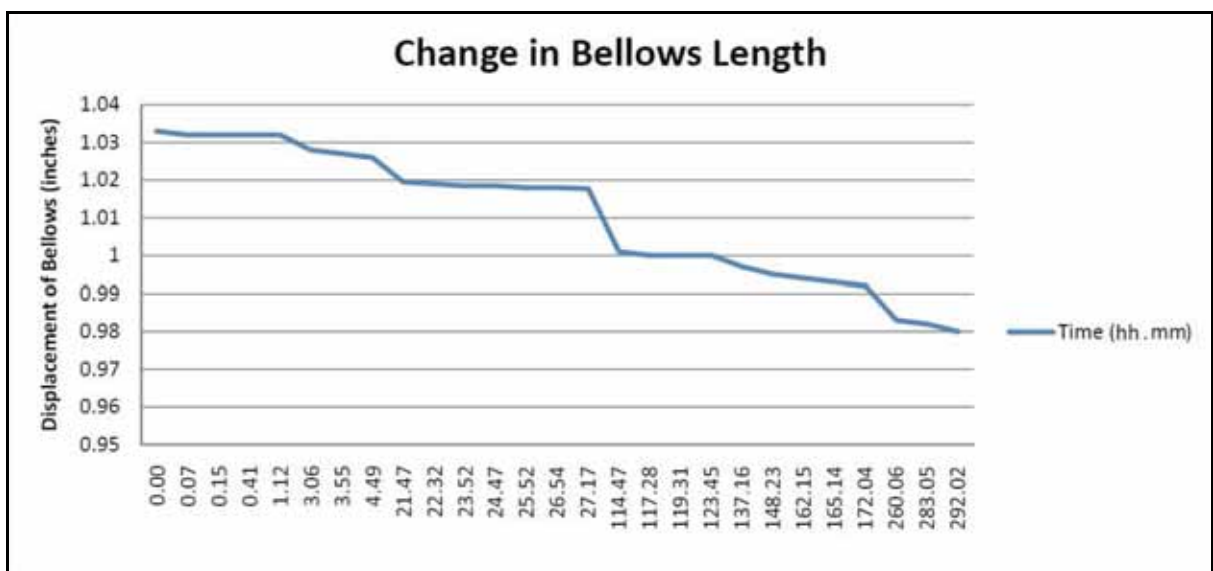
A 15-pound load was then applied to the bellows that simulates the load it would experience when attached to the engine. Under this load, the bellows displacement was measured to be 1.33-inches. The loss of internal pressure (bellows displacement) was monitored and recorded as a function of time (**Plot 1** and **Table 1**). The following displacements and times were recorded:

Plot 1: Bellows Length Change vs Time

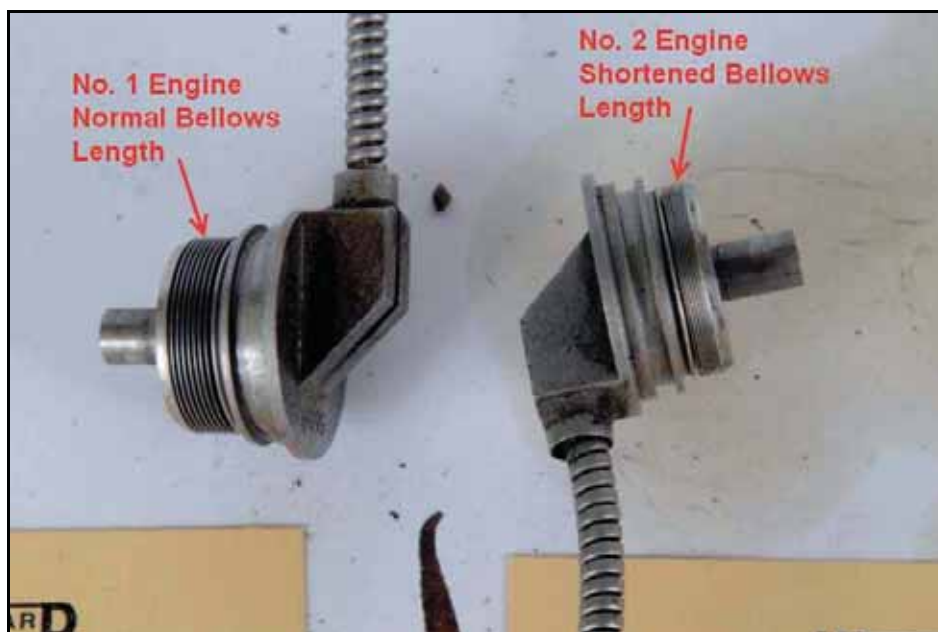
The length of the No. 2 engine bellows being considerably shorter than specified is consistent with a breach or leak within the system.

Photo No. 1: P_{T_2}/T_{T_2} sensor bellows from No. 1 and No. 2 Engines

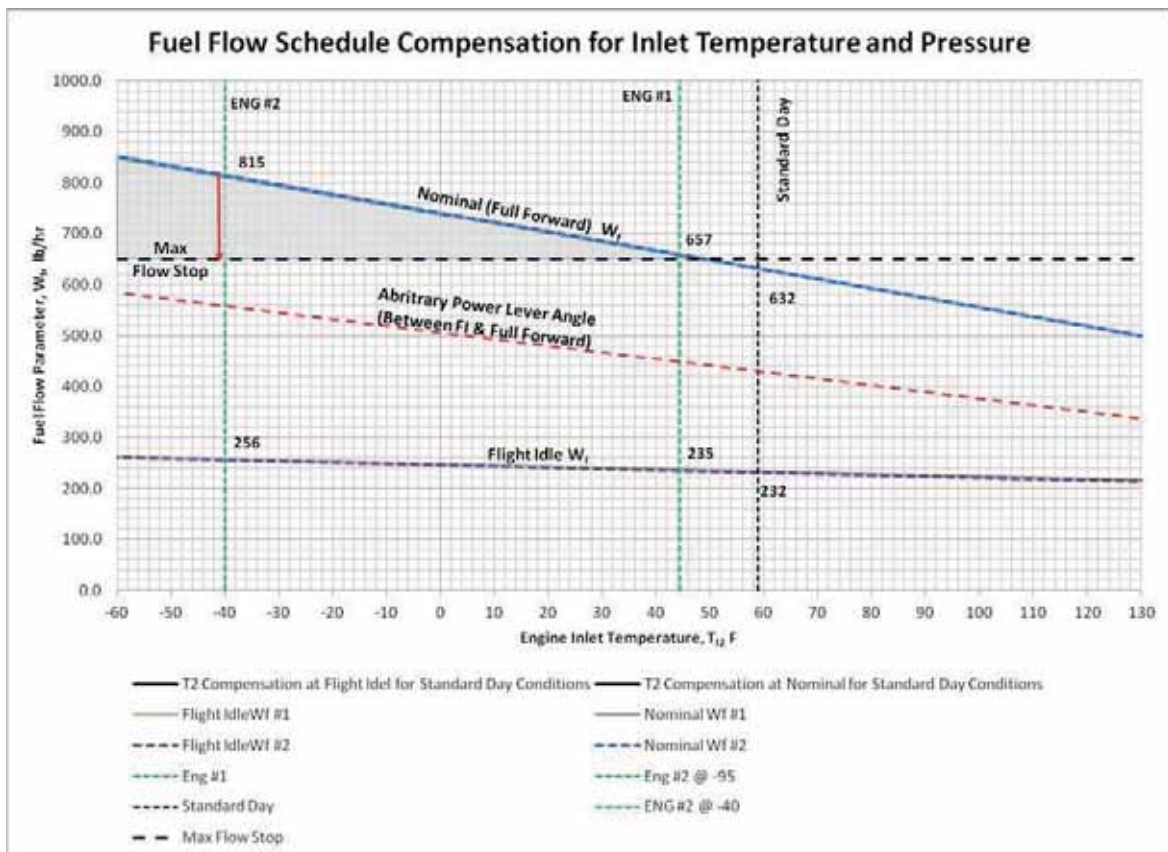
As the power lever is moved from Flight Idle to full forward, which is illustrated at an arbitrary power lever position by the dashed red line, there is a proportionally higher fuel flow to the No. 2 engine than to the No. 1 engine.

Figure No. 2: Fuel Flow Schedule Compensation (Source Honeywell)

Thus, as the power levers are advanced for take-off, the effect of a shortened bellows is to increase the fuel flow to the engine on the side with the shortened bellows, i.e. the No. 2 engine on EC-ITP.

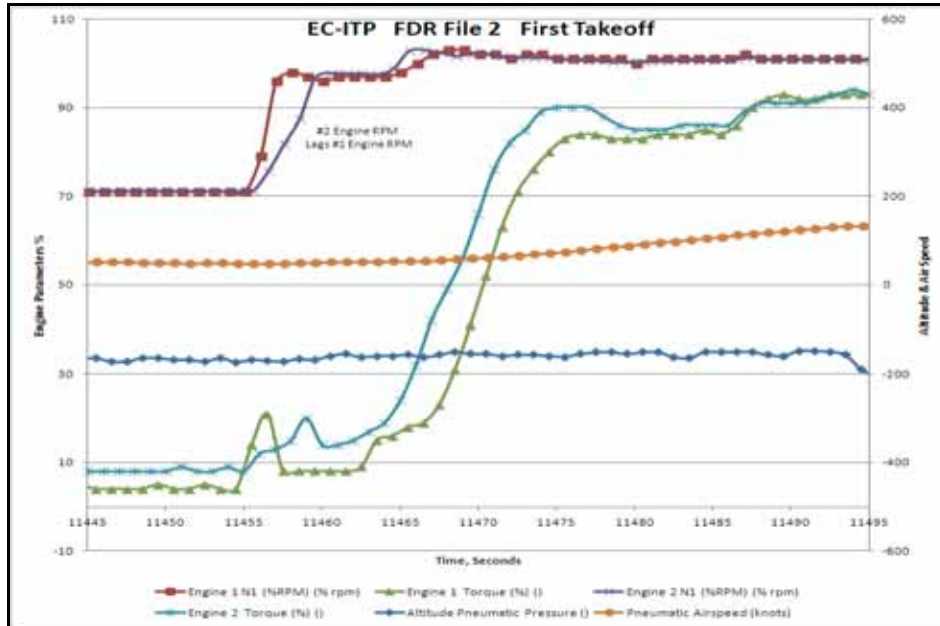
Figure No. 4 and **Figure No. 5** present FDR data for two further take-offs made by EC-ITP some weeks before the accident flight. Similar characteristics are seen, in that the engine No. 2 RPM lags that of engine No. 1 as the speed levers are advanced in each case. Also, the torque achieved by engine No. 2 advances ahead of that achieved by engine No. 1 and, particularly as seen in **Figure No. 5**, the No. 2 engine torque remains higher than that of No. 1 engine as the aircraft speed increases during its take-off run.

Figure No. 4: Sample of take-off FDR parameters weeks prior to accident

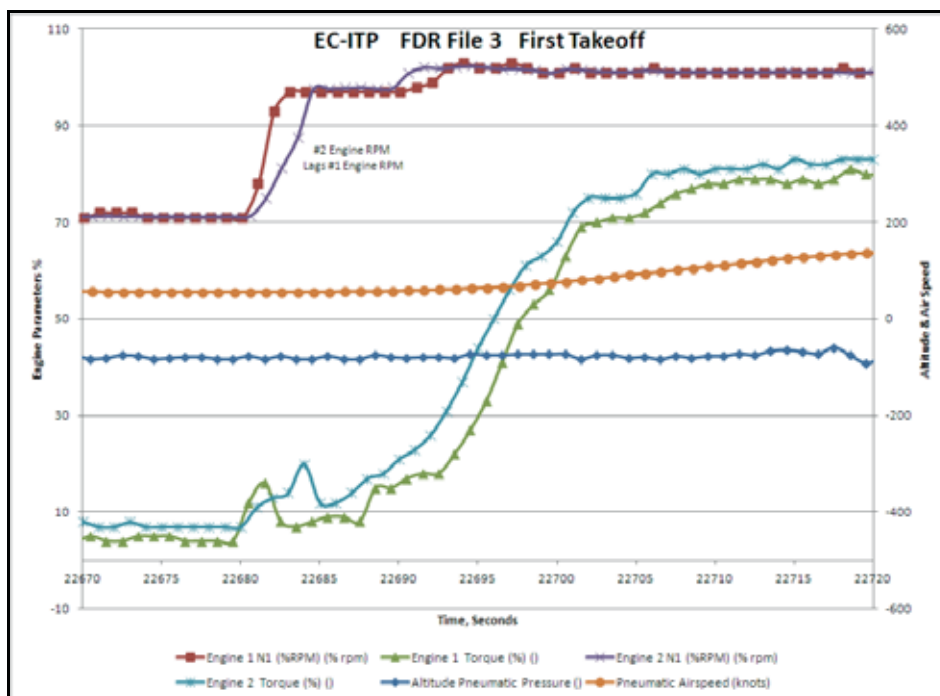
Figure No. 5: Additional sample of take-off FDR parameters weeks prior to accident

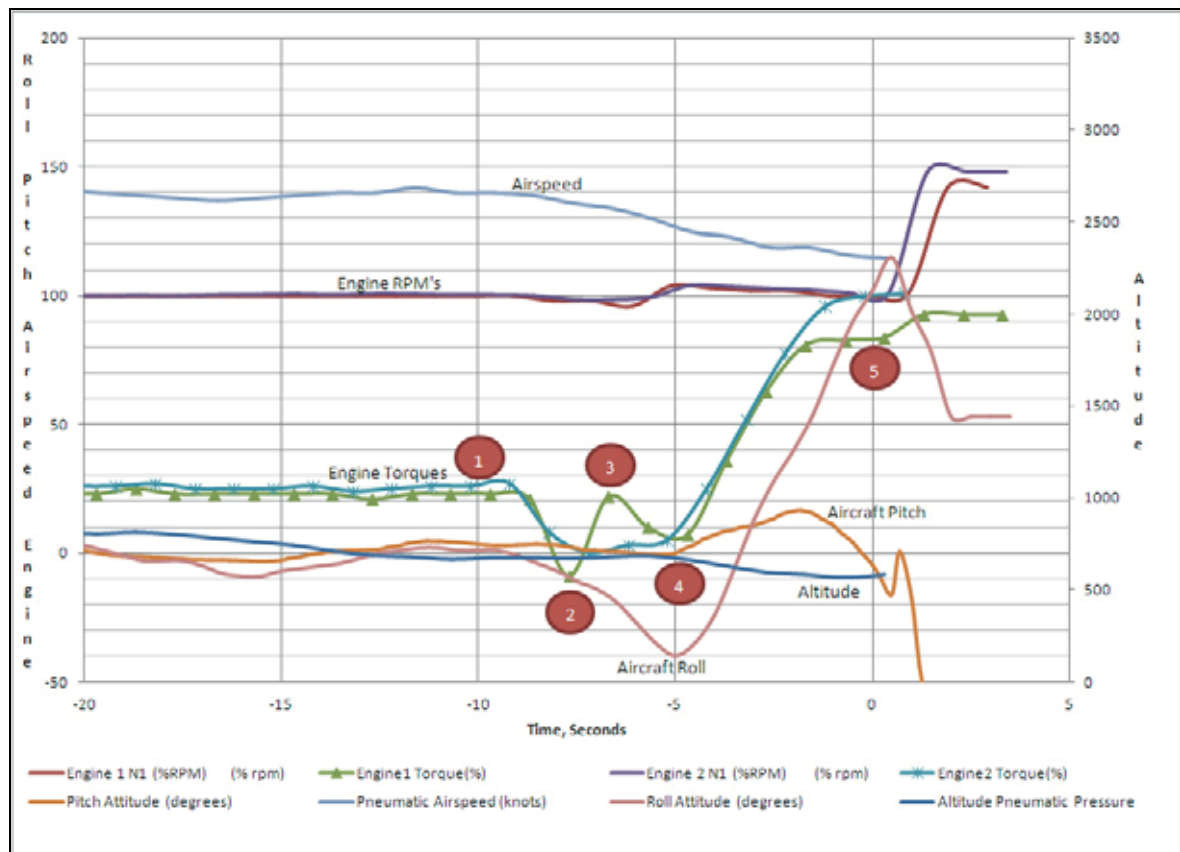
Figure No. 6 illustrates various FDR parameters recorded during the accident sequence. The x-axis represents time measured in seconds with the “0” point representing a time approximately one second before commencement of the impact sequence, when the values of recorded parameters became unreliable.

Figure No. 6: FDR Parameters during final approach (accident flight)

At datapoint 5, the engine RPM had decreased to 100.8% with a torque of 100.0% and a fuel flow of 573.9 lb/hr. These figures indicate that the fuel flow was again on the power lever schedule and that the USG and the OSG were inactive.

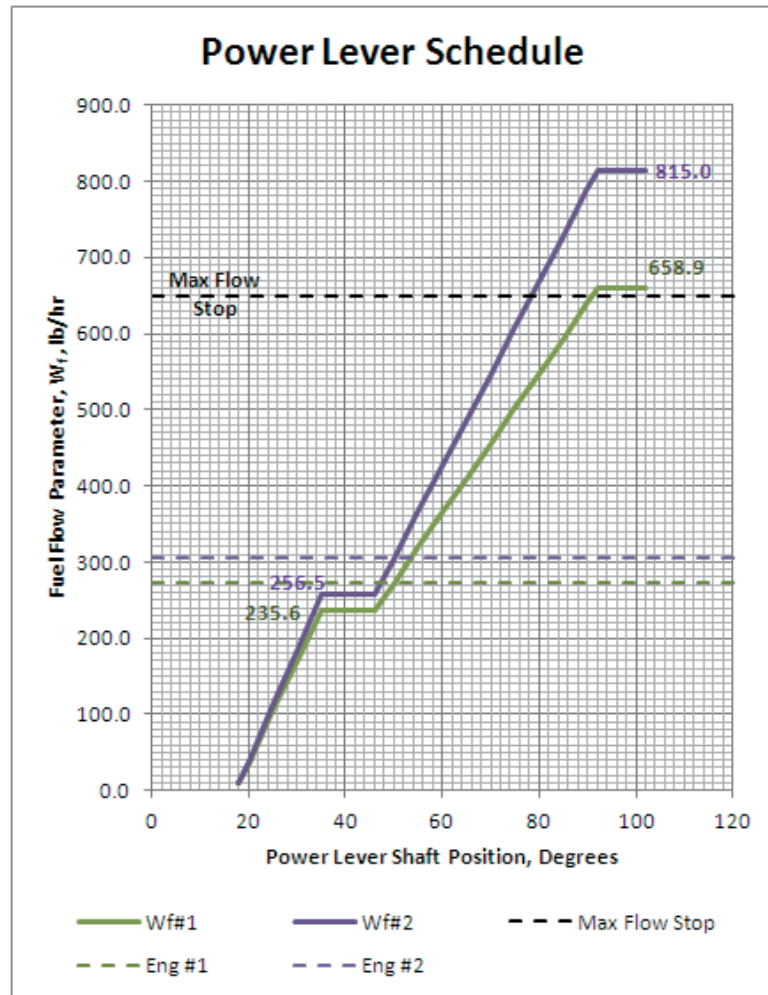
All of the above calculations take no account of the effects of the shortened P_{T2}/T_{T2} sensor bellows height and the consequent negative temperature bias. In order to calculate the power lever angle at those data points where the fuel flow was on the respective power lever schedule, it is necessary to use the curves shown in **Figure No. 7** (which is a reproduction of **Figure No. 3**) and takes into account the effects of the shortened bellows.

Figure No. 7: Fuel Flow/Power Lever Angle (PLA) Curves

In this figure, the curve of fuel flow (Wf#1) against PLA for the No. 1 engine, is shown in green while that for the No. 2 engine is shown in purple. If each of the fuel flow figures shown in **Table No. 3** is brought across to the applicable curve in **Figure No. 7**, then the equivalent power lever angles for each point can be derived. This data is shown for engines No. 1 and No. 2 in **Tables No. 4** and **No. 5** respectively.

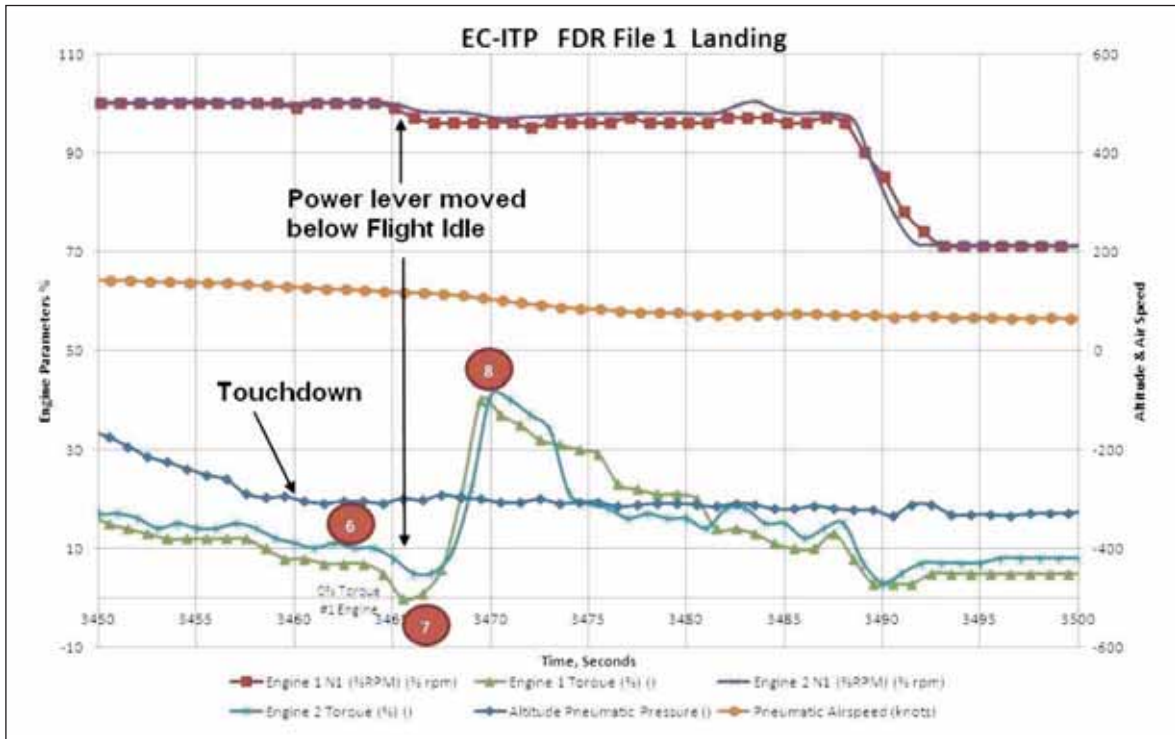
The Investigation looked at a landing which had been made by EC-ITP at a Spanish airport several weeks before the accident, and for which FDR data was available. **Figure No. 8** illustrates the FDR data for this landing in similar format to that shown for the accident. Time in seconds is shown on the x-axis while the various engine parameters along with altitude and airspeed are shown on the y-axis. The touchdown occurred at FDR time reference 3460.

Figure No. 8: FDR Data from Previous Landing

A similar analysis was carried out for this landing, and the manufacturer’s computer model was used to calculate the fuel flows at datapoints 6, 7 and 8 as shown in **Figure No. 8**. The data is shown for the No. 1 engine in **Table No. 6** and for No. 2 engine in **Table No. 7**.

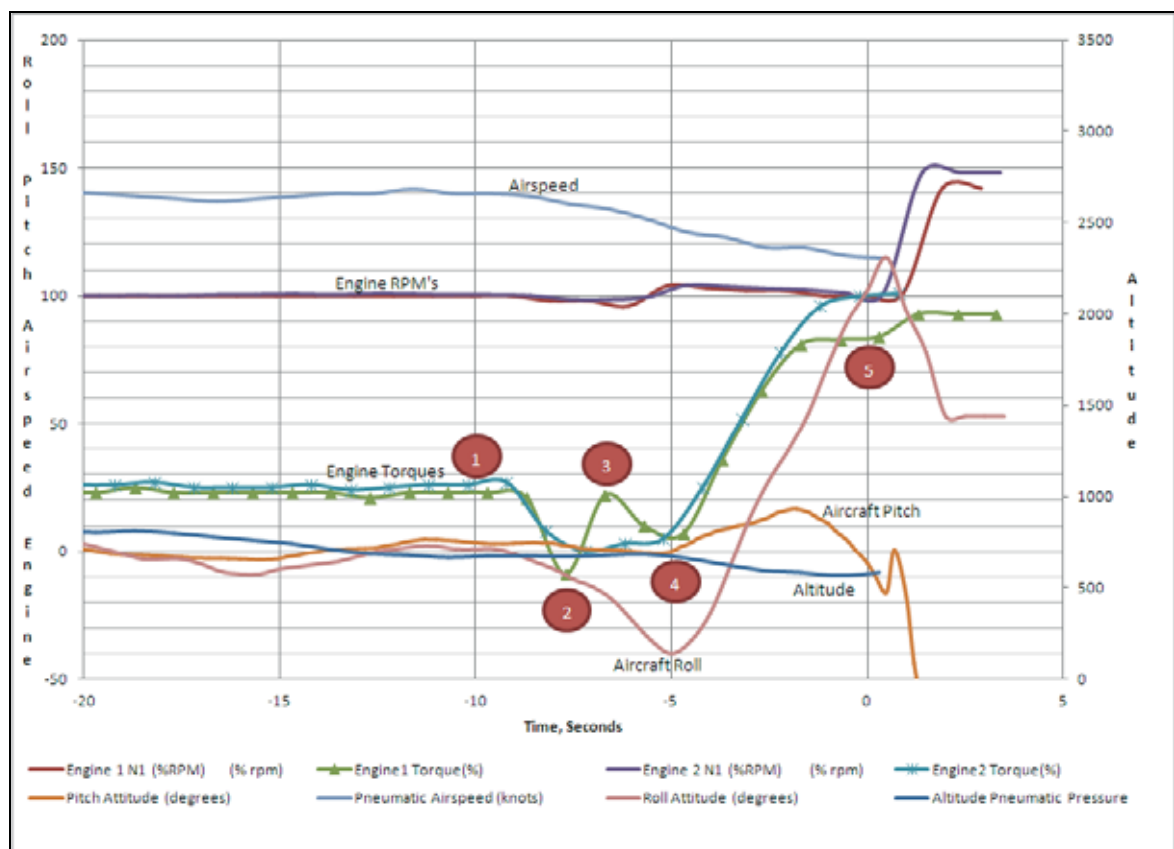
Regarding the final approach and the time period from -20 seconds to approximately -9 seconds, the engine torque for the No. 1 engine was recorded at values generally in the range 21 to 23% while that for the No. 2 engine was in the range 25 to 27%. During this period, the engine speeds were recorded as 100% for No. 1 engine and at values in a range between 100.0% and 100.7% for No. 2 engine, **Figure No. 9**.

Figure No. 9: FDR Parameters during final approach (accident flight)
