Report A-023/2016

Accident involving a GLASER DIRKS
DG-300 ELAN aircraft, registration D-0118,
in the municipality of Sabiñánigo
(Huesca, Spain) on 7 July 2016

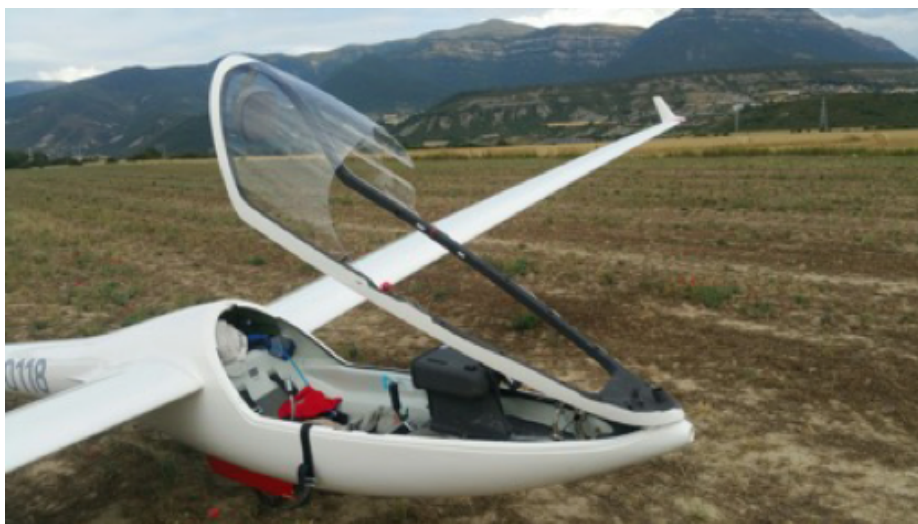
The impact broke a large portion of the cockpit and part of the instrument panel, and caused minor injuries to both of the pilot's legs.

Around 70% of the canopy's glass was broken, from the front of the cockpit to just behind the pilot's head. The frame also delaminated in several areas.

The impact affected the behavior of the instruments, moving the FLARM, the operation of which was not checked, and causing the loss of the anemometer and altimeter readings.

A navigational device mounted with a suction pad inside the canopy was lost when it fell out.

Figure 1. Damage to the glider's canopy

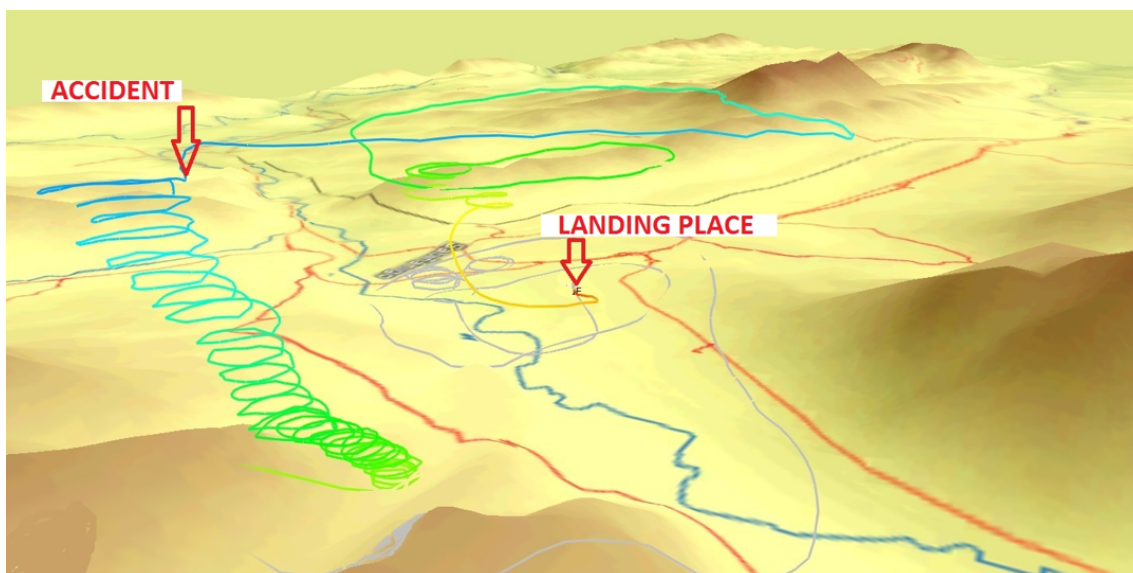
The GPS did record the full flight. A study of the flight path shows that it was during the last climb, done with help from a thermal, that the glider collided with the vulture. The glider reached an altitude of 2300 m during this climb. Then, in a controlled, spiraling descent, the pilot was able to fly to a field where he could land the aircraft.

Figure 2. Views of the final climb showing where the aircraft impacted the vulture and the descent to the landing location

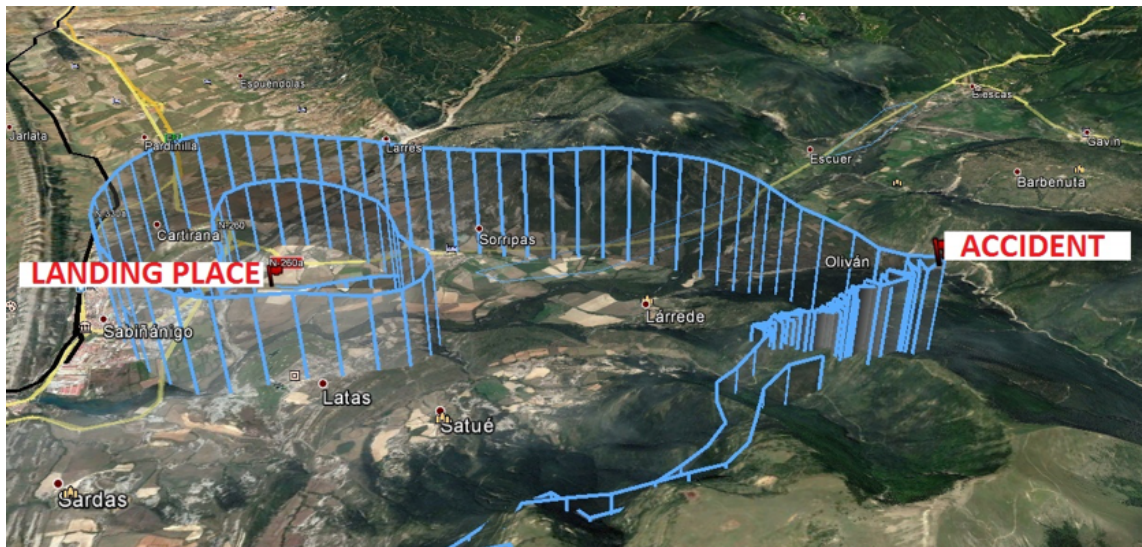
Figure 3. Views of the final climb showing where the aircraft impacted the vulture and the descent to the landing location
