Report A-032/2017

**Accident involving a Bell 412 aircraft,
registration EC-MMC, operated by Babcock
International Group PLC, and a CASA 1131
aircraft, registration N1950M, at the
aerodrome of Mutxamel (Alicante, Spain) on
30 December 2017**

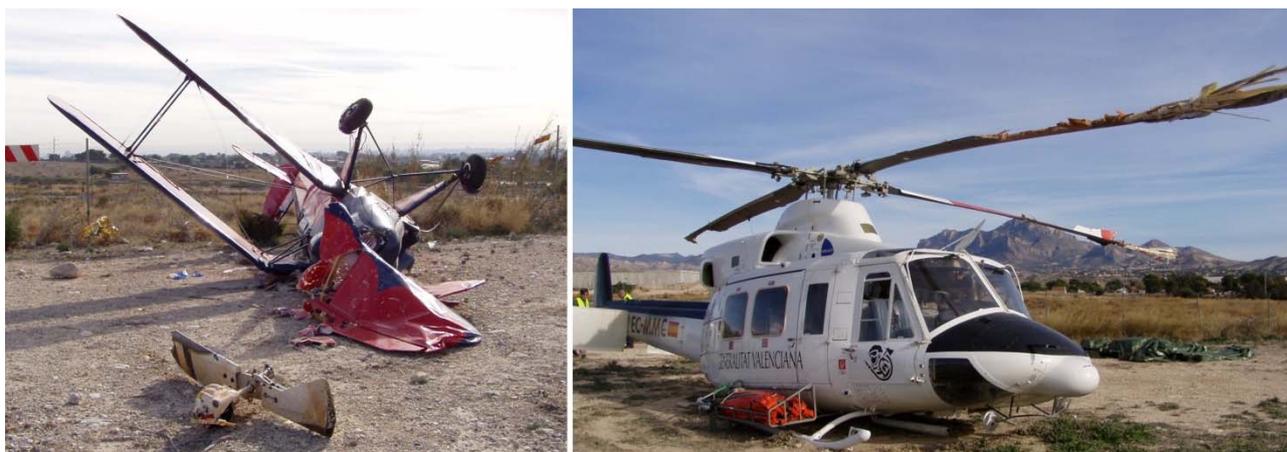
Figure 2. Aircraft after the accident

The photos in Figure 2 show the final condition of both aircraft.

The Bücker 131 crashed to the ground in an inverted position some 60 m away from the runway 30 threshold, damaging as it fell the metal perimeter fence of the aerodrome. It came to stop approximately facing northwest.

After the two aircraft collided, the pilot of EC-MMC managed to regain control of the helicopter, making an emergency landing with the skids impacting the ground. The pilot landed on a strip some 40 m away from the runway threshold, coming to a stop facing slightly to the southwest.

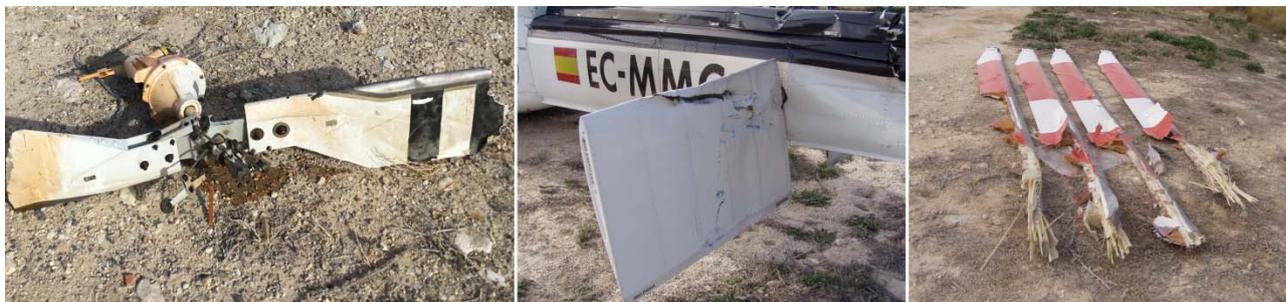
Figure 3. Aircraft EC-MMC

The collision between the two aircraft caused the tail rotor of aircraft EC-MMC to detach, the tail rotor drive shaft to break, damaged the horizontal stabilizer, tailcone and all four main rotor blades, and collapsed the skids.

The photo in Figure 3 shows the tail rotor and the condition of the horizontal stabilizer and main rotor blades after the accident.

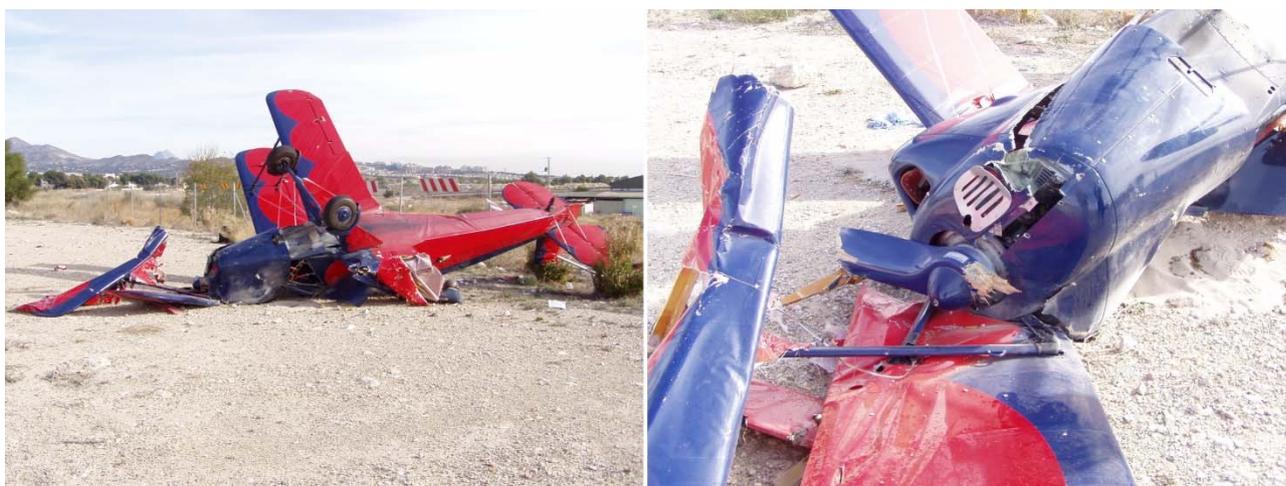
Figure 4. Aircraft N1950M

On the Bücker, the top and bottom right wings, propeller blades and engine cowling broke. There was also miscellaneous damage to the fuselage and in the cockpit.

Figure 4 shows the final condition of the Bücker.

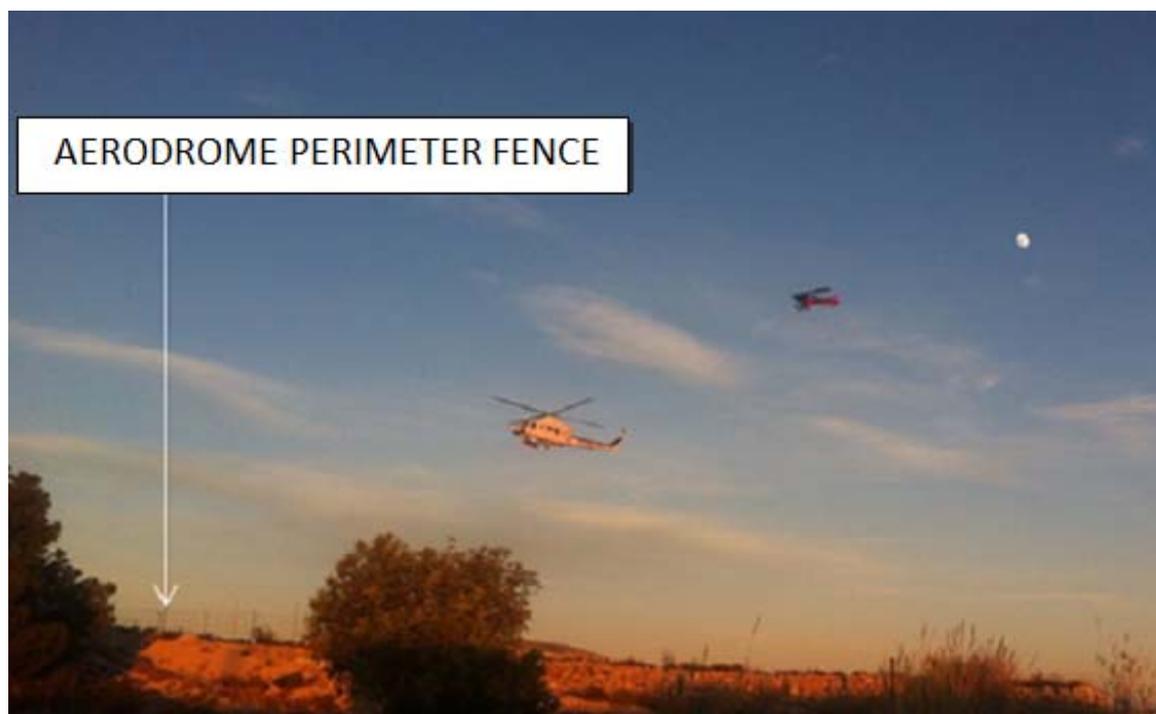
Figure 5. Positions of the aircraft on final approach

Figure 5 shows a photograph taken by eyewitnesses located outside the aerodrome grounds, specifically, south of the runway 30 threshold, moments before the accident.

The photo shows the aircraft involved descending during the final approach to runway 30.

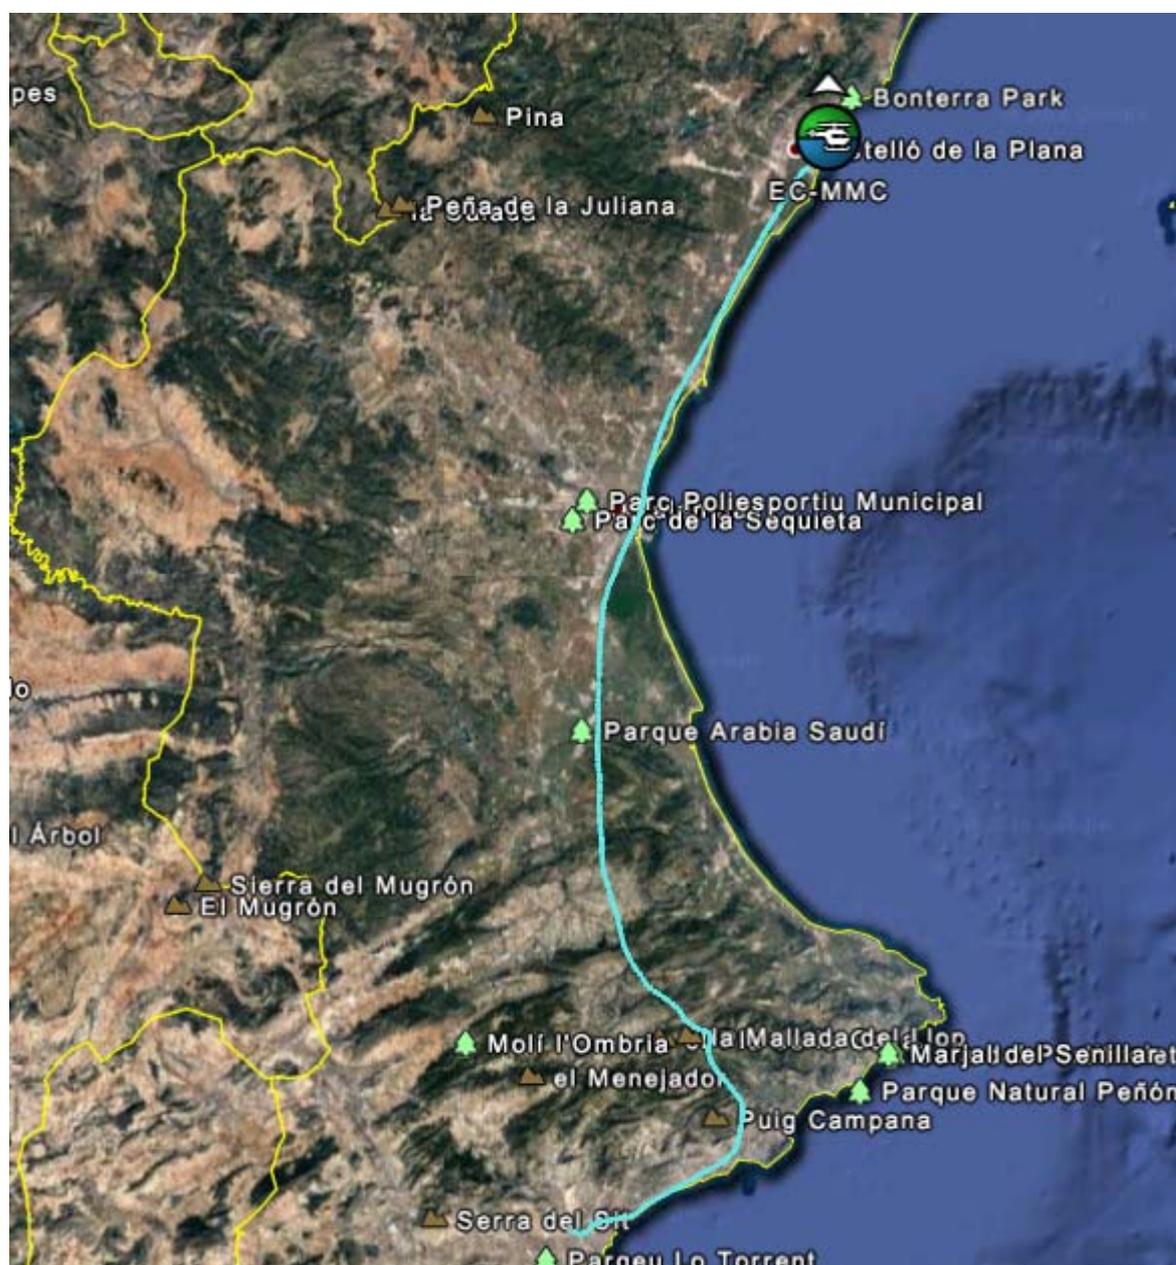
Figure 7. Track of aircraft EC-MMC

Shown in red in Figure 7 is the track followed by aircraft EC-MMC as it joined the final segment of the aerodrome pattern. The track was obtained from the fleet tracking data.

The track followed by aircraft EC-MMC shows that it directly joined the final segment of the pattern to land on runway 30, as instructed in the visual approach chart for the aerodrome.

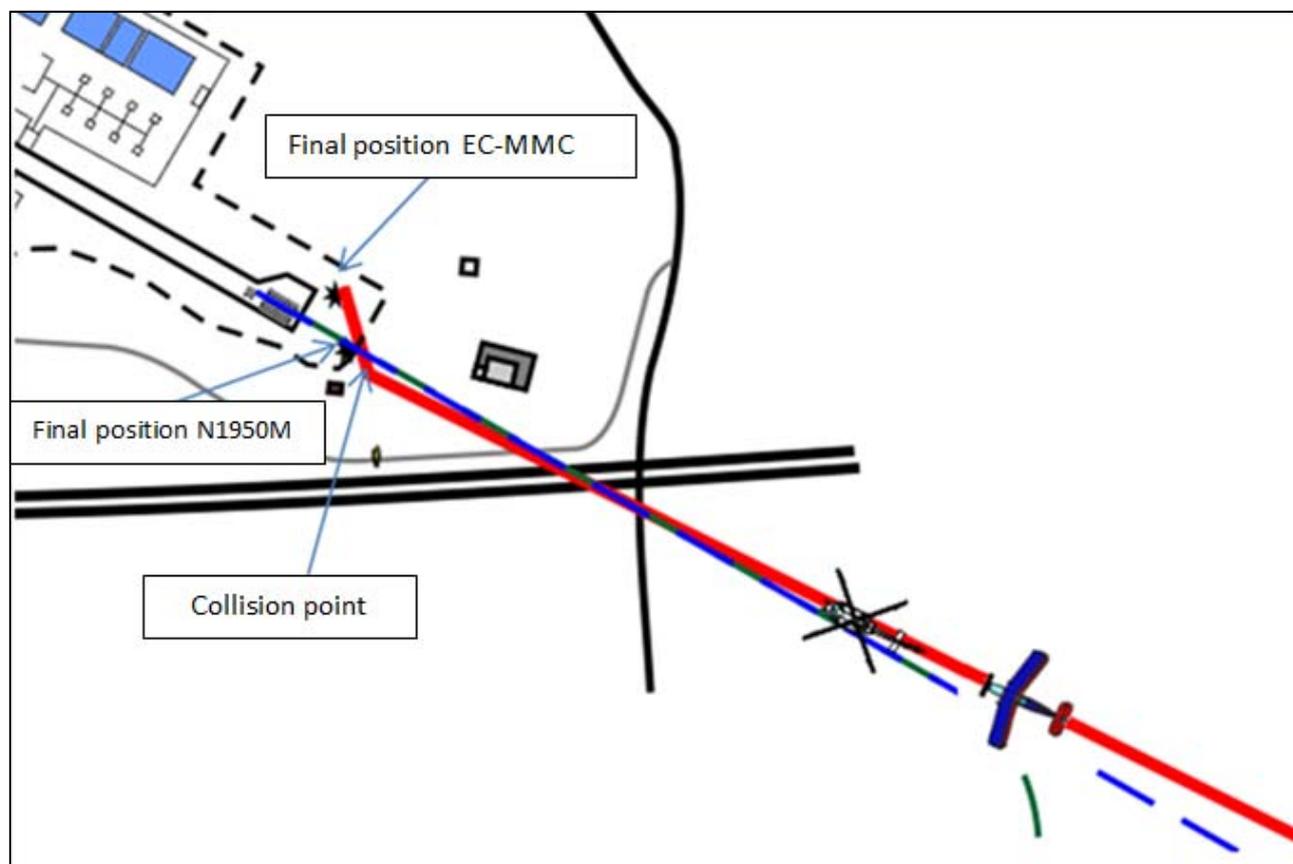
Figure 9. Aircraft on final approach to RWY30

The close-up shown in Figure 9 provides the positions of both aircraft on final approach seconds before the collision. This sequence was obtained from the fleet tracking data provided.

Also shown is the point of impact and the final positions of the aircraft after the accident.

In the moment of the collision, occurred approximately at 17:42 h, the height was 4 m, and groundspeed and course for the helicopter were 61 km/h and 294°.
