CIAIAC

Report ULM A-002/2018

Accident involving an Evektor EV-97
Eurostar aircraft, registration EC-EZ3,
at the Cordoba Airport (Spain) on 13
January 2018

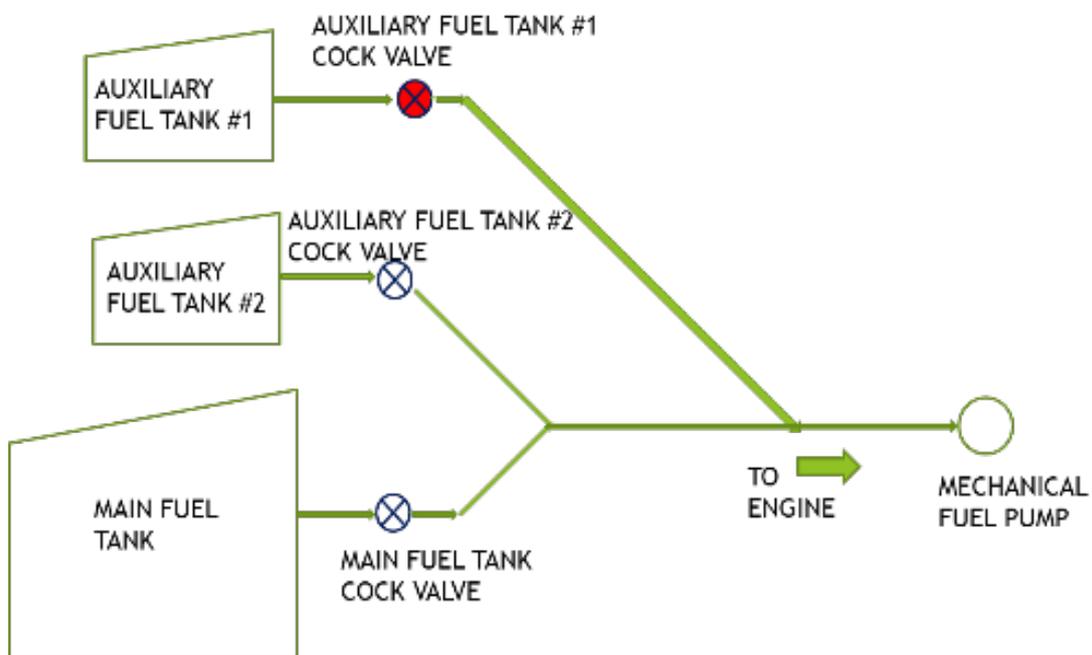
Illustration 4. Diagram of the tanks and connecting lines in the fuel system of the accident aircraft

two auxiliary fuel tanks. One of these two auxiliary fuel tanks (identified as auxiliary tank #2 in this report) had been removed by the aircraft's current owner before the accident. The other auxiliary tank, however (identified as auxiliary tank #1 in this report), with a 42-liter capacity, maximum of 50 liters, was being used by the current owner.

Auxiliary tank #1, along with the lines connecting the tanks, was installed higher than the main fuel tank and the mechanical fuel pump. This means that the mechanical fuel pump was below auxiliary tank #1 but above the main tank.

The fuel system on the accident aircraft had been altered, and was not the same as the fuel system originally installed by the manufacturer. This design and modification of the fuel system had already caused a previous incident on this aircraft, on 24 September 2012, due to an error in the operation of the system, thus confirming its inherent operational weakness.

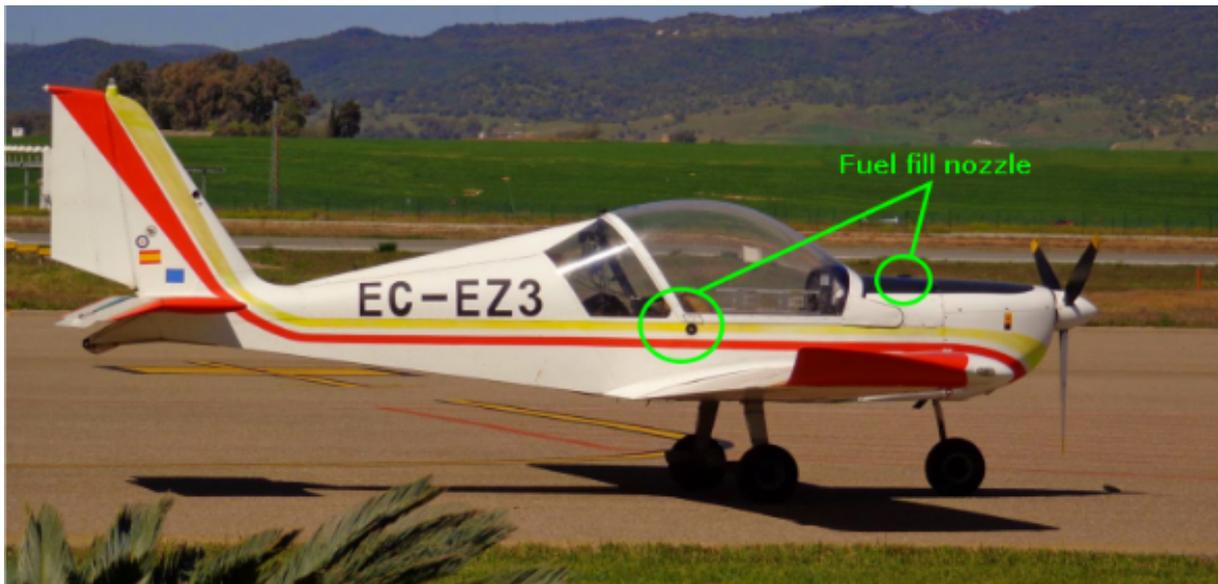
Illustration 5. Fuel fill nozzles on the accident aircraft

the main tank, this nozzle was not used; in its place, the fuel was loaded through the auxiliary tank fill nozzle located on the engine cover. The fuel was transferred from the auxiliary to the main tank by gravity by opening a cock valve that had been installed when the fuel system was modified. To keep the mechanical fuel pump on the engine from sucking in air instead of fuel and stopping the engine, it was necessary to close the cock valve before the fuel in the auxiliary tank was depleted.

A second fuel fill nozzle had also been installed at the front of the fuselage, forward of the cockpit. This fill nozzle was for auxiliary tank #1. The photograph below of the accident aircraft shows a fuel fill nozzle on the right side of the fuselage, below the cockpit, which supplies the main tank, and this second fill nozzle above the engine, which supplies auxiliary tank #1¹¹.

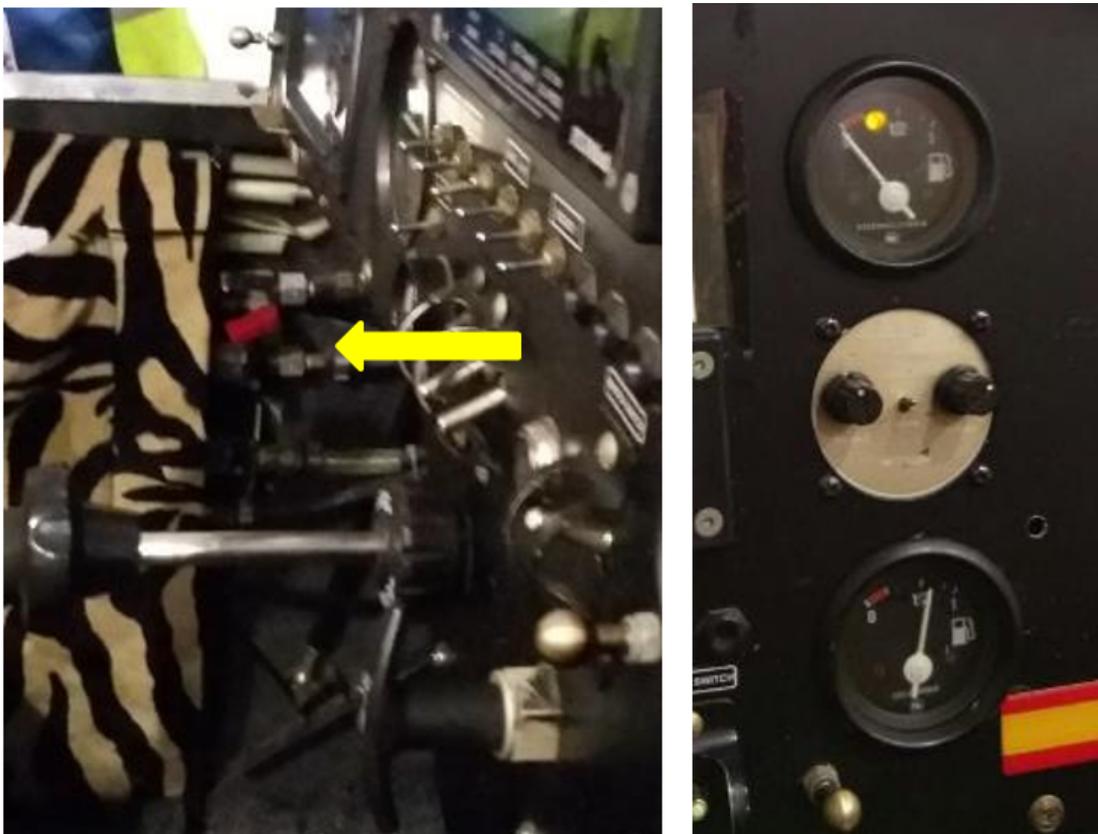
Illustration 6. Close-up in the cockpit: (left) the three fuel cocks that control the three fuel tanks, (right) fuel gauges for the auxiliary and main tanks

The photographs below show how the fuel supply to the engine is controlled in the cockpit. The photograph on the left shows the three fuel cocks that control the flow of fuel from the various tanks to the engine, and the photograph on the right shows the two fuel gauges: the top one shows the amount of fuel in auxiliary tank #1, and the bottom one the amount of fuel in the main tank.

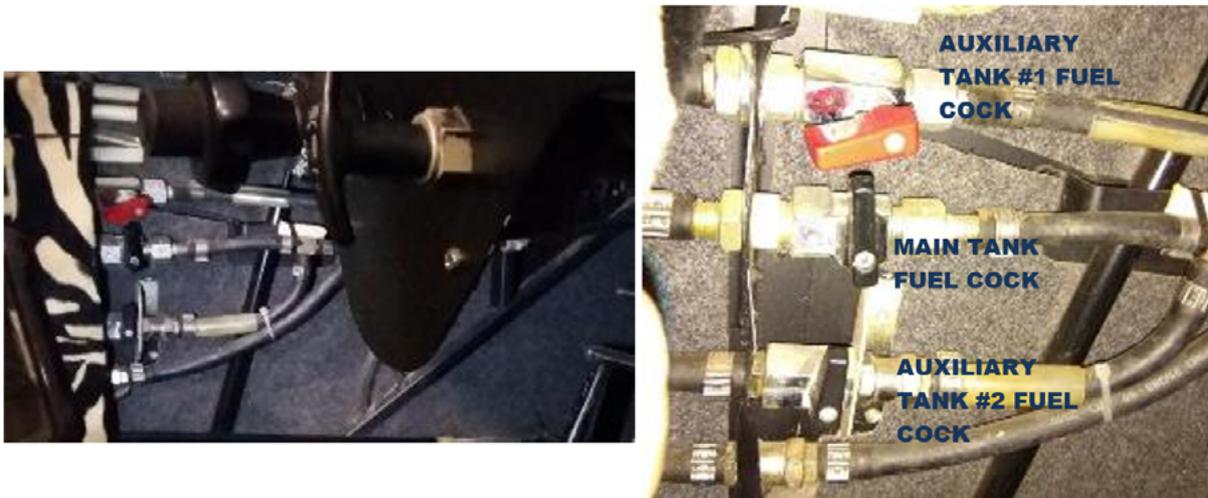
Illustration 7. Identification of the three cock valves

On the day of the accident, the cock valve mentioned in the above paragraph was open, allowing fuel to be transferred from the auxiliary tank to the main tank. The checklists, written by the operator, contain items reminding the pilot of the requirement to close the cock valve both before takeoff and when the engine is turned off after landing. However, those actions were not carried out on that day.

Each of the cock valves used to control the flow of fuel from the various tanks to the engine is shown in the photographs below.

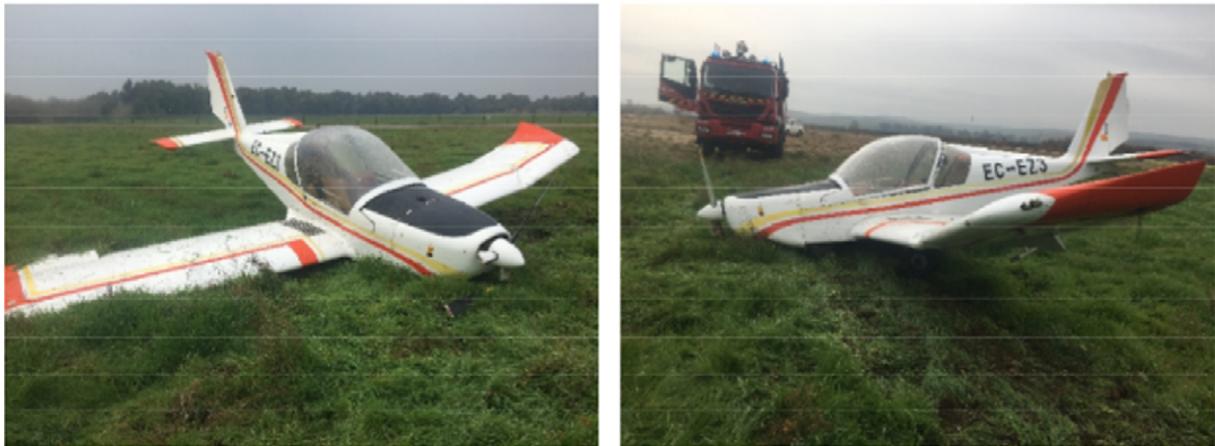
Illustration 10. Final condition of the ultralight

The aircraft sustained significant damage during the off-field emergency landing. The landing gear on the aircraft was damaged and the left wing was bent upwards.

During the emergency landing, the aircraft impacted with the left wingtip, which caused it to turn sharply left until it came to a stop, some 30 meters away from runway 03.

The photographs below show the final position of the aircraft. The left wing was bent upward, the nose gear gave way below the fuselage and the right main gear was bent. Of the three propeller blades, two were broken.

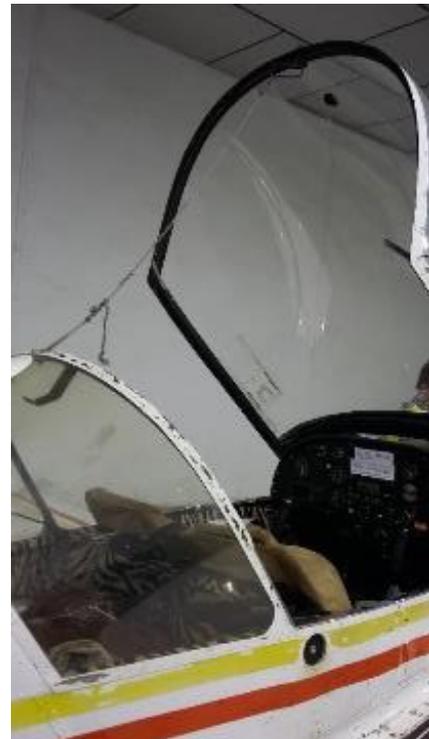
Illustration 13. String used in the aircraft to keep the canopy from opening in flight

¹³. It should be noted that in November 2015, Evektor-Aerotechnik issued service bulletin EV97-033a, classified by the manufacturer as mandatory and applicable to all Eurostar and Sportstar aircraft with a metal frame around the canopy. The reason given was that as a consequence of non-observance of procedures, in certain circumstances the cabin lock could be released in flight, causing the canopy to open. The SB requires installing a mechanical latch in the frame of the canopy to act as an additional safety element and keep the canopy from opening if the locking mechanism failed (it would only open a few centimeters).
