COMISIÓN PERMANENTE DE
INVESTIGACIÓN DE ACCIDENTES
E INCIDENTES MARÍTIMOS

CIAIM-04/2023 report

Collision between the fishing vessel ZERUKO ERREGIÑA and the recreational vessel CLEM 7 miles east of the lighthouse of La Entallada (Fuerteventura), on March 30, 2022

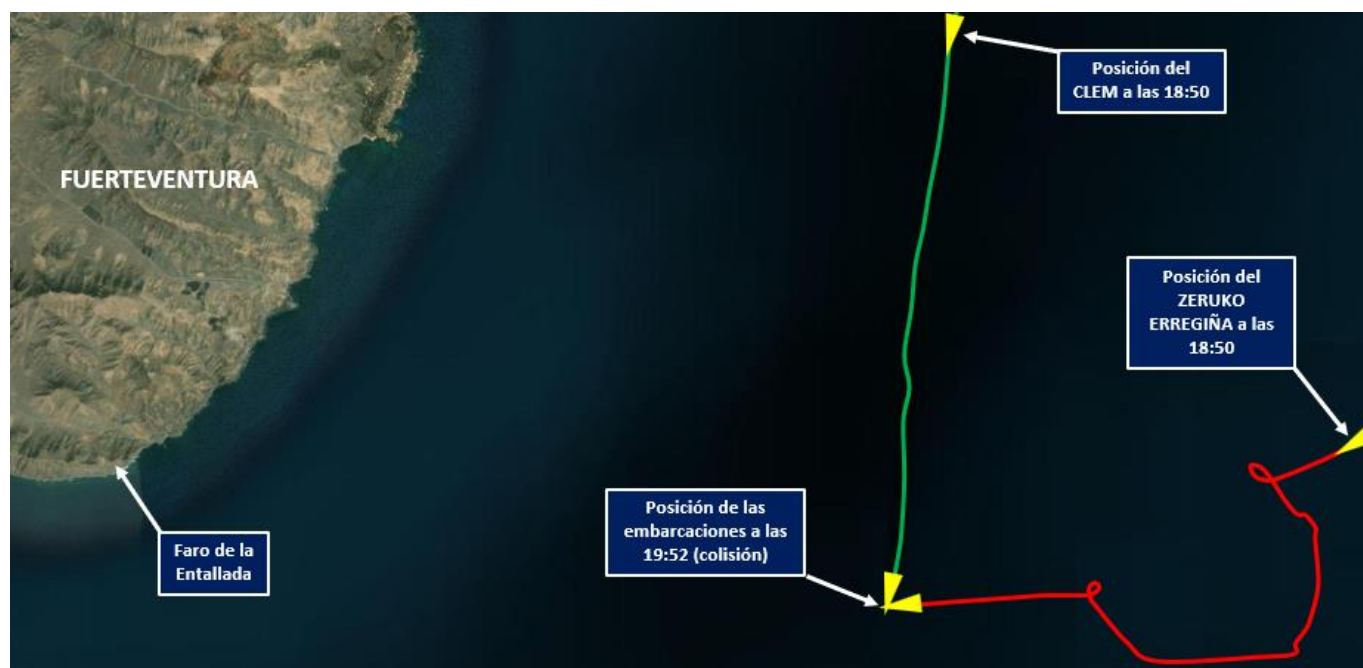
Figura 5. Courses followed by the fishing vessel ZERUKO ERREGIÑA (in red) and the recreational vessel CLEM (in green) since one hour before the accident. (Special data infrastructure viewer of the Hydrographic Institution of the Spanish Navy)

- 12 In Figura 5 of the previous section, which shows the courses of the CLEM and the ZERUKO ERREGIÑA starting from one hour before the accident, no significant changes of direction on the part of the two boats are observed in the
- 14 moments prior to the accident. This can be seen clearly in the representation shown in Figura 7 and by an analysis of the data in Table 1.
- 16 During the 15 minutes prior to the accident, the distance between the two boats decreased from two and a half nautical miles, the distance between the boats when they were at their initial positions in Figura 7, without the
- 18 two skippers doing anything to avoid the risk of collision, which increased progressively with the passing of time. The accident occurred at 19:52 hours, near Position 33 in Table 1.

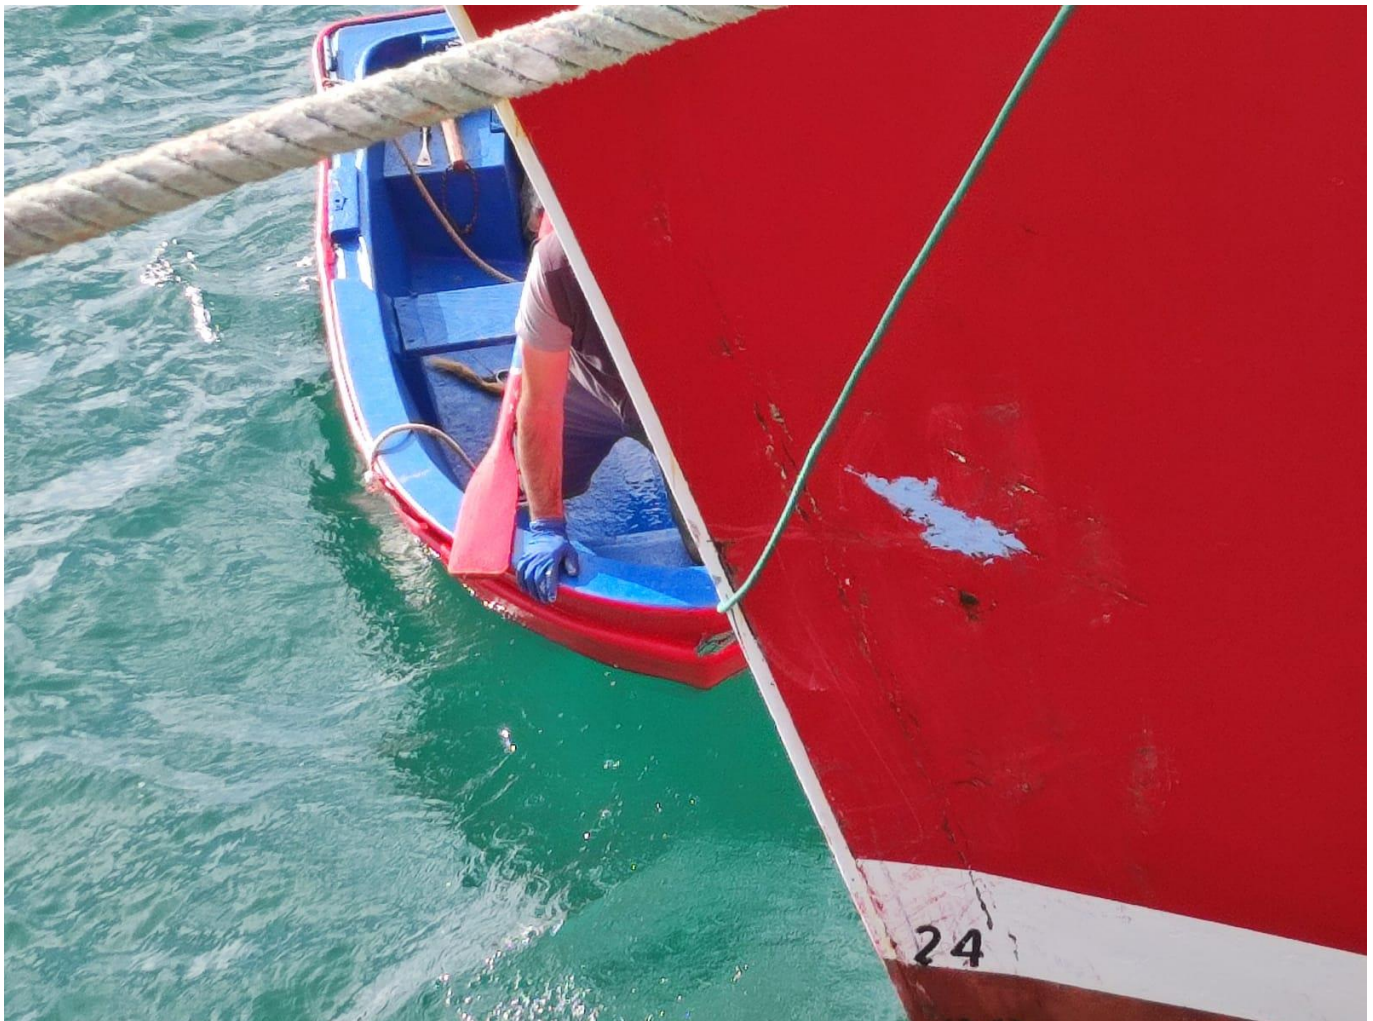
10 On 31 March a technician from a boatyard in Arrecife inspected the damage to the fishing vessel ZERUKO ERREGIÑA
(see Figura 6). In his report, the technician stated that during his inspection he did not observe any structural
12 damage in the zone affected by the collision, but only a few scratches.

Figura 6. Close-up of the damage suffered by the ZERUKO ERREGIÑA during the accident

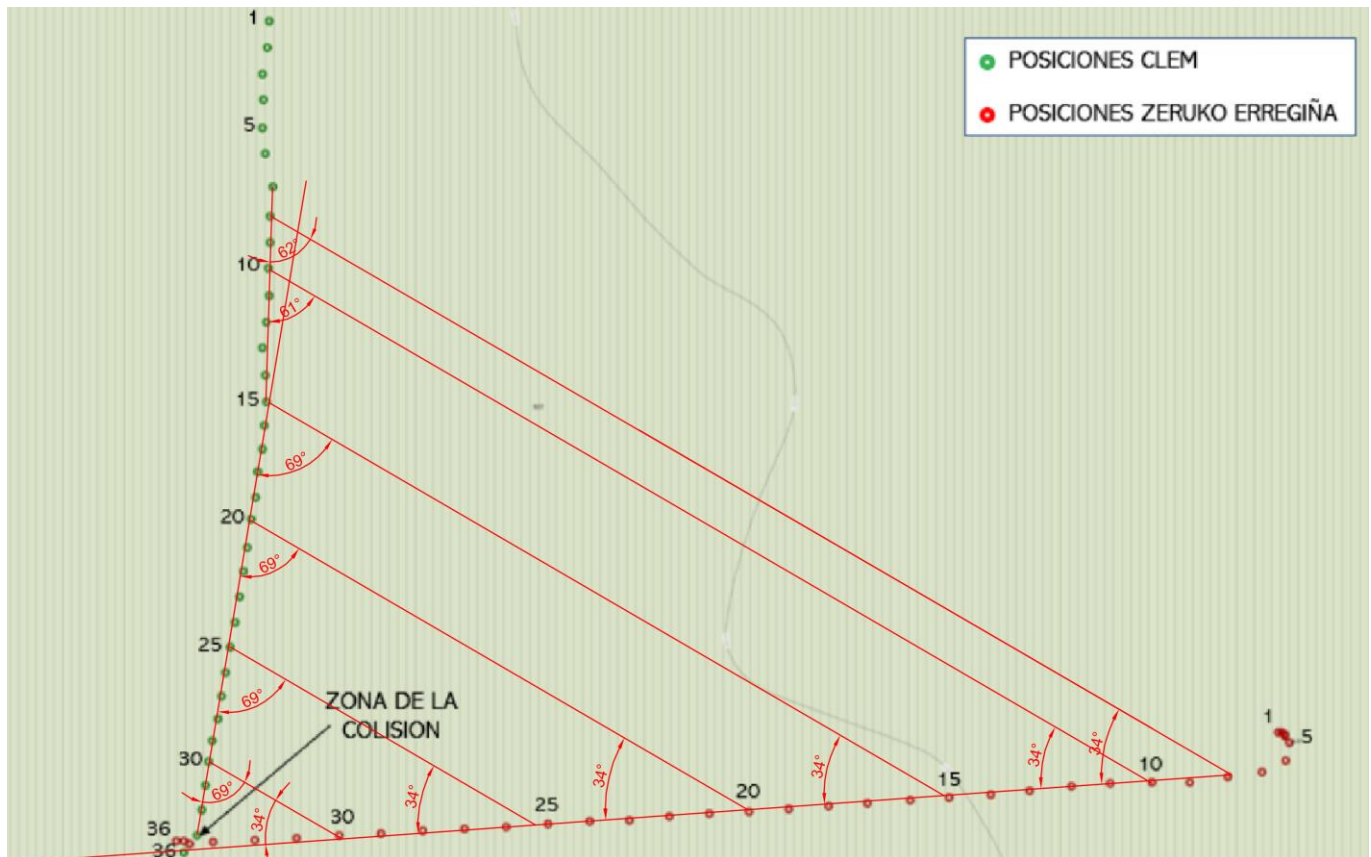
Figura 7. Positions of the fishing vessel ZERUKO ERREGIÑA and the recreational vessel CLEM before the accident

- 24 An analysis of Table 1 and of the graph in Figura 7 shows that towards 19:38 hours, near Position 8, the skipper of the fishing vessel set its direction on a course close to 260° and increased its speed to 8 knots. The direction and
- 26 speed of the boat remained more or less constant until the time of the accident. The variations in the direction of the vessel seen in the table of data are due to the drifting caused by the wind and the swell, and the
- 28 corresponding corrections made by the automatic pilot to maintain the direction set. The variations in speed may

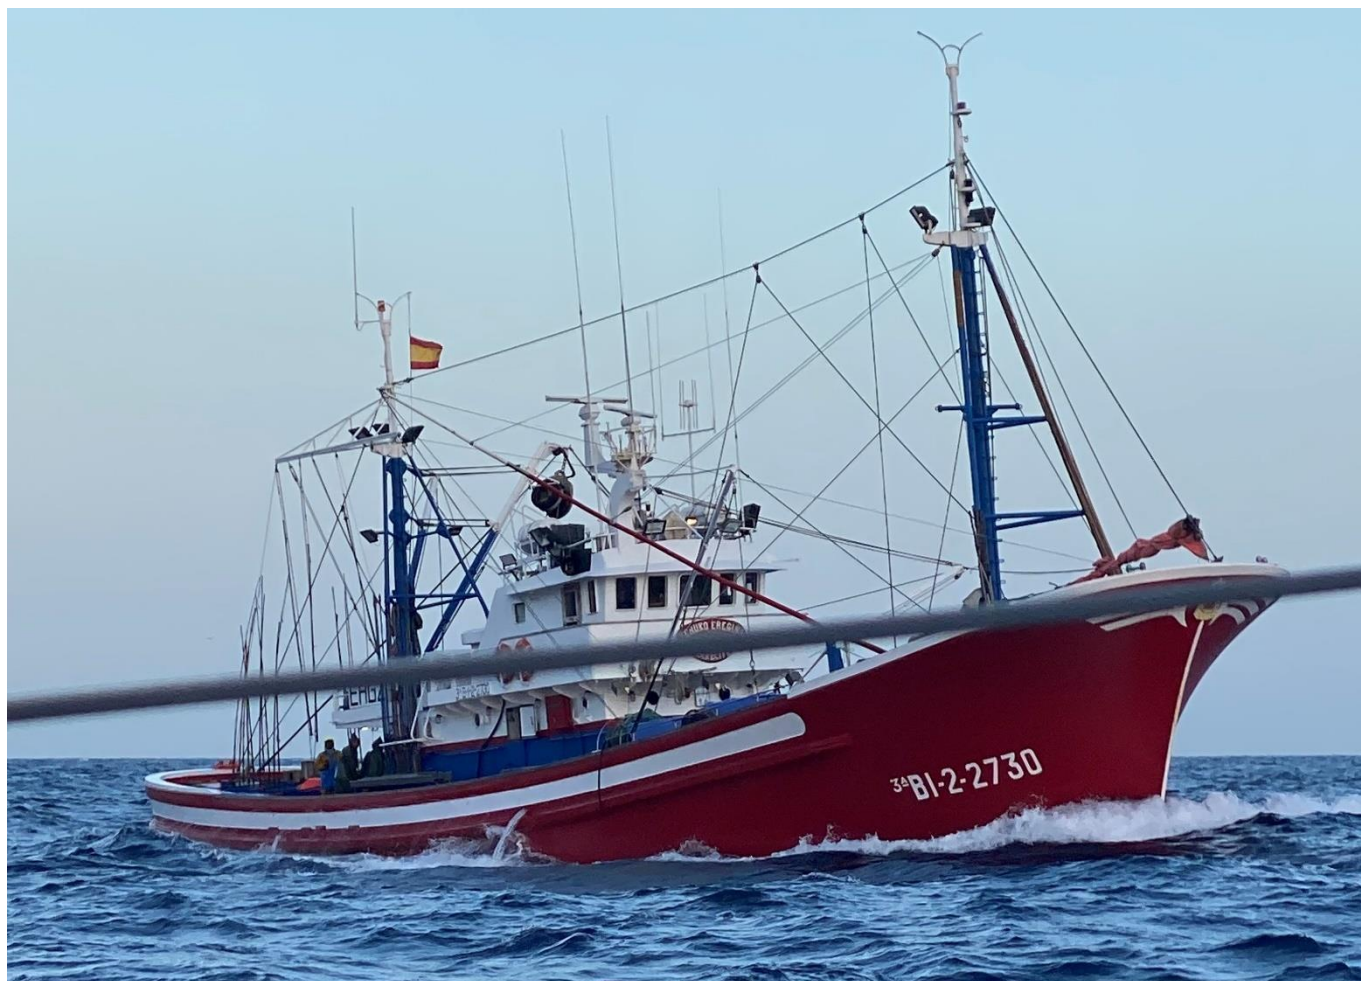
Figura 8. Photograph of the fishing vessel ZERUKO ERREGIÑA taken by the skipper of the CLEM just before the accident

Furthermore, in the previous image it can be observed that the ZERUKO ERREGIÑA does not display any indication that can identify it as a fishing vessel, as required by the COLREGs in Rule 26 - Fishing vessels.
