Report on the investigations of  
heavy weather damage  
on board the container ship  
***Maersk Newport***  
50 miles west of Guernsey  
on 10 November 2008  
and fire  
alongside at the container berth in Algeciras, Spain  
on 15 November 2008

**Report No 13/2009**  
**June 2009**

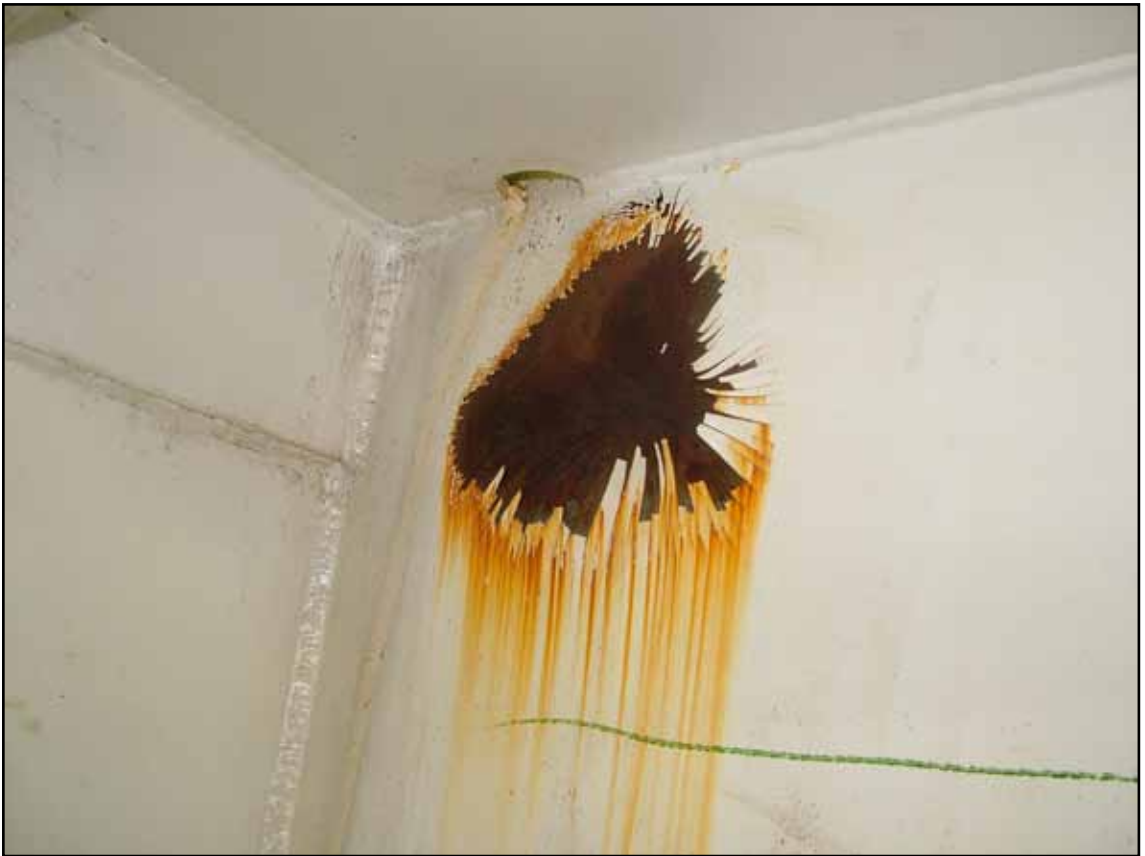
Figure 3

The outgoing chief engineer cautiously opened the bow thruster room hatch and, as there was no evidence of a fire, he went down the ladders. As he descended he immediately noticed three, 150mm by 250mm, holes in the port side of the hull. As the vessel pitched, water was sprayed into the compartment and over the electrical distribution and control panels. The chief engineer also noticed that there were numerous hull indentations (**Figures 3 and 4**) and that the bilge was full of water. He reported the damage to the master on the bridge and that he suspected that the port anchor had been released, causing the damage. He then instructed the fourth engineer to return to the ECR to fully isolate the electrical supplies to the bow thruster room. The bilge suction valve was opened and the 5 ton/hour bilge pump was started in an attempt to lower the water level.

Hull indentations - port side bow thruster room

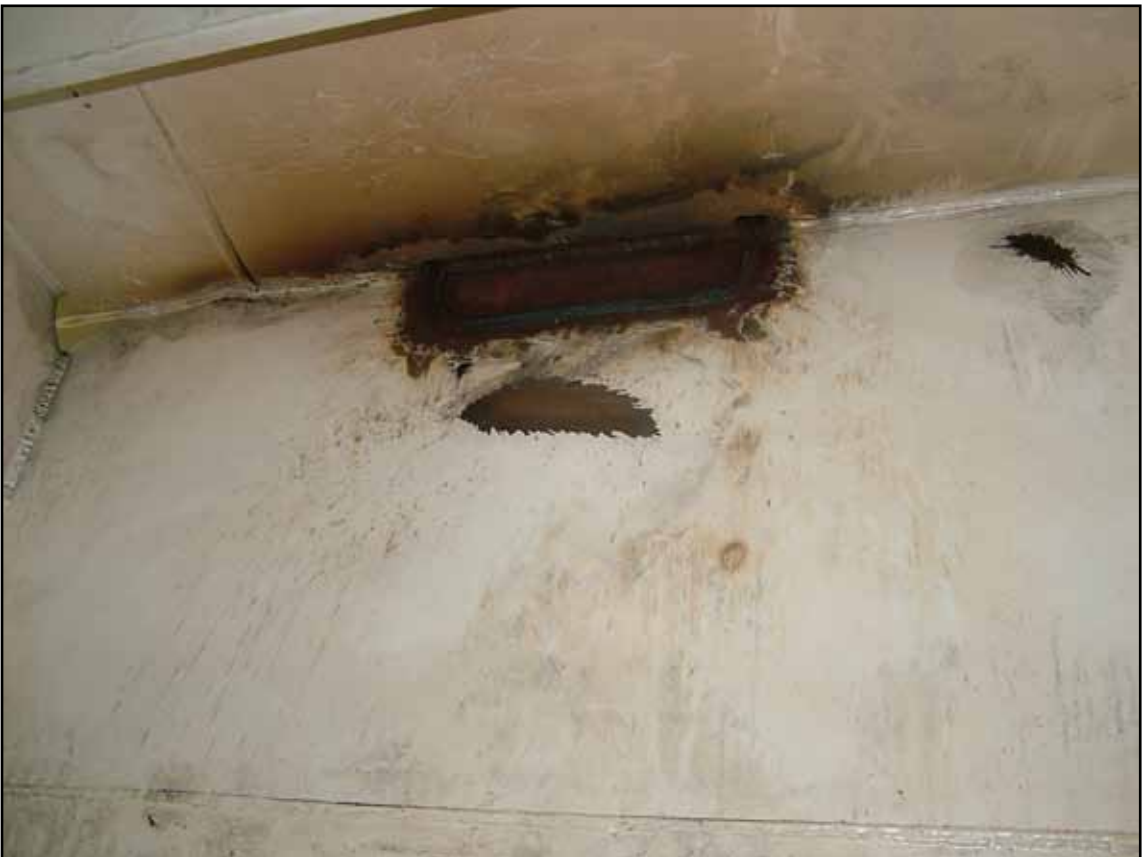
Figure 4

Hull indentations - port side bow thruster room

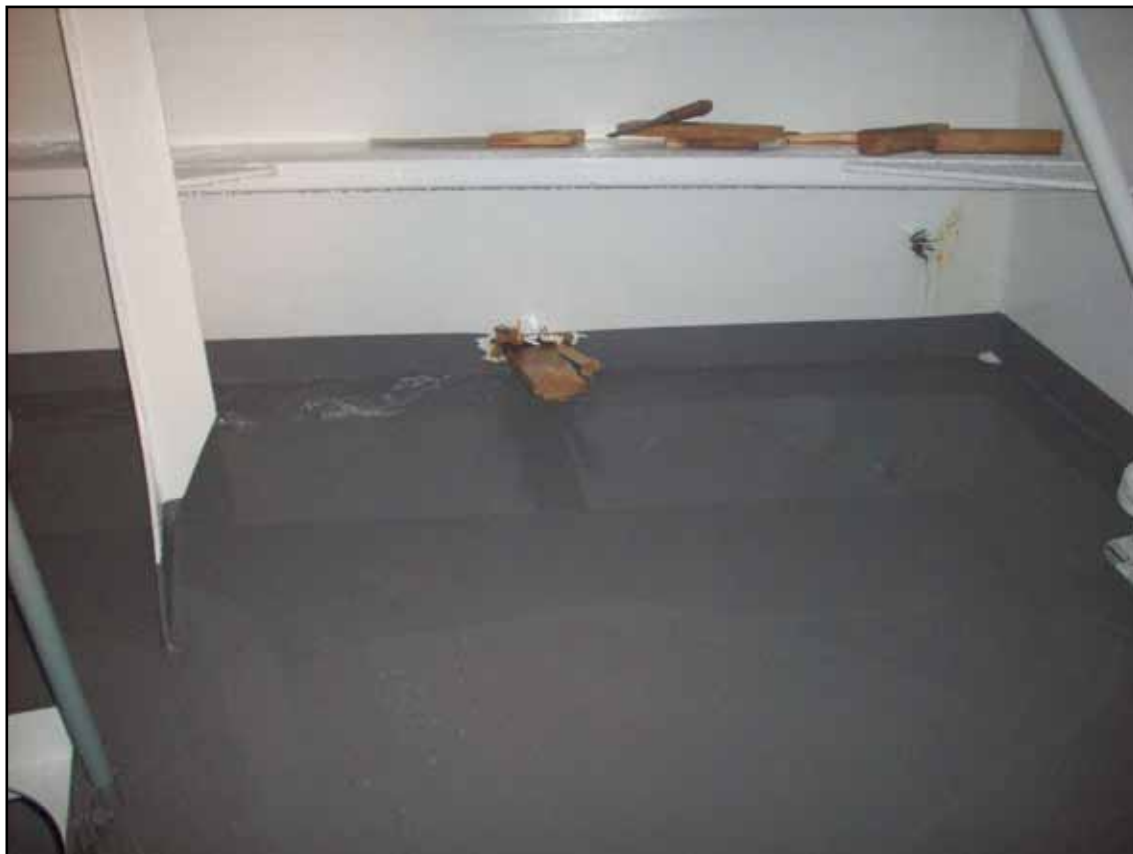
By about 1400 the team in the bow thruster room had managed to significantly reduce the inflow of water (**Figure 6**). The bilge water at this point was about 1.25m deep and appeared constant, so the engineering team believed that the bilge pump was coping with the rate of water ingress. In the meantime, the ship was ballasted with about 400 tonnes of sea water using the after ballast tanks.

Example of bow thruster room damage control measures

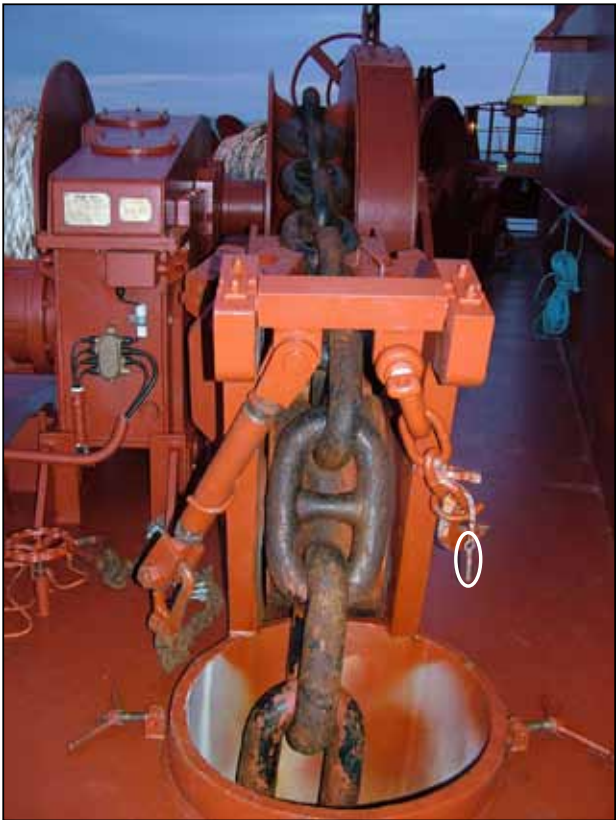
Figure 7

The forecastle team found that about  $\frac{1}{2}$  to  $\frac{3}{4}$  shackle of the port anchor cable had been released. The lashing chain Senhouse slip tapered securing pin had become detached from the slip and was hanging by its chain (**Figure 7**) and that the lashing chain was hanging loose. It was also found that the forward guillotine block was in the upright open position while the after guillotine block was in the horizontal closed position – **Figure 8**. Before the anchor cable was recovered, the chief officer checked the winch brake and managed to apply one full turn of the brake handwheel. After the port anchor was fully secured, checks were made to confirm that the starboard anchor was also fully secured.

Senhouse slip securing pin in detached position

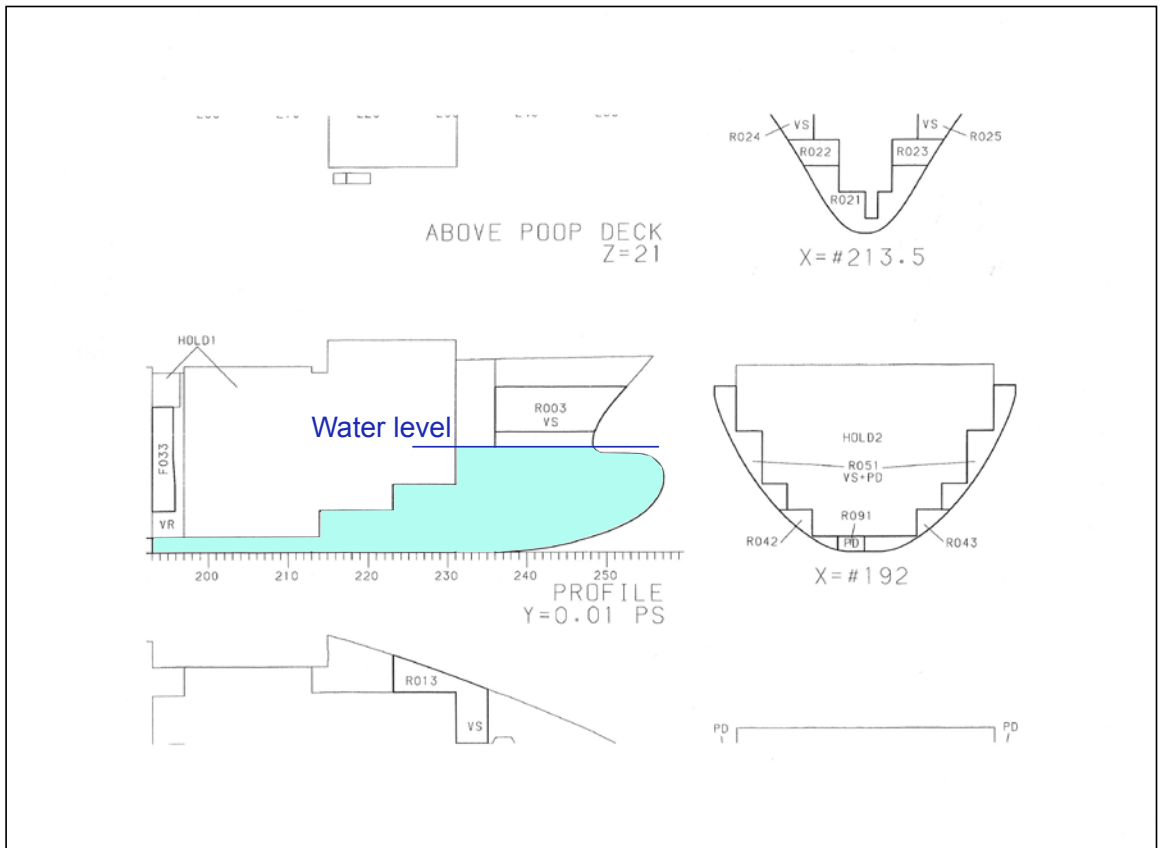
Figure 9

Ship's section showing extent of flooding

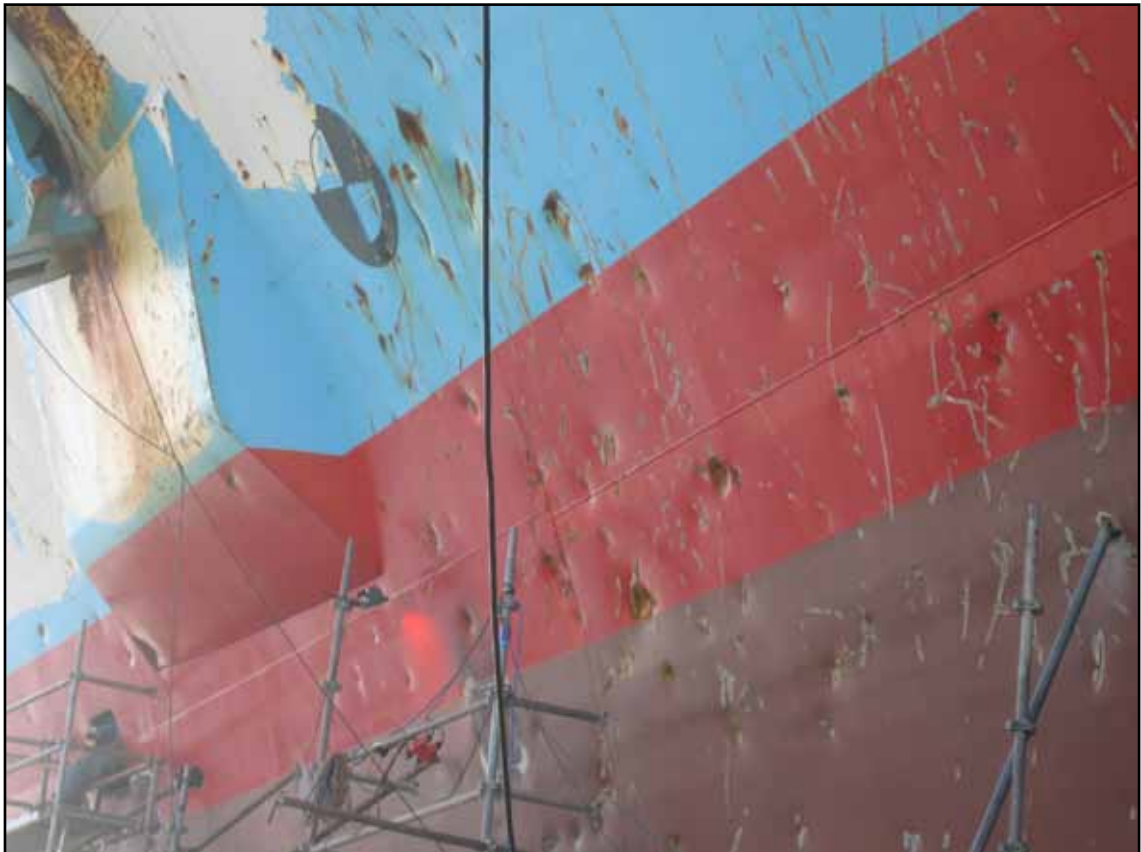
Figure 11

Hull indentations

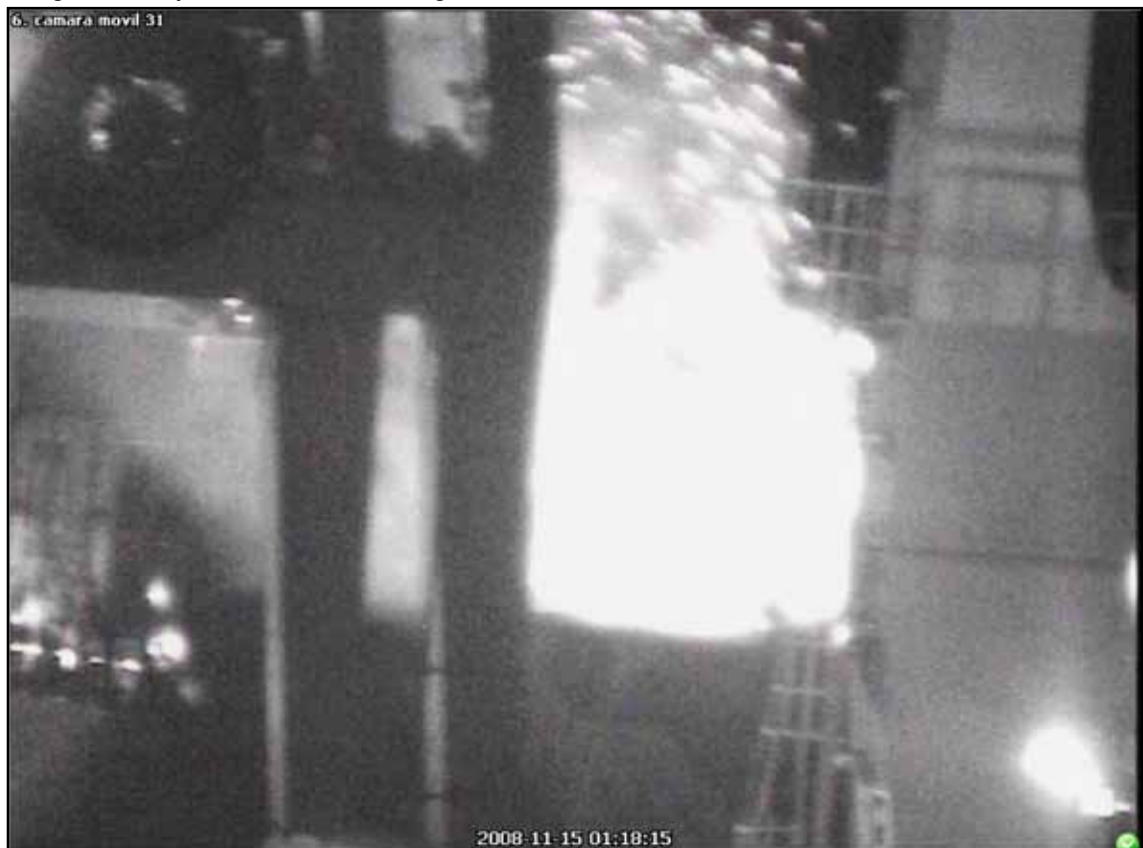
Figure 14

Still of acetylene bottle explosion taken from the APM Terminal's security camera video recording

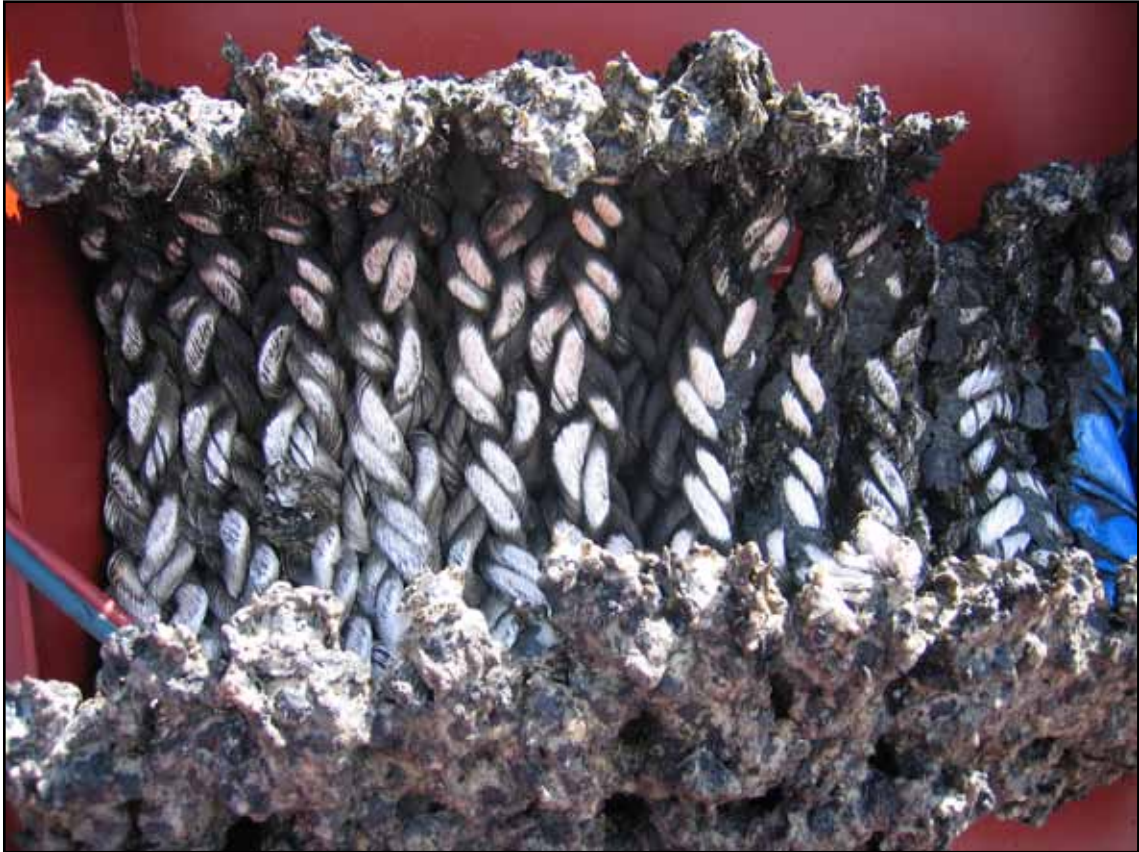
Figure 16

Fire damaged mooring rope from the port windlass winch drum

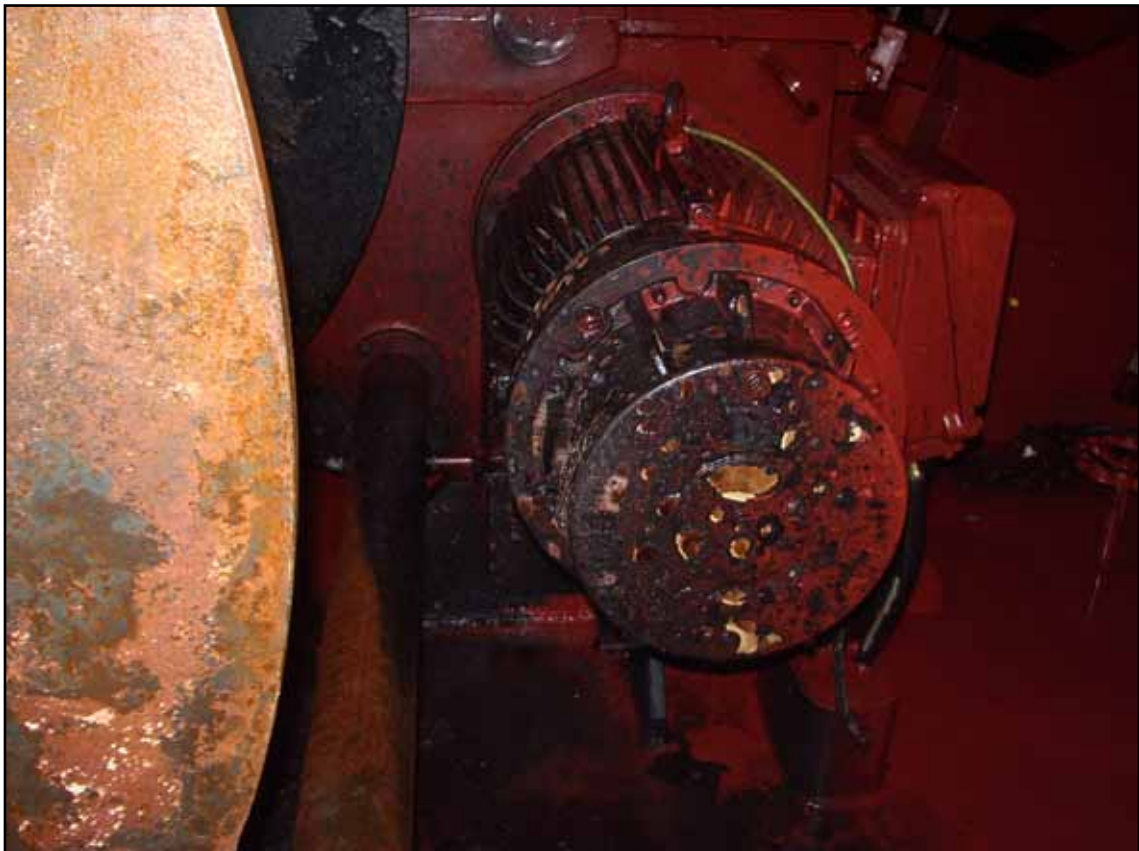
Figure 17

Fire damage to the port windlass winch

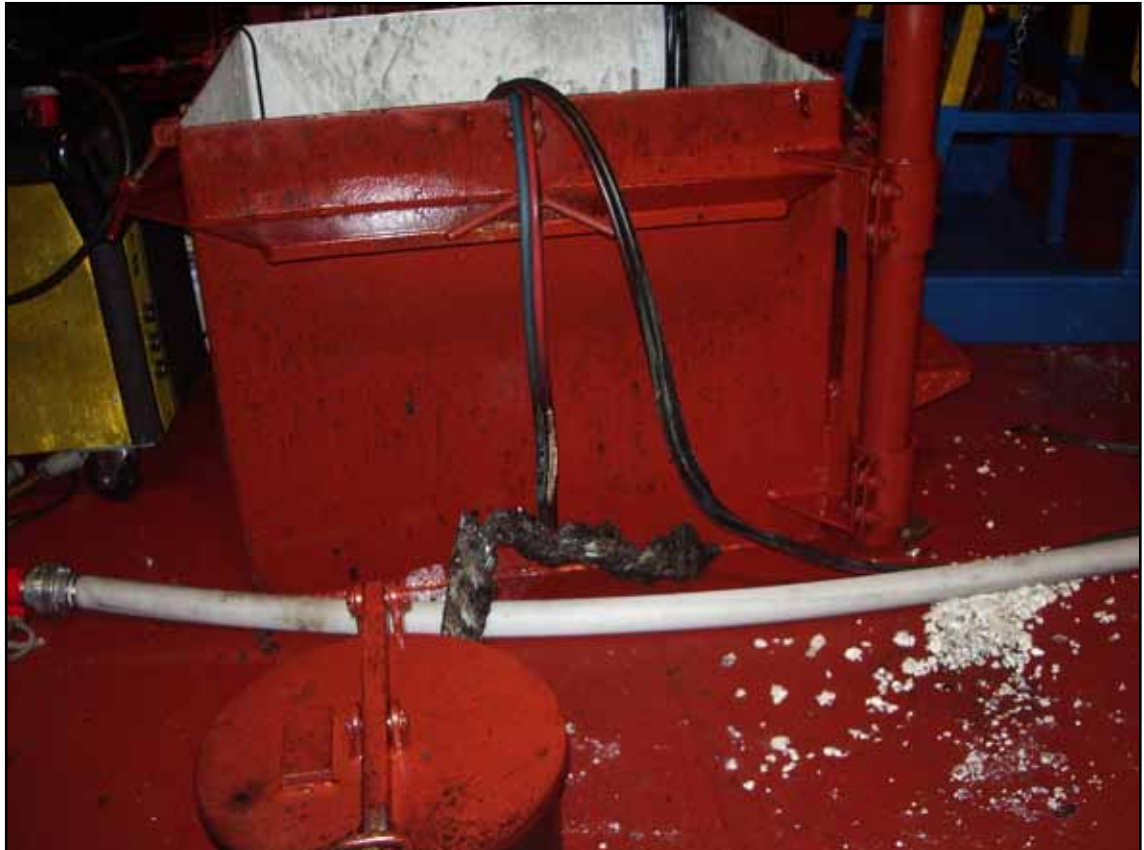
Figure 18

About 10m of the contractor's three oxygen and acetylene gas hoses were burnt through (**Figure 18**), but the remaining 40m were unaffected. The hose non-return valves and flame arrestors fitted to the bottle regulators had been largely destroyed as had most of the acetylene and oxygen bottle regulating valves.

Acetylene and oxygen hose fire damage

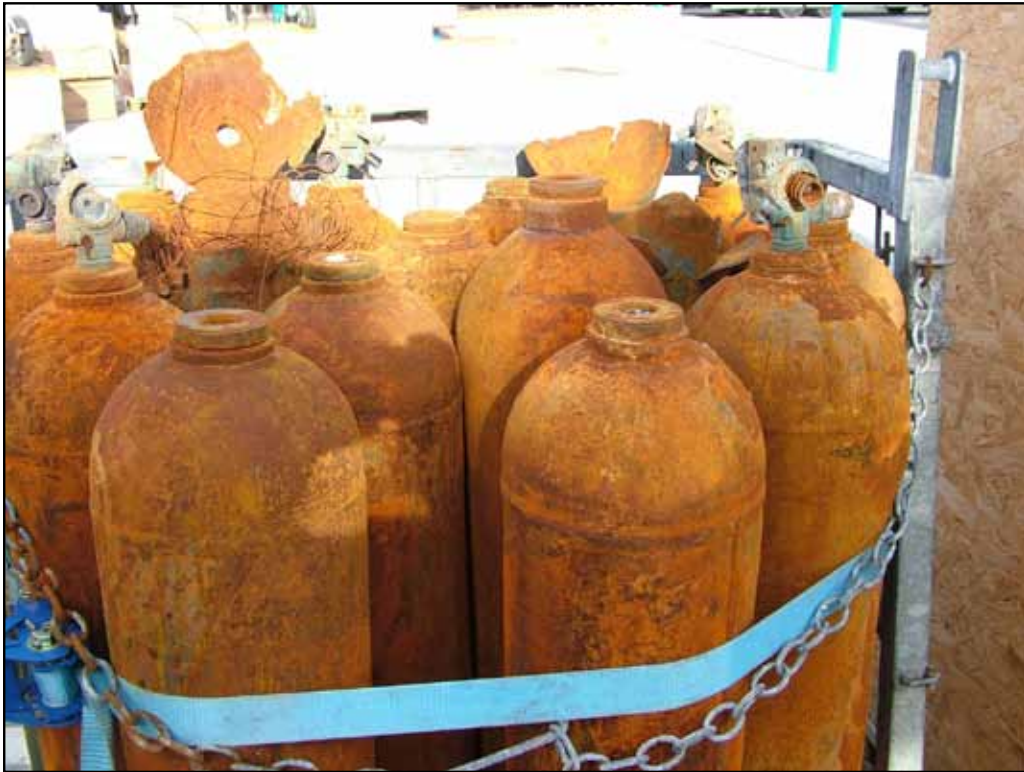
The 15 acetylene and 16 oxygen bottles were damaged beyond use. Two of the acetylene bottles had exploded and many of the others suffered splits and severe distortion (**Figures 19 and 20**). One oxygen bottle had exploded and the rest suffered from severe heat damage (**Figure 21**).

Explosion damaged acetylene bottles

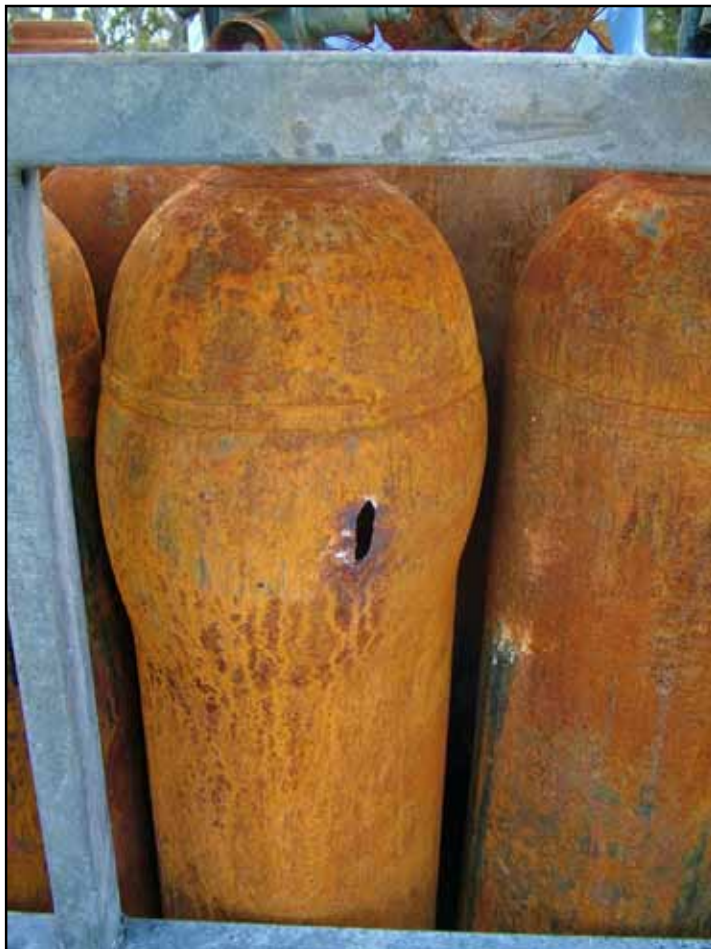
Figure 20

Distorted acetylene bottles

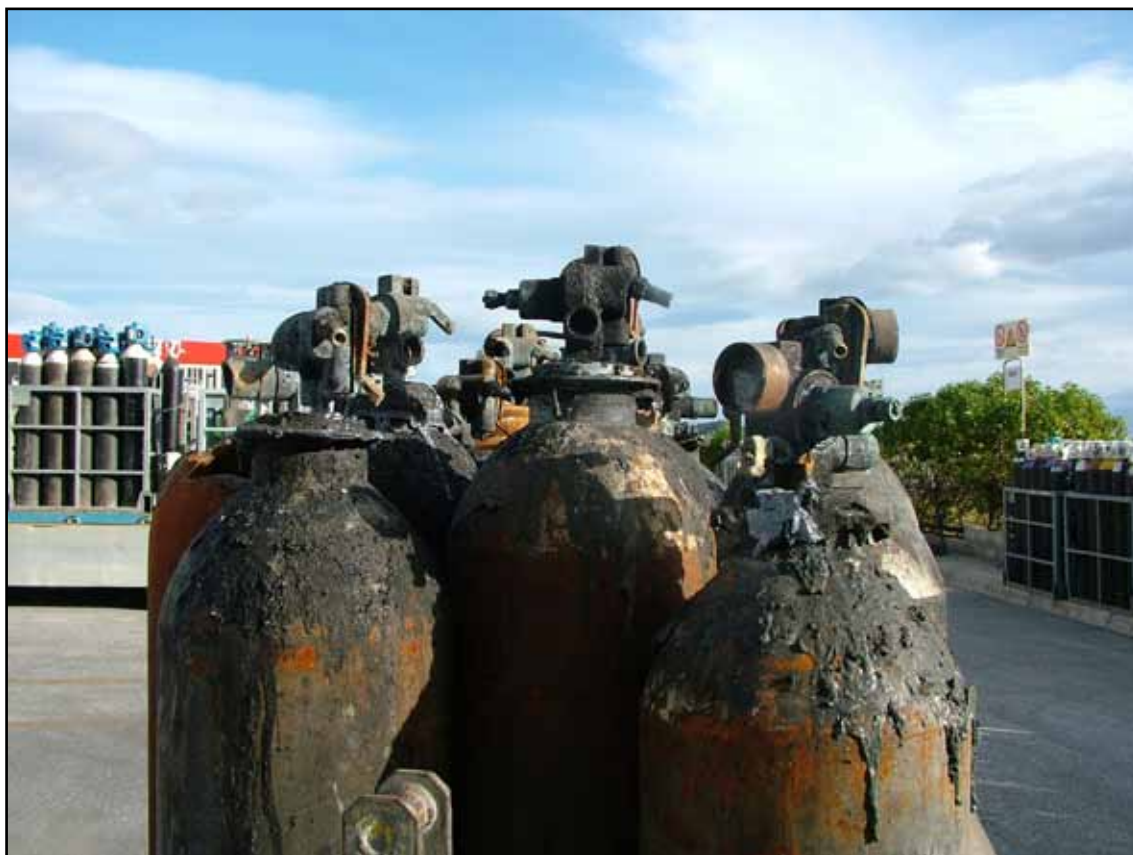
Fire damaged oxygen bottles

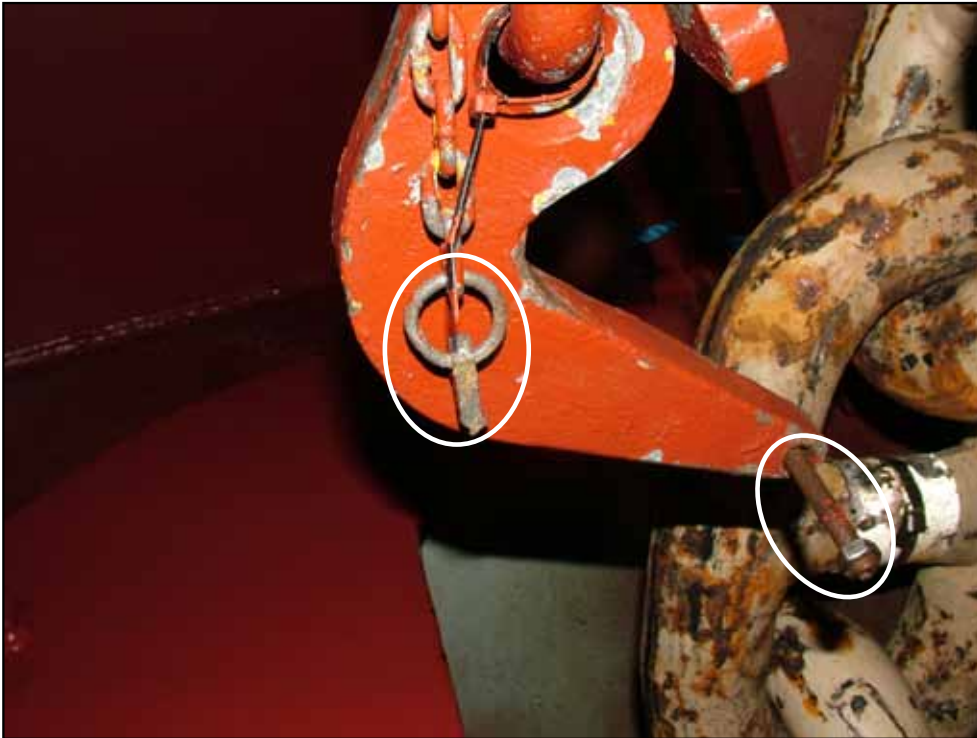
Figure 28

*Maersk Newport's* starboard anchor Senhouse slip failed tapered securing pin and replaced arrangement

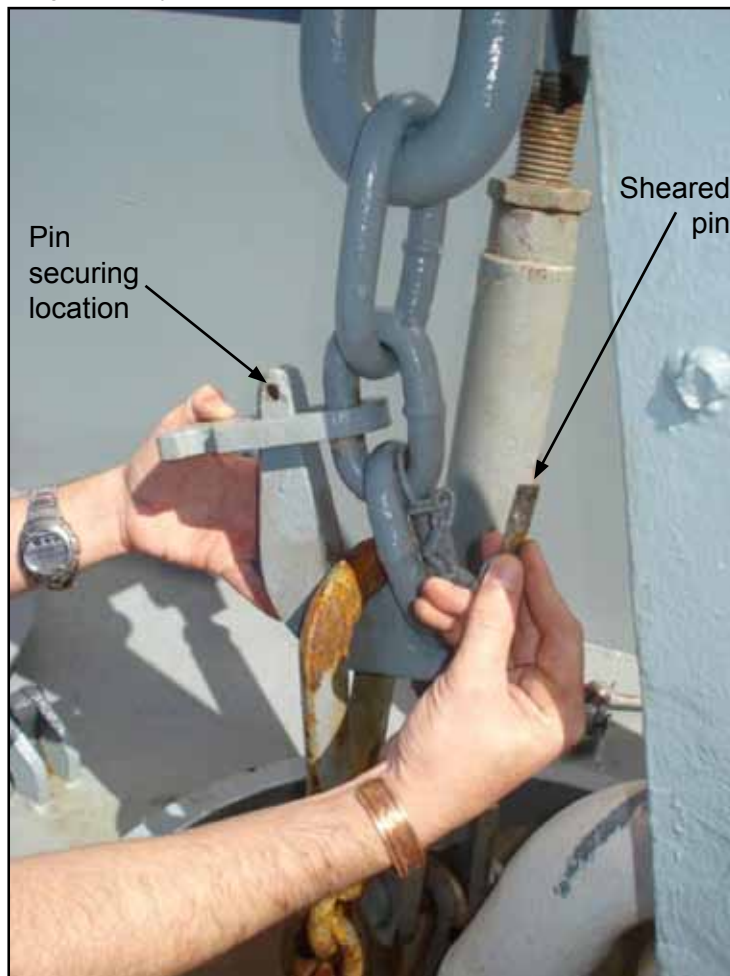
Figure 29

*Safmarine Nyassa's* starboard anchor Senhouse slip sheared tapered securing pin
