CIAIM-05/2016 REPORT

Collision between Merchant Ship BALTIC BREEZE and Fishing Vessel MAR DE MARIN in the Ria of Vigo (Pontevedra) on 1 April 2014, in which five crew members were killed

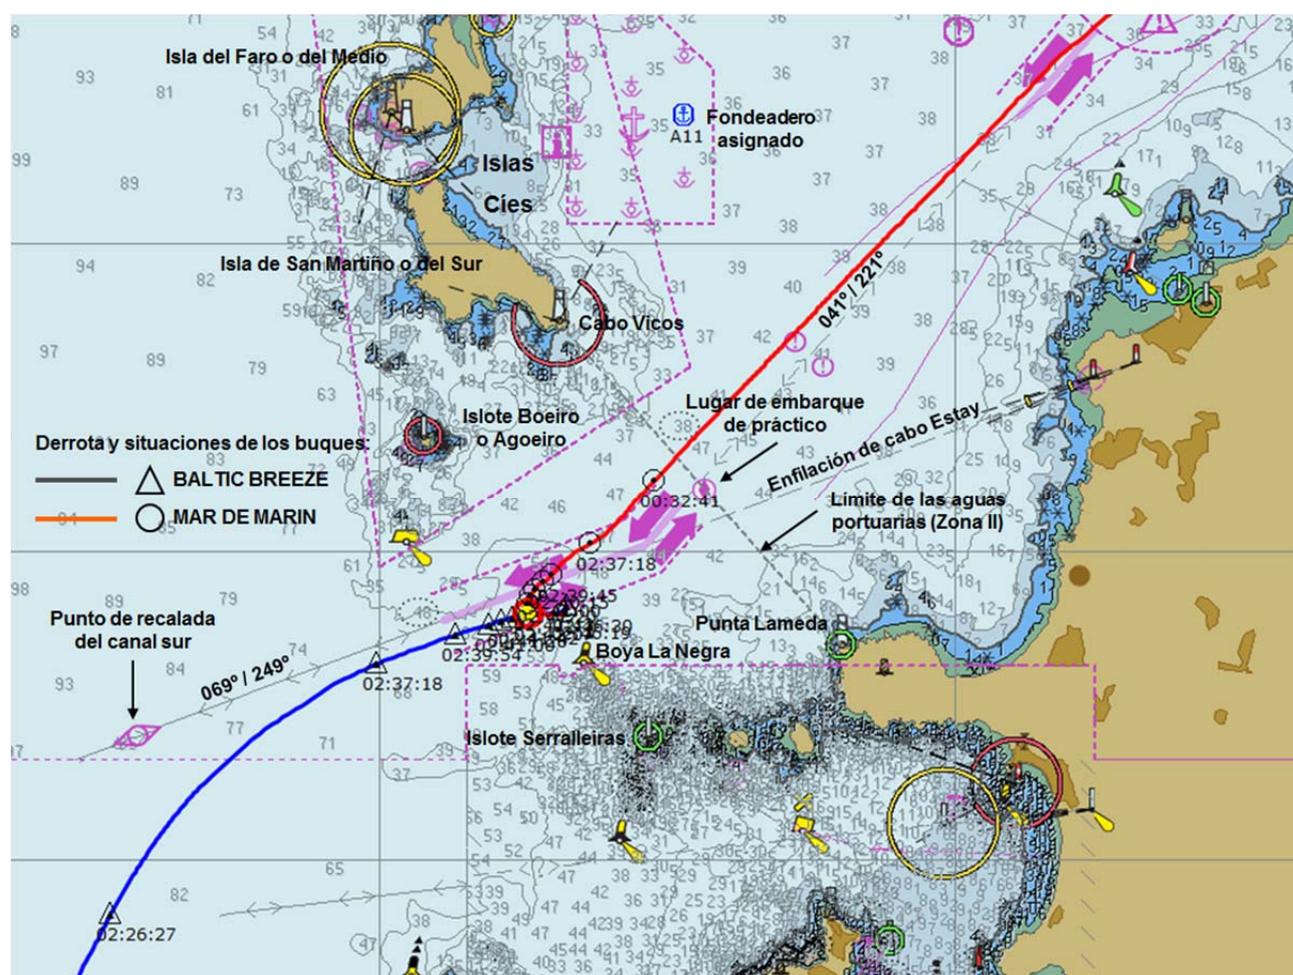
Figura 4. Overview of the Traffic Separation Scheme in the south lane of the Ria of Vigo and ship courses of the vessels involved in the collision

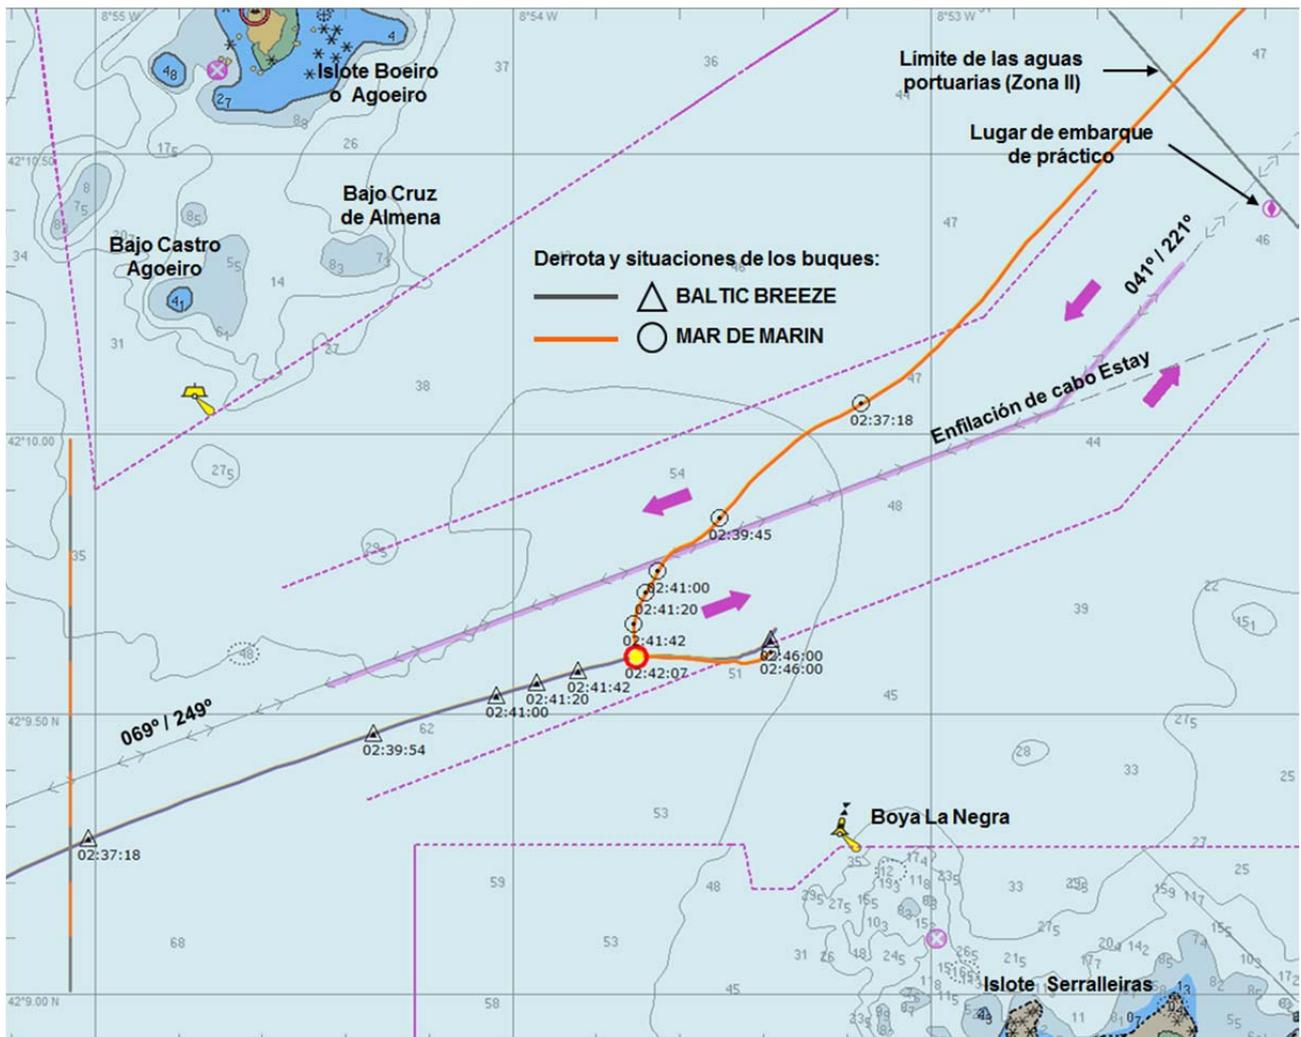
At 02:37:18 LT, the fishing vessel's chief mate advised VIGO TRÁFICO about a merchant ship crossing ahead in the Traffic Separation Scheme. The operator at this control centre answered that the merchant ship was proceeding properly in the inbound lane, as displayed in the radar, and navigating in accordance with TSS regulations (see *figure 6*).

Figura 6. Detail of the course followed by the vessels involved in the collision

Considering such navigation system, several minutes before the call to the control centre had been made at 02:37:18 LT, the merchant's ship location would have been displayed on the TSS added depictions as if she was crossing it. However, the merchant ship was sailing off this TSS scheme and had started to manoeuvre long time before setting course to the inbound lane (see *figure 6*).

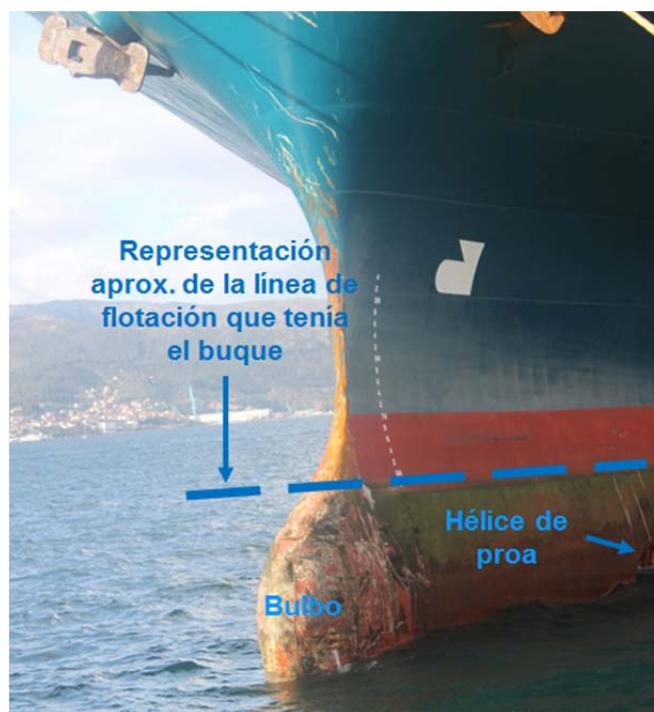
The merchant ship's bulb hit the fishing vessel's starboard side below water line like a battering ram. A leak was caused in the cargo hold and the fishing vessel was pushed until the merchant ship headway⁷ decreased.

Figura 7. BALTIC BREEZE bow view (when the collision occurred the bulb was submerged)

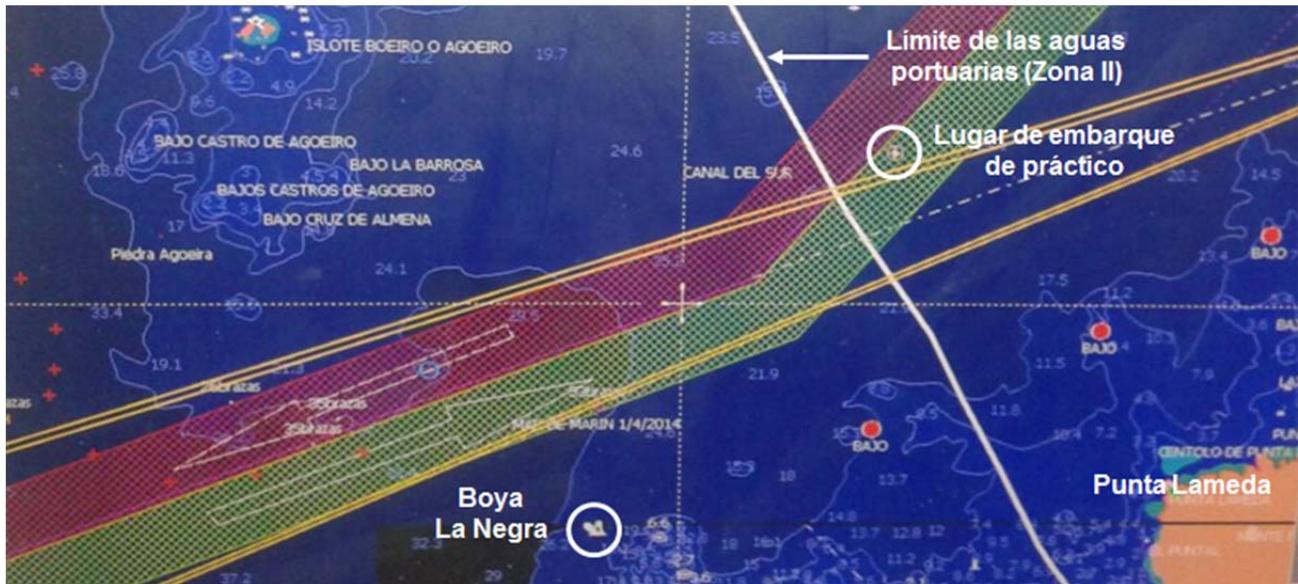
The most likely reason for that behaviour is that an electronic chart system (ECS) was used onboard the MAR DE MARIN instead of the official paper nautical charts existing on board. The system charts had not been issued or updated by any authorised hydrographic service. Primarily, these charts only showed signal lights for entering the Ria of Vigo and a number of axial lines depicting the recommended two-way fairway, but not the TSS.

Figura 9. Display of the Ria de Vigo Vessel Traffic Service by an electronic chart system equal to the MAR DE MARIN electronic chart system

From all above described, it can be inferred that the first mistake the chief mate made was the use of a non-standardised navigation system and some nautical charts which had not been issued or updated by an authorised hydrographic system. As a result, the merchant ship was mistakenly located inside the Traffic Separation Scheme of the Ria of Vigo. It should be noted that this was not an occasional chief mate's practice, since no official nautical chart was used on board to draw envisaged voyages or to lookout the vessel's course.

2. To be aware of the safety hazard to navigation when using a non-standard navigation system or electronic nautical charts not approved or updated by an authorized hydrographic service instead of official paper nautical charts in order to plan and depict the ship's course during the voyage.

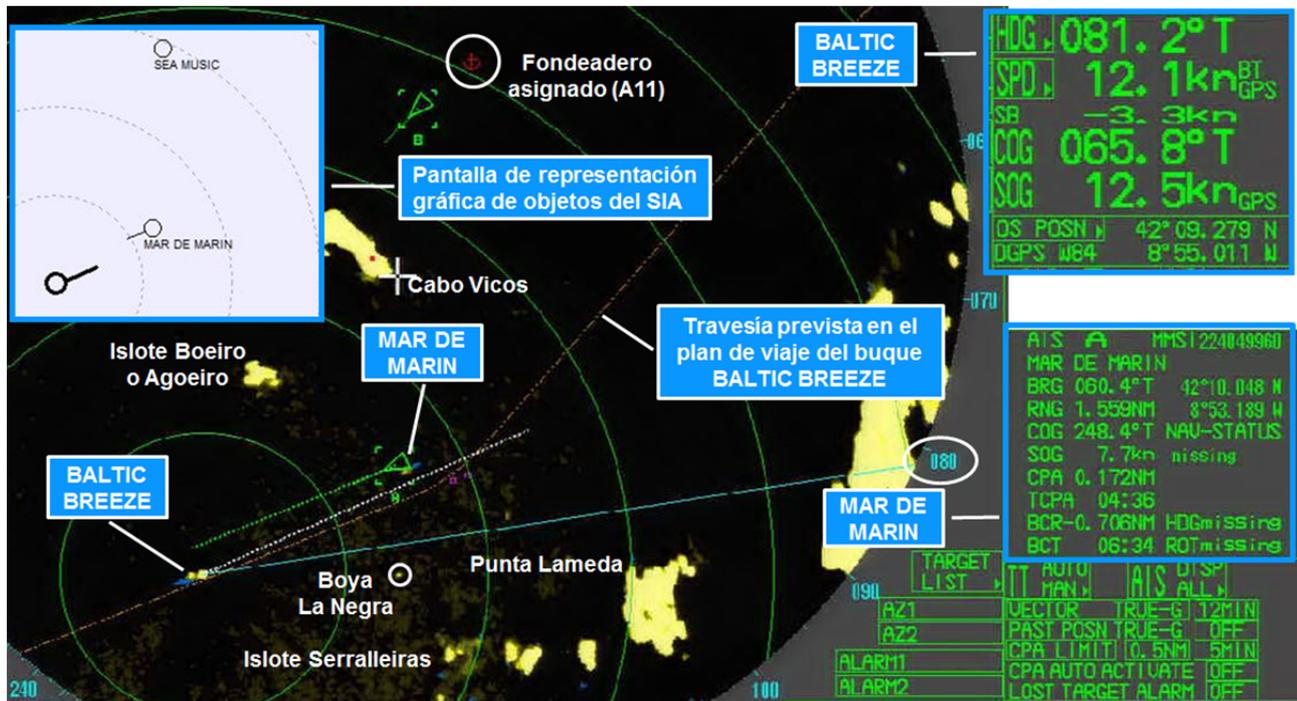
Figura 10. Layout obtained from the information displayed on BALTIC BREEZE radar¹⁸ and AIS screen at 02:37:18 LT

More specifically, when the chief mate contacted the control centre at 02:37:18 LT, the screen would have displayed MAR DE MARIN heading and speed over ground of 248° and 7.7 knot respectively and BALTIC BREEZE altering course to 083° to correct drifting (sea current effect) and leeway (wind effect), whose course and speed over ground were 066° and 12 knots respectively, without impeding or likelihood to impede passage. All this should have clarified any doubt on a «crossing» situation (see *figure 10*).

3. To be aware of the safety hazard to navigation when the officers of the watch are not familiar with radar and AIS tracking systems as additional source of information for a proper lookout of ship motions and avoidance of collision.

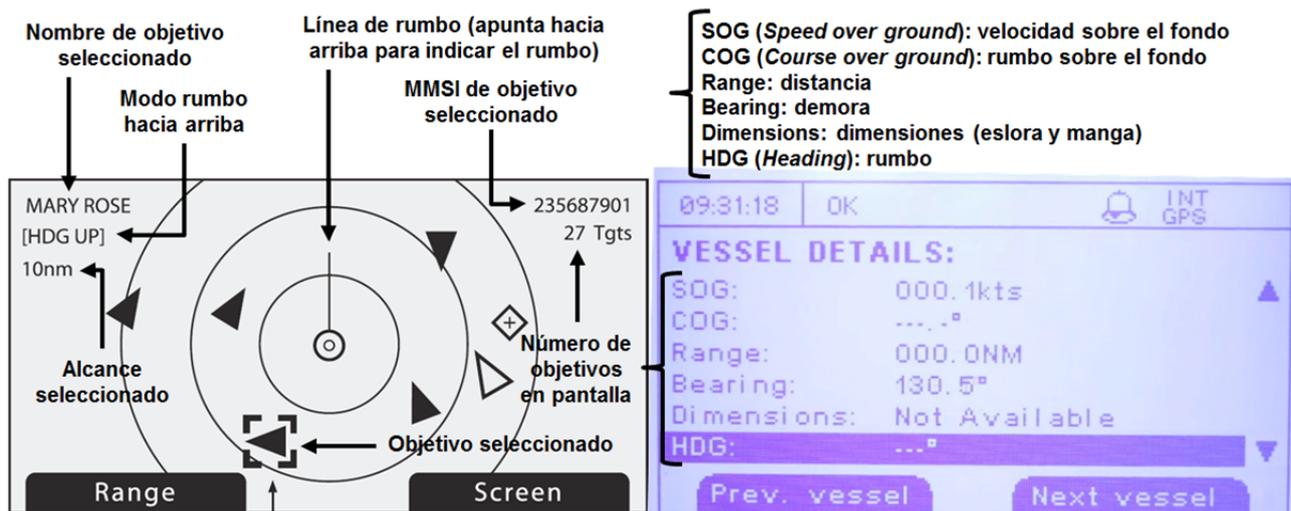
In this case, every course alteration would immediately become evident on the AIS screen, since dynamic information on heading and speed over ground and well as on turn speed and direction was being updated every 12 seconds, but every 4 seconds if a change in the heading occurred (see *figure 11* and *table 6*).

Figura 11. Target Depiction and Information displayed on an AIS screen equal to the one installed in MAR DE MARIN

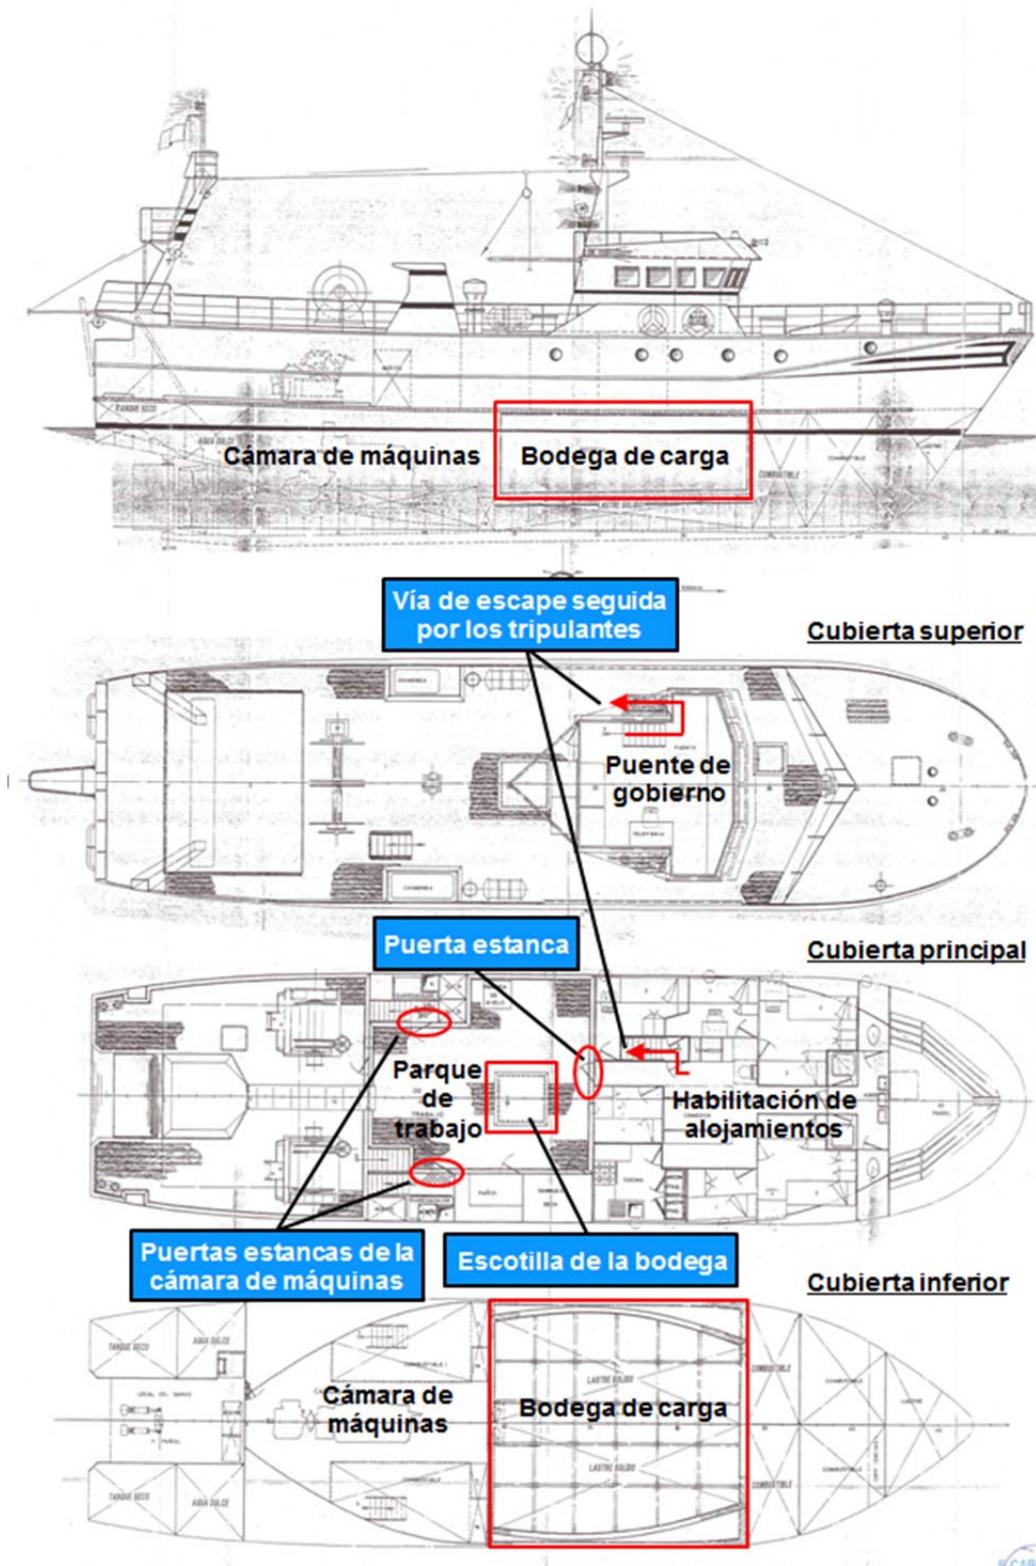
Figura 12. MAR DE MARIN General Arrangement Drawing

As a result of the impact on the fishing vessel's starboard side, a leak was caused in the cargo hold. Before the crew members could react and leave their cabins, a massive water ingress to the processing and accommodation areas occurred through the 1,000 x 1,000 mm cargo hold hatch (see *figure 13*).

In this sense, the reason for the water to raise the hatch cover and enter the processing area as stated by crew members could be that either the cover was closed but unlatched or the latches fastening the hatch cover to the coaming broke. This is not considered likely, since the bolts of the latches were made of low carbon steel, fitted stainless steel nuts and the hydrostatic pressure underneath the cover would not have been high at the early stages of the accident.

4. To be aware of the safety hazard to ships involved in not keeping water tight doors and hatches duly closed and latched unless required for fishing tasks or shipboard operations.

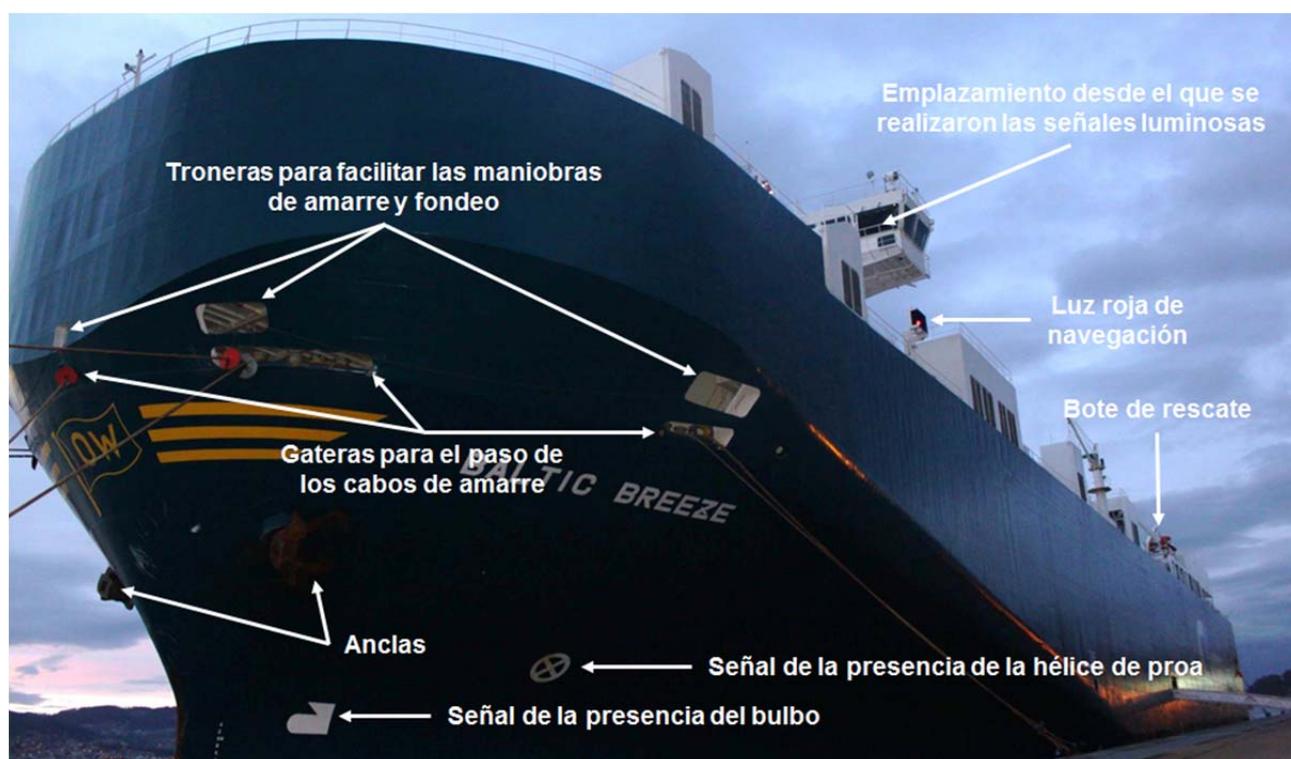
Figura 13. BALTIC BREEZE Bow and Portside View (blind sector from the captain's position in the Navigation Bridge)

Finally, the captain could no longer see the fishing vessel, as the ship's structure prevented her from being seen (see *figure 13*). At 02:41:00 LT, he ordered to stop the engine by means of the engine order telegraph. There was no sufficient time to notice the outcome of the transmitted stop command, since two minutes after the collision, the ship was still proceeding headway and pushing the fishing vessel with her bulb penetrating this vessel's side.
