Report EXT A-006/2014

Accident involving a BOEING B-737-800,
registration EI-ENB, operated
by RYANAIR, in the vicinity
of Toulouse (France) on 23 June 2014

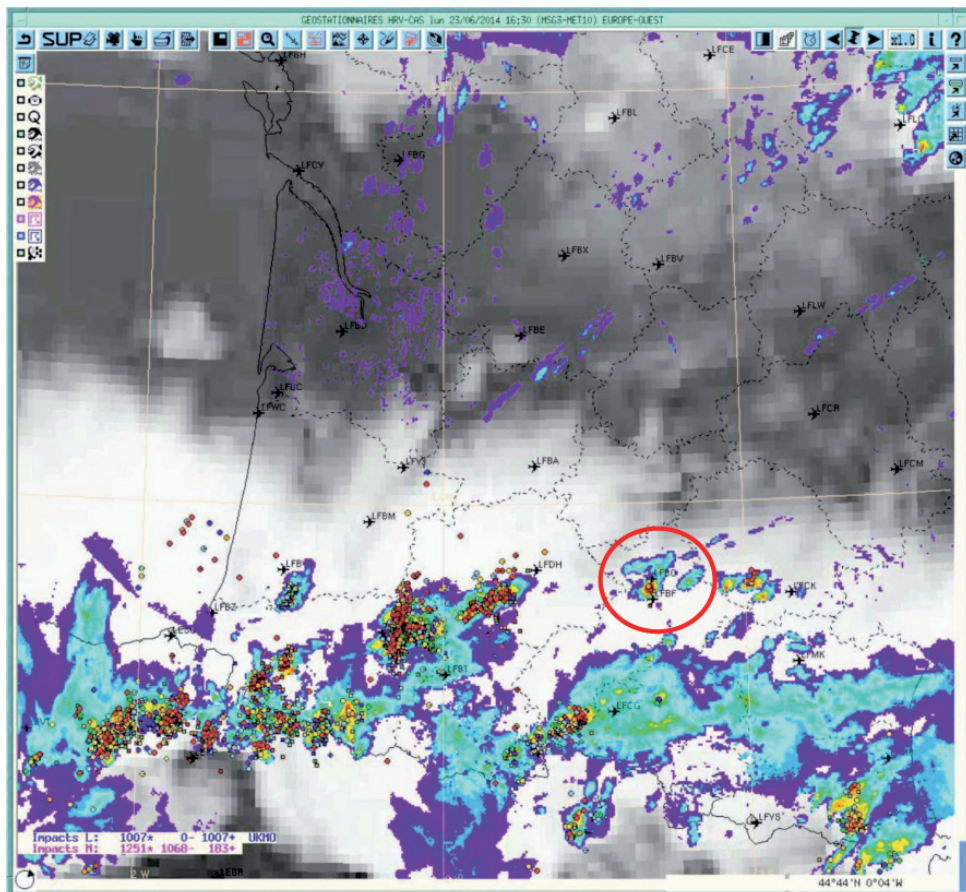
Figure 1. Satellite (IR) and radar images, and lightning map for 16:30 UTC.
The area of the event is circled in red

Figure 1 shows the satellite (IR) and radar images for 16:30 UTC. As we can see, the Pyrenean mountains were affected by developing storms, especially along their Western half. The figure also shows several isolated storm cells north of the Pyrenees, which include the one that affected the accident flight.

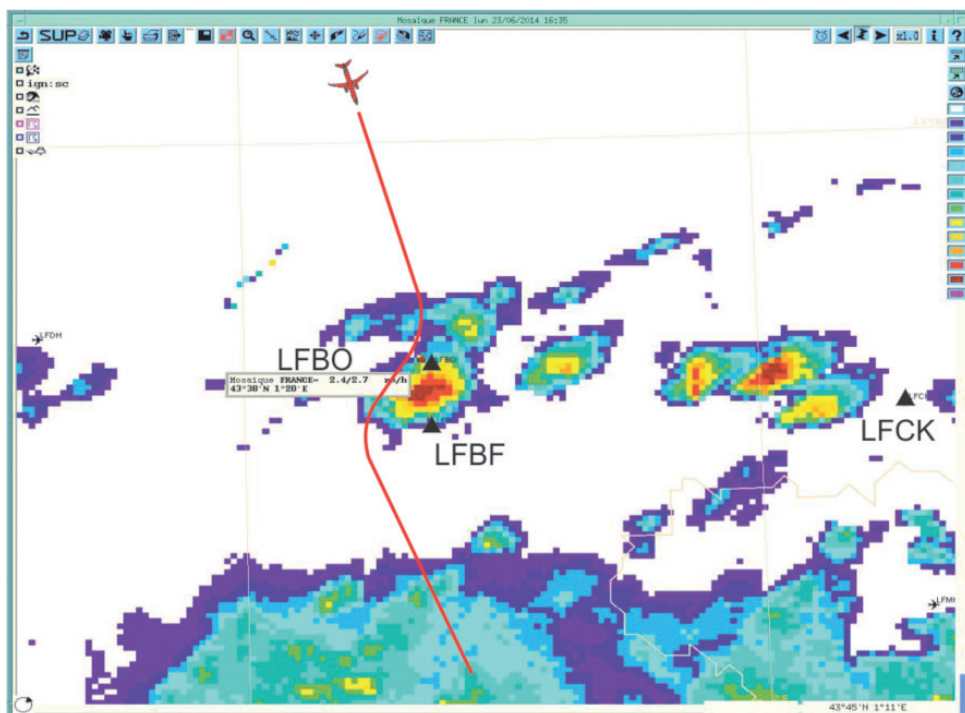
The image from 16:35 UTC (figure 2) shows an increase in the surface area colored in yellow, orange and red.

Figure 2. Weather radar image from 16:35 UTC, with the aircraft's trajectory superimposed on it

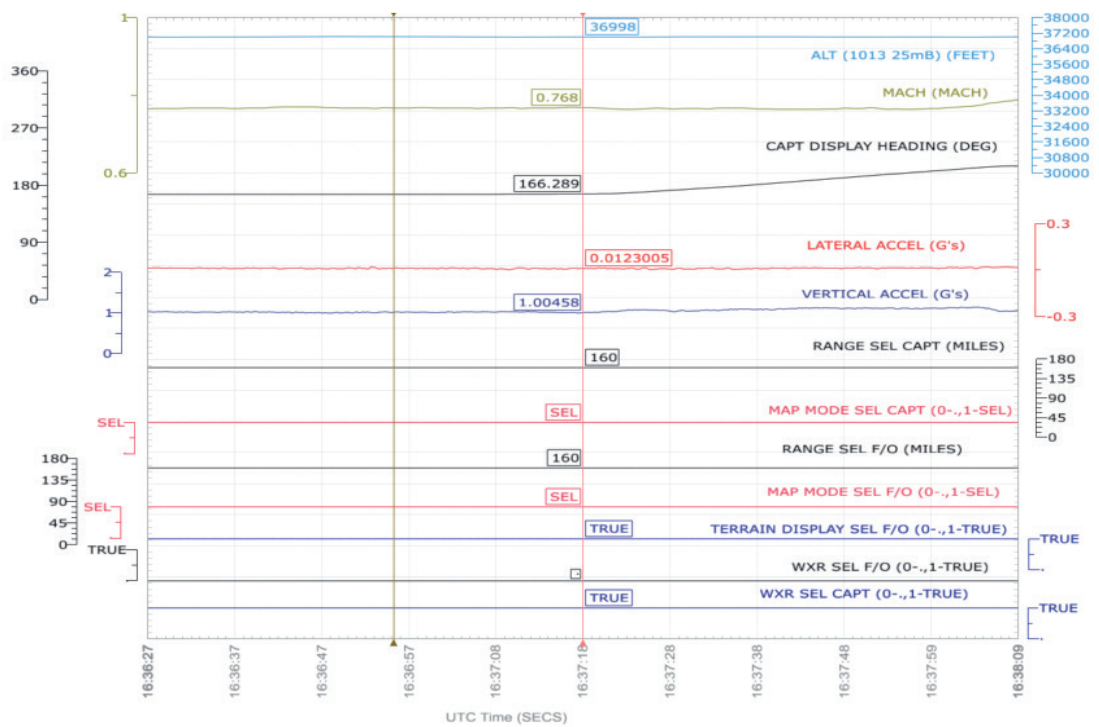
The graph reveals that at 16:37:16 UTC, the aircraft, which was on heading 165°, started a turn to the right to change course to 202°. This turn was made with the autopilot in HDG (heading) mode.

Figure 3. Graph of certain flight data in the two minutes preceding the turbulence

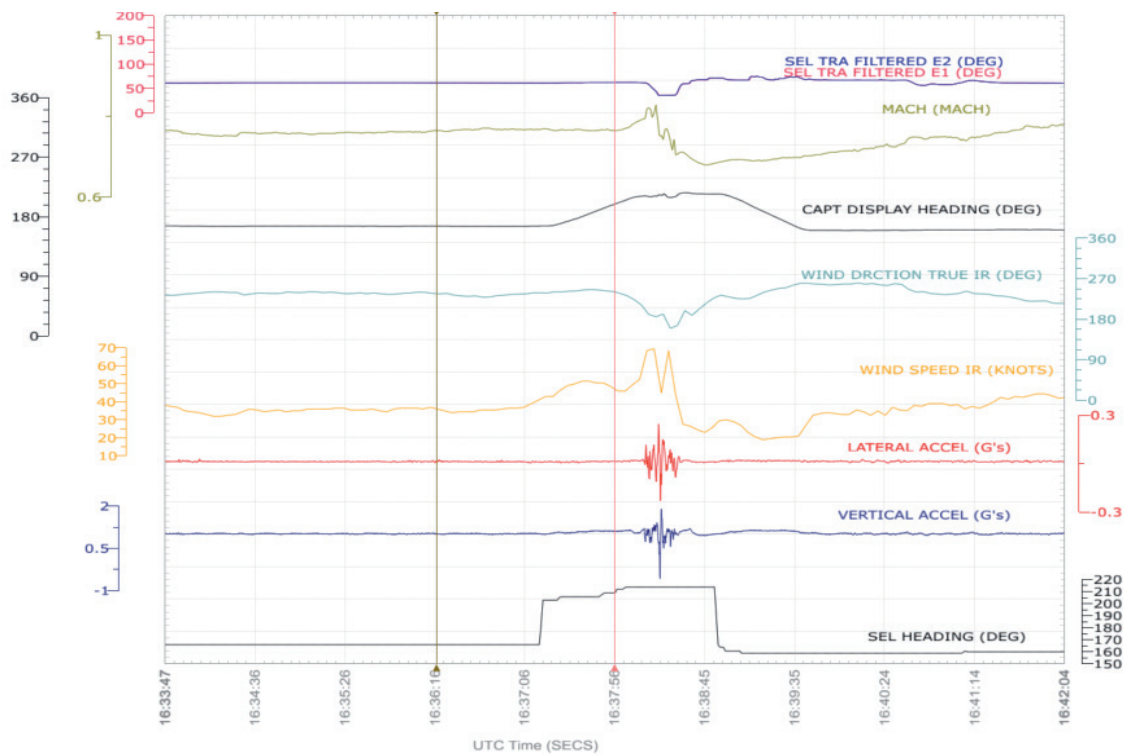
This graph, like the one in Figure 3, shows the heading change made by the crew at 16:37:16 UTC using the HDG mode selector.

Figure 4. Graph of flight parameters recorded between 16:33:47 UTC and 16:42:04 UTC

Also evident is the fact that the action to change the aircraft's heading was taken about 10 s after the wind speed recorded by the aircraft started to increase. Until that moment, the values of the remaining parameters recorded by the FDR were within normal ranges.

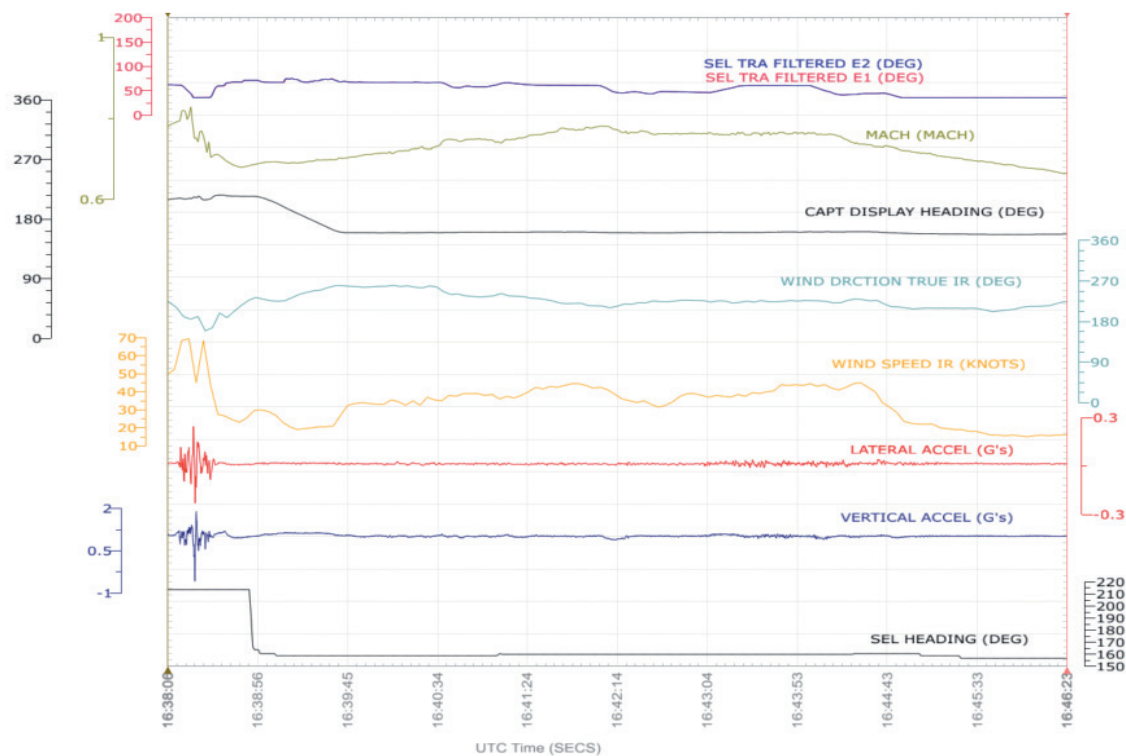
Figure 5. Graph of flight parameters recorded between 16:38:00 UTC and 16:46:23 UTC

As the graph clearly shows, the period of severe turbulence occurred during the aircraft's right turn. In fact, the turn continued after the period of intense acceleration, which took place at 16:38:40, ceased.

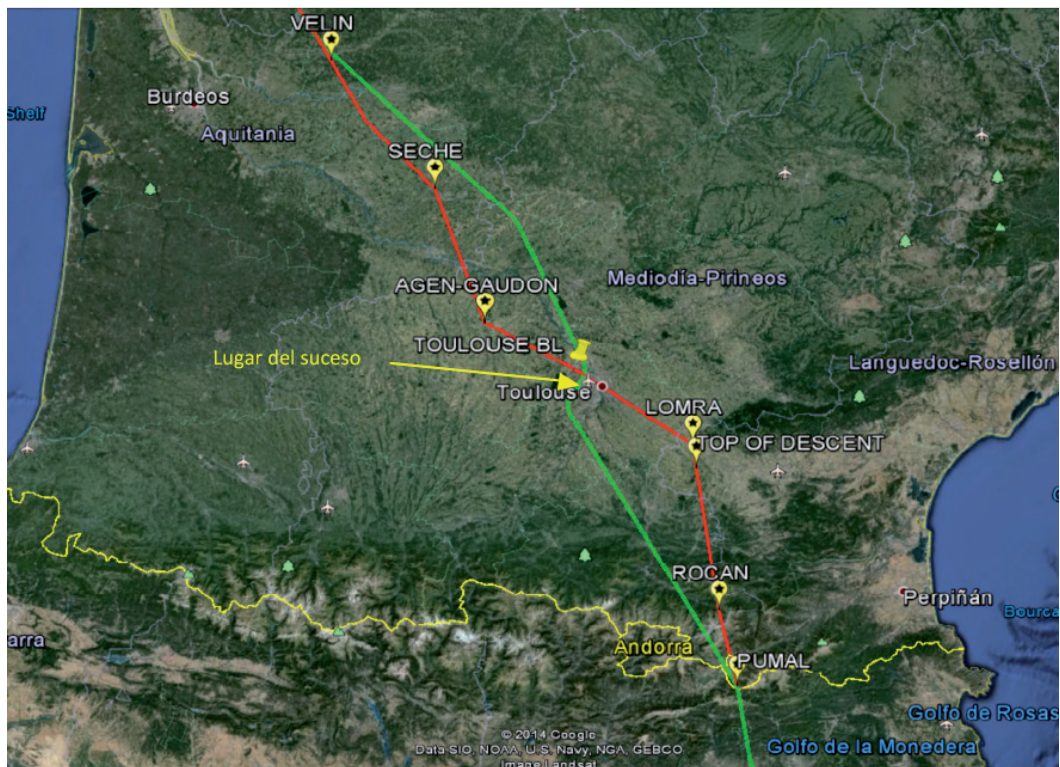
Figure 6. The flight path as per the operational flight path is shown in red and the actual path taken in green

At that point the aircraft deviated slightly left from its planned trajectory (see Figure 7). The aircraft remained at FL370 despite reaching the point in the flight plan where in theory it was supposed to climb to FL390. Some 66 NM past VELIN, the aircraft turned right onto heading 160°, which took it directly to Toulouse.
