Technical report S-27/2011

Investigation of the heeling experienced by fishing vessel CURRANA TRES, 50 miles off the west coast of Ireland on the 14th of May 2010

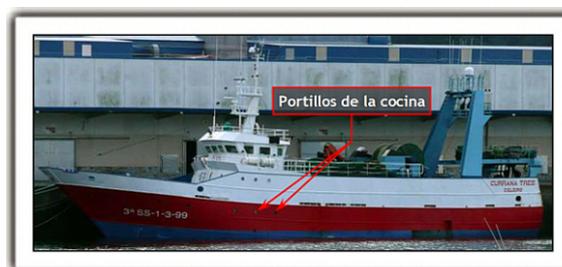
Figure 2. Position of the galley portholes

The Cook sounded the alarm when he noticed that the galley portholes (figure 2), located on the port side main deck were submerged.

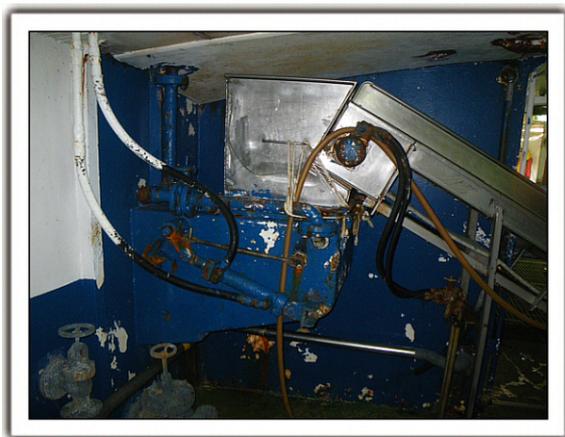
Figure 3. Waste hopper

Subsequently, they verified that the waste hopper's outer door had not been properly closed and was probably the reason why the fishing area had flooded.

The most probable cause of the incident was the flooding of the fishing area through the waste hopper located on the port side. The waste hopper's outer door had been left open or had been improperly closed and the lower door was open.

Water entered through the waste hopper because the vessel experienced an excessive draught to the stern and the lower portion of the waste hoppers outer door was normally below the flotation line. In this configuration, the stern sank even further during trawling and the sea level was above the waste hopper's lower door, causing the fishing area to flood when the waste hopper doors were left open or weren't closed properly.

4. The vessel is very sensitive to an operational error when operating the waste hopper since simply by not checking that the outer door is closed properly may have resulted in the loss of the vessel. The existence of such opening is a hazard that was not been properly controlled.

6. To analyze the advantage of prohibiting fishing vessels from using waste hoppers or other types of openings that are located below the first flooding point as per the stability book calculations and the freeboard calculation.

8. To establish operating procedures that guarantee that under all circumstances, both waste hopper doors will be properly closed when no personnel are present at the fishing area.

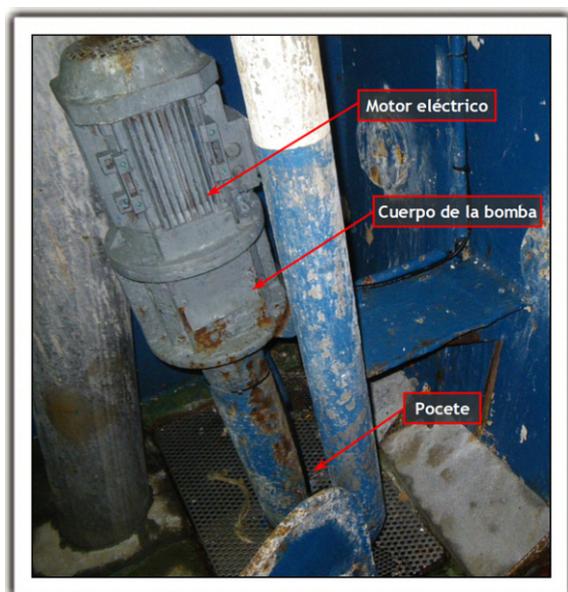
Figure 4. Stern sump pump located on the starboard side of the fishing area

With the inner door of the waste hopper closed, the flood was controlled but the heeling of the vessel towards the port side was such that the water level had reached the upper deck. The First Mechanic checked if the fishing area's sump pumps were operating properly. The port side sump pump's electric motor, which was located aft of the waste hopper was not working because it had gotten wet during the flooding of the fishing area. The rest of the fishing area pumps (two on the starboard side, forward and aft and one on the port side, aft) were operating properly but were not bailing out the water because the flood had not reached their wells since the vessel had heeled towards her port side and her stern had sank further than her bow.

The water that entered the waste hopper caused the vessel to heel towards her port side and her stern to sink. In this condition, only the fishing area sump pump that was located at the stern on the port side had water in its well and was operating. However, these pumps are not designed to handle the flooding of the fishing area and their flow was not enough to bail out the water that was entering through the waste hopper and therefore, the flooding of the fishing area was progressively increasing. When the water level reached the electrical motor of the sump pump that was operating, the motor got wet and the pump stopped bailing out water, which resulted in an increase in the flood rate, which endangered the stability of the ship.

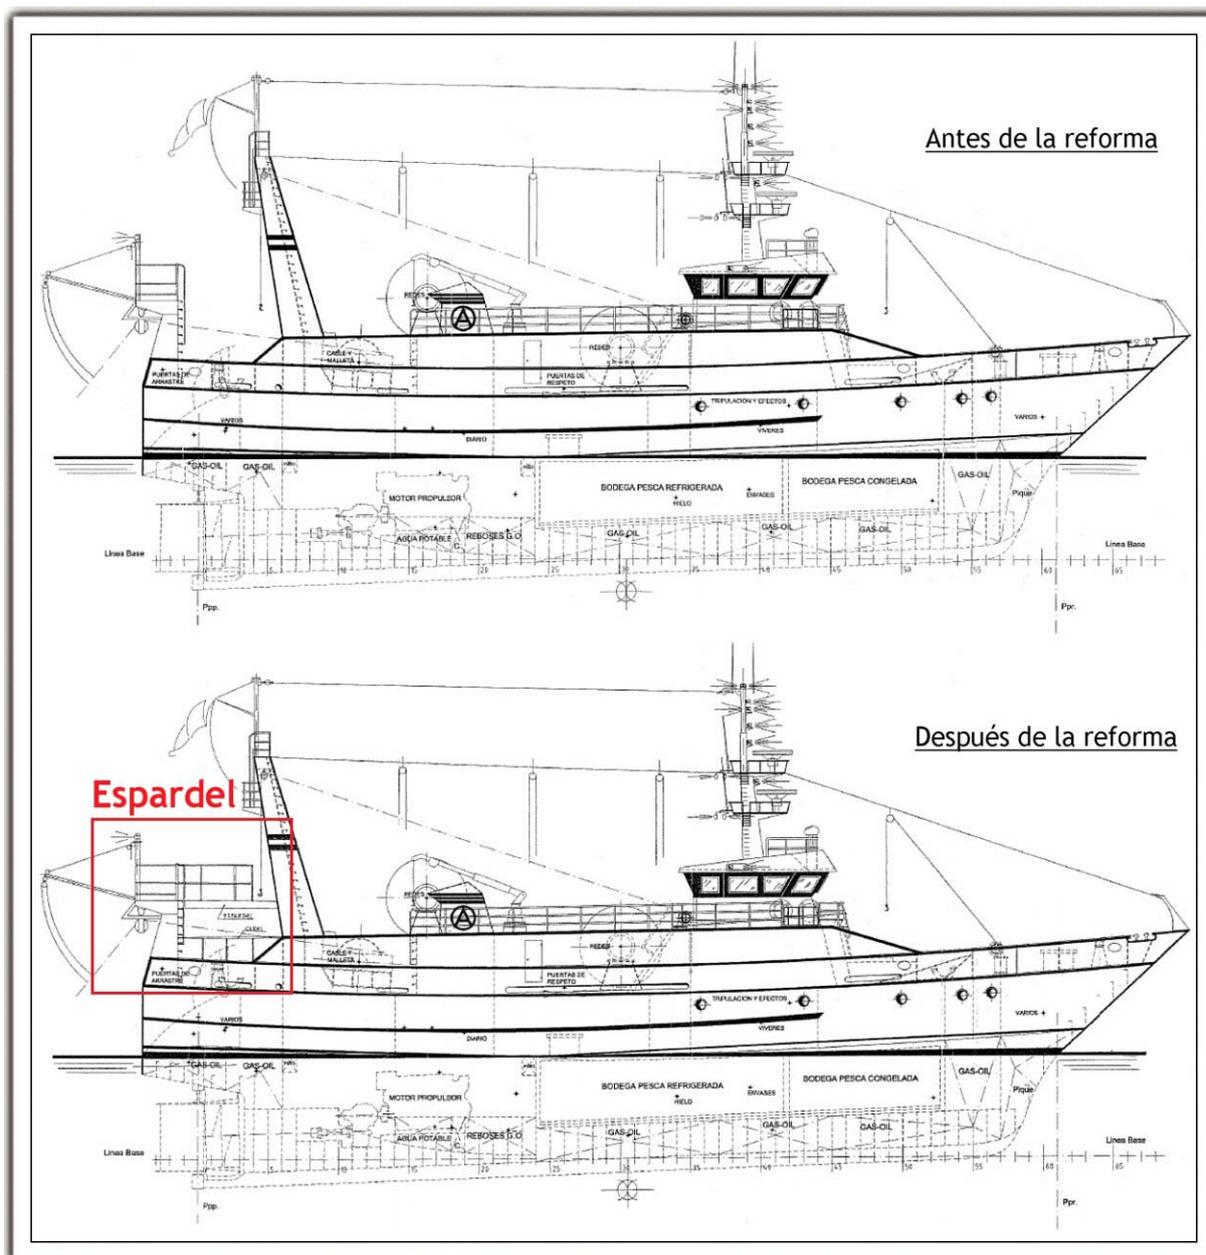
Figure 6. Vessel CURRANA TRES. General arrangement before and after the modification work conducted in April 2005

- The existing 1.5 t crane was replaced with a 3 t crane and a platform was built (figure 6).

The total weight added to the vessel during these modifications was 3.48 t, with an initial lightweight of 362.44 t. During the modernization project conducted in April 2005, the specifications stated that the vessel still complied with the stability criteria and that a new stability test was not required since the change in the vessel's lightweight was 0.96%.

Both improvement projects were carried out on the vessel without prior authorization from the Administration. According to the improvement projects, the weight of the vessel had increased by 16.58 t, which was a 4.54% increase in her initial lightweight.

4. To require a stability test be conducted anytime they become aware that modifications have been carried out, which have not been supervised by the Maritime Authorities.
