Operator: IBERIA
Aircraft type and model: Boeing B-727-256
Nationality: Spanish
Place of accident: Monte Oiz, 1.027 meters high
30 Km. SE of Bilbao Airport
43°13'42" N
2°35'24" W (M. Oiz)
Date and time: 19 February, 1985
08.27:04 hours

Aircraft Boeing B-727-256, registration EC-DDU, of IBERIA Airlines, performing scheduled flight IB-610 (Madrid-Bilbao), crashed into a metallic structure, base of television antennas, placed on Monte Oiz (1027 mts.).

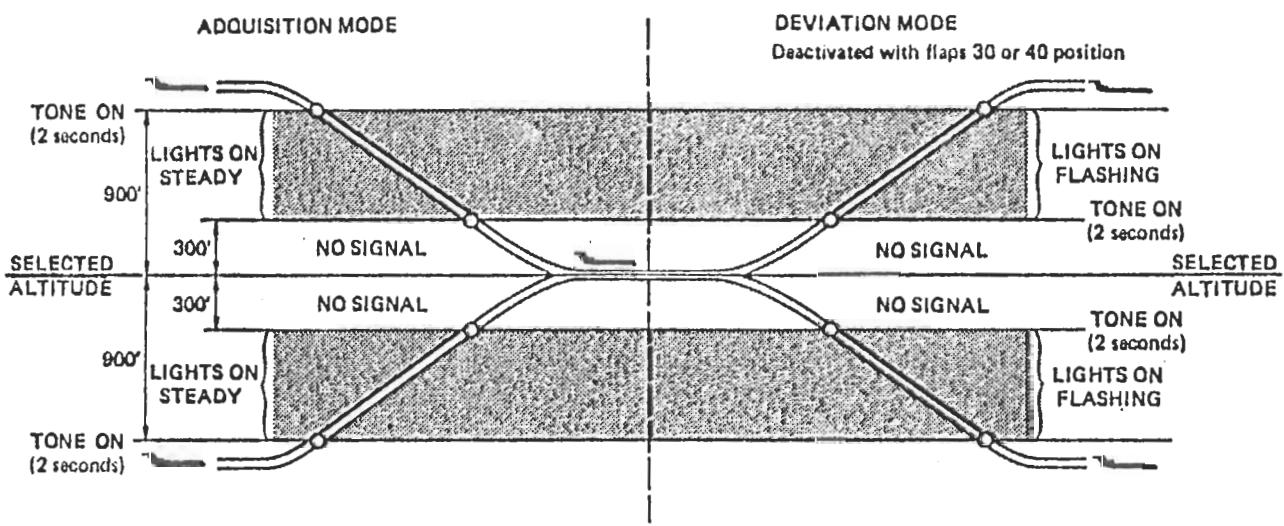
Fig. 3

In general, the Altitude Warning System is used together with the A/P. In this case, the operating sequence is as follows (Fig. 3): once the pilot has selected the desired altitude and has set

the barometric pressure with the "BARO" button, the set is armed by pressing the "ALT. SEL." button placed in the A/P control panel, and the ARM light (amber) placed on the same button is turned on. When the aircraft is 900 feet away with respect to the selected altitude, audio generator is activated, the "ALTITUDE ALERT" amber steady lights, placed in the panels of both pilots are turned on; these lights are turned off when the aircraft is 300 feet away from the selected altitude and is approaching the same; depending on the descent rate and on the altitude error at a pre-set distance from that which was selected, the ARM light (amber) shall go off and the ENG light (green) shall glow, indicating that the aircraft has changed to ENGAGED mode beginning to level towards the selected altitude until it is captured, changing then to capture mode. This light shall remain on until the aircraft leaves the captured altitude.

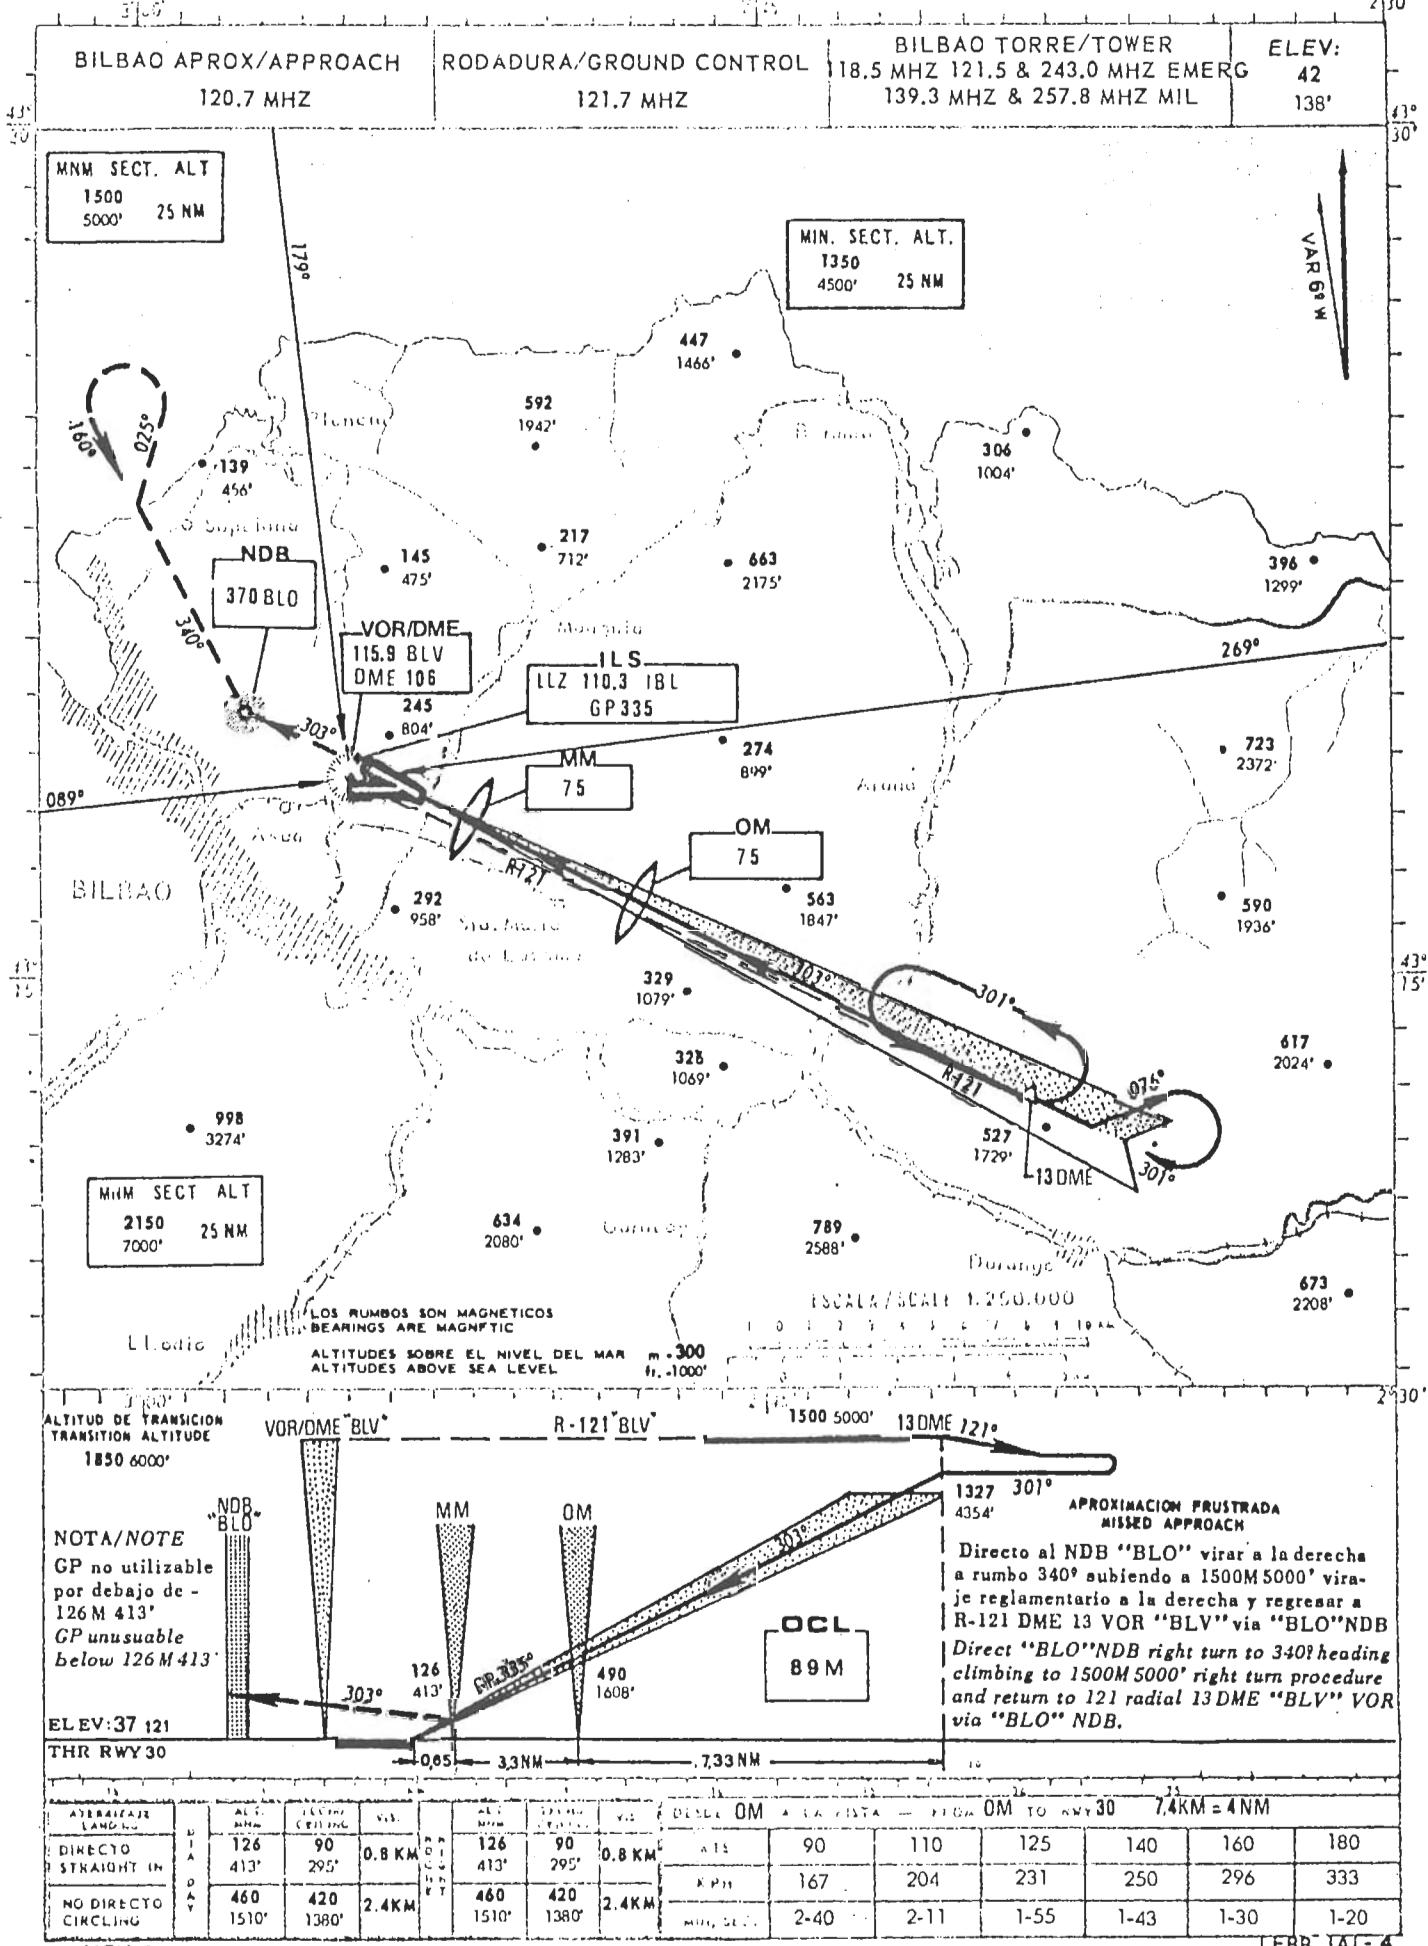
VOR/DME ILS RWY-30

At the time the study on possible manoeuvres was performed, taking into account local topography, it was observed that Monte Oiz (1.027 meters), was a determining obstacle in fixing the minimum height for the intermediate approach, thus being established at 1327 meters (4354 feet).

- k) The crew rounded the number corresponding to an altitude of 4.354 feet in the selection on the Altitude Alert system by defect, to 4.300 feet, instead of doing it in excess to 4.400 feet.

- g) Insist on the technical crews to place on the Altitude Alert system windows the altitudes which figure on the approach charts, always rounding to the higher hundred.
- h) Urge the appropriate aeronautical authority to assure periodic inspection systems for the specific zones that include protection surfaces, in order to avoid the appearance of obstacles that surpass the maximum permitted altitudes.
