DATA SUMMARY

Date and time	31 October 2008; 07:15 UTC
Site	Lanzarote Airport

Registration	EC-HJQ
Type and model	BOEING 737-800 S/N: 28387
Operator	Air Europa

Aircraft	Damage to all landing gear tires
Third parties	Two approach lights on the opposite threshold

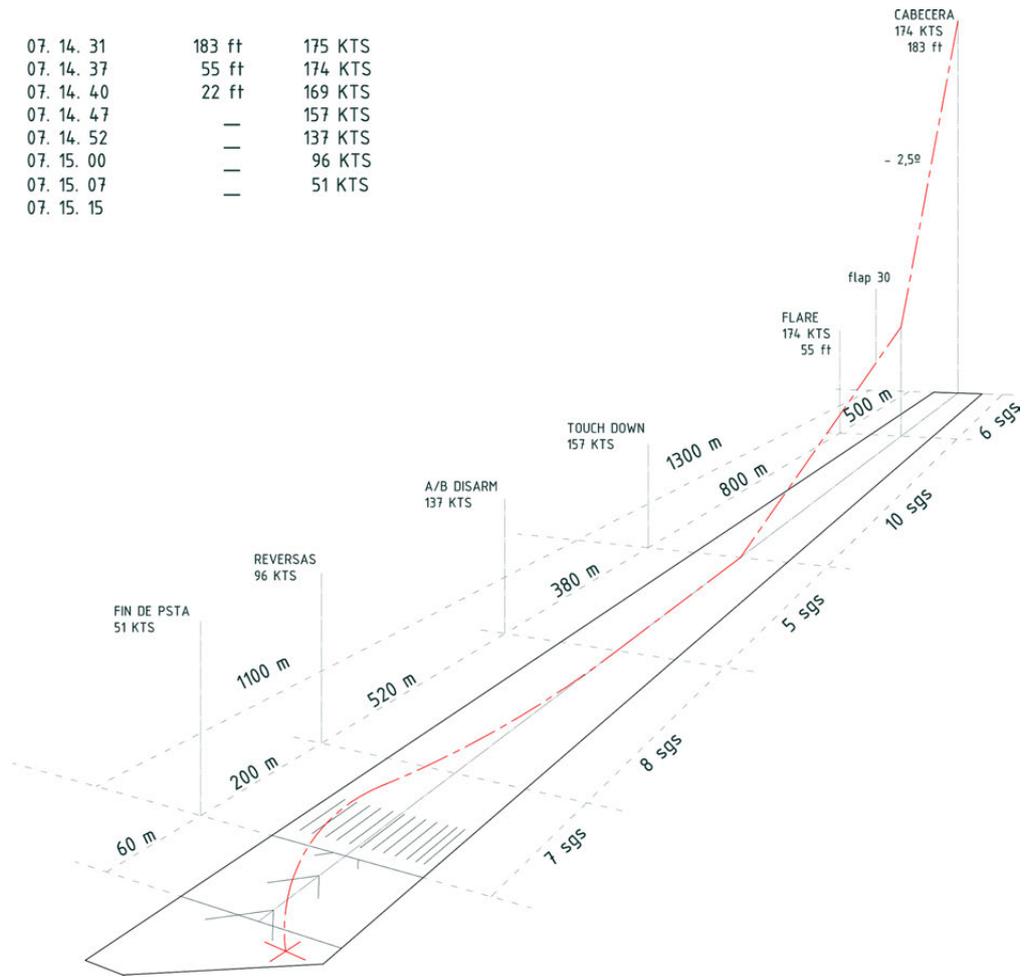
APPENDIX B

cabecera 21	07. 14. 31	183 ft	175 KTS
flare	07. 14. 37	55 ft	174 KTS
flap30	07. 14. 40	22 ft	169 KTS
touch down	07. 14. 47	—	157 KTS
A/B disarm	07. 14. 52	—	137 KTS
reversas	07. 15. 00	—	96 KTS
colisión fin pista	07. 15. 07	—	51 KTS
stop	07. 15. 15	—	—

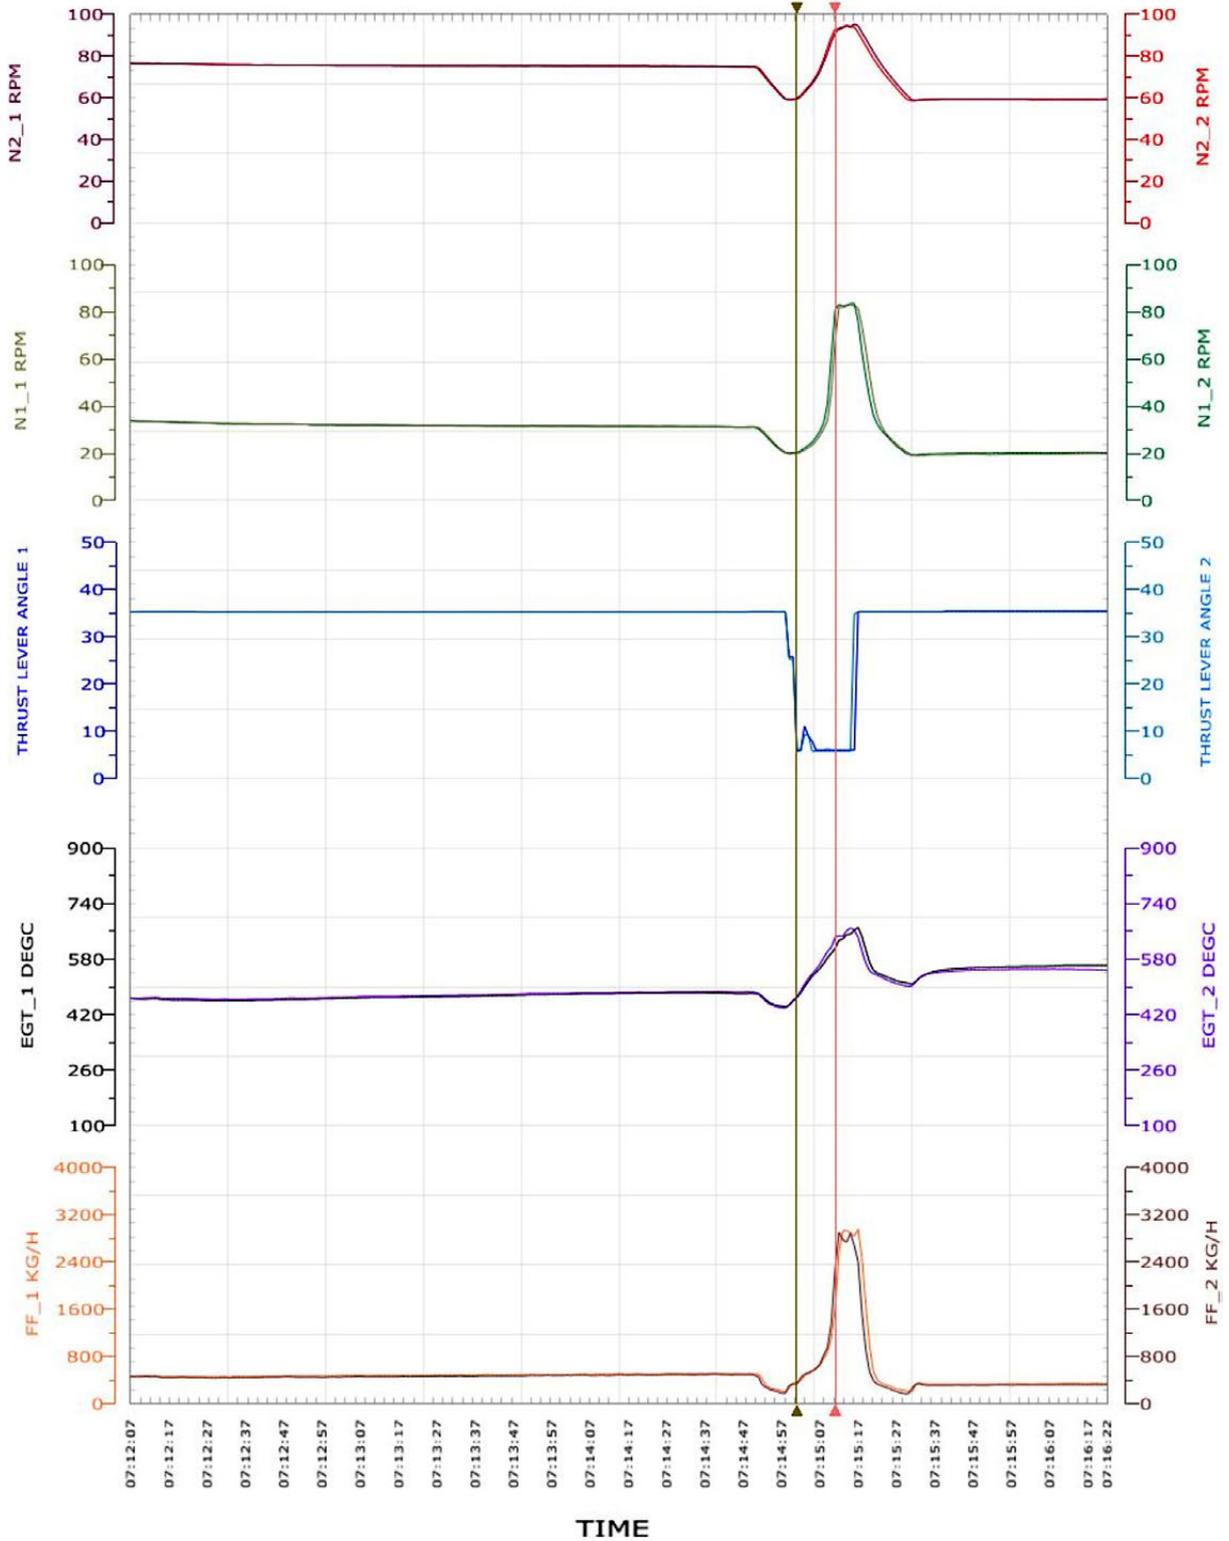
APPENDIX C

Engine parameters
