Report A-032/2017

**Accident involving a Bell 412 aircraft,
registration EC-MMC, operated by Babcock
International Group PLC, and a CASA 1131
aircraft, registration N1950M, at the
aerodrome of Mutxamel (Alicante, Spain) on
30 December 2017**

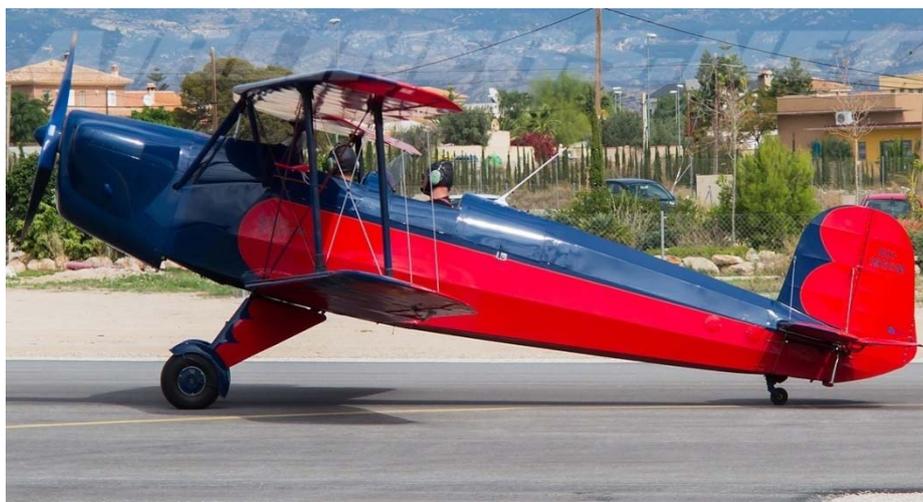
Figure 1. Aircraft N1950M

Investigators were unable to locate the aircraft logbook either at the pilot's home or among his belongings at the hangar where the aircraft was parked. The airworthiness information provided by the FAA indicated that when the aircraft was purchased on 2 August 2013, work was done to remove the coating on the wings, ailerons and central section, inspect the ribs, spars and fastening components, and repair ribs and supports. Since then, the accident pilot had flown about 500 hours on the aircraft.

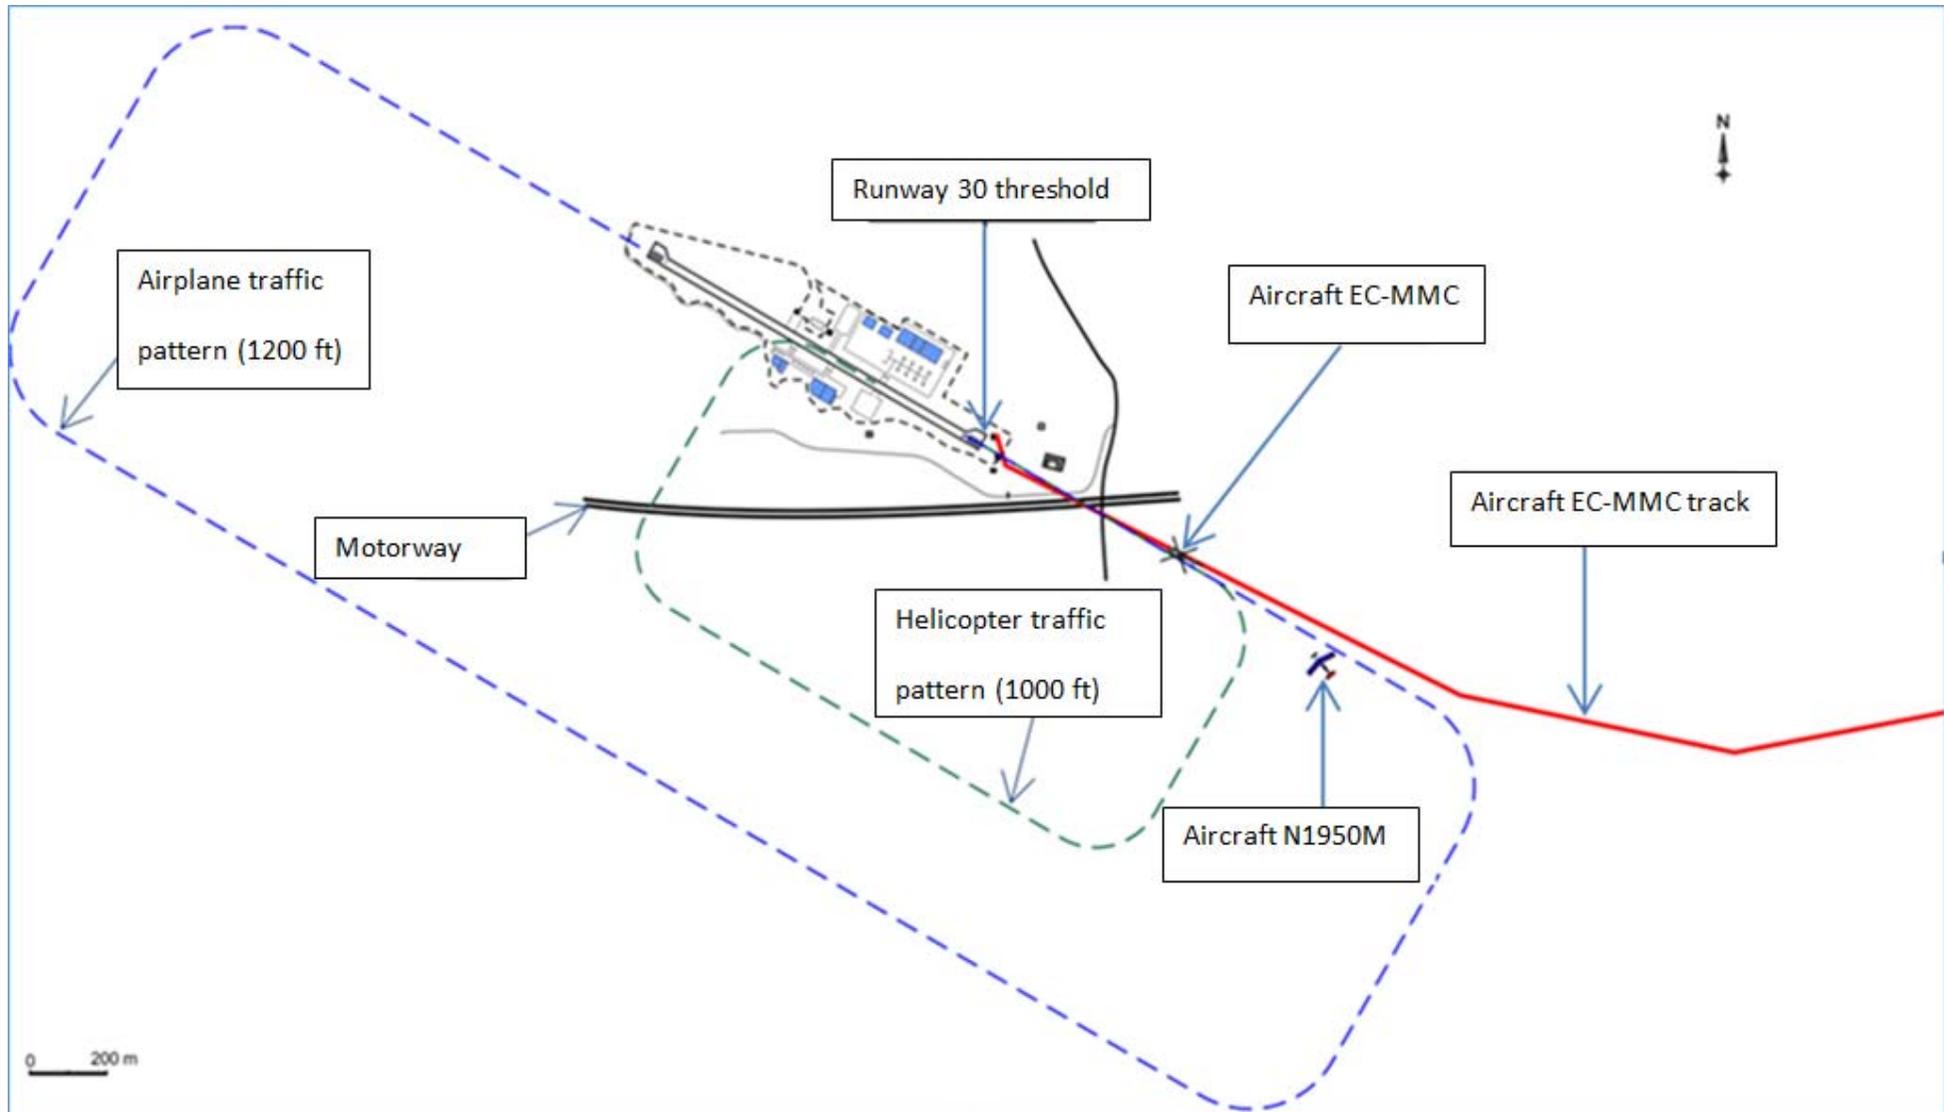
Figure 8. Relative positions of aircraft EC-MMC and N1950M

The track followed by aircraft EC-MMC shows that it directly joined the final segment of the pattern to land on runway 30, as instructed in the visual approach chart for the aerodrome.
