CIAIAC

Report ULM A-002/2018

Accident involving an Evektor EV-97
Eurostar aircraft, registration EC-EZ3,
at the Cordoba Airport (Spain) on 13
January 2018

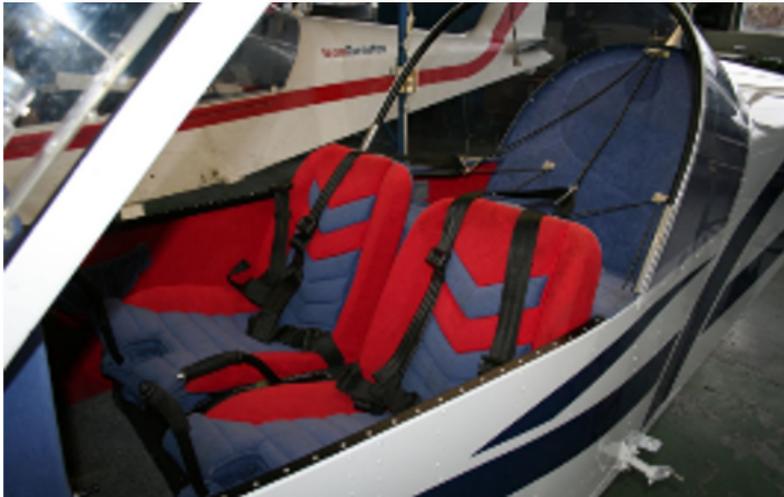
Illustration 11. Harness installed by the aircraft manufacturer

The photograph shows the kind of safety harness installed by the manufacturer in the accident aircraft. It is a four-point harness with dual shoulder belts, with a strap

passing over both shoulders of the occupant. The straps of the shoulder belts combine to form a “Y” and are attached to a point on the cockpit structure. There is also a lap belt.
