Report on the investigations of  
heavy weather damage  
on board the container ship  
***Maersk Newport***  
50 miles west of Guernsey  
on 10 November 2008  
and fire  
alongside at the container berth in Algeciras, Spain  
on 15 November 2008

**Report No 13/2009**  
**June 2009**

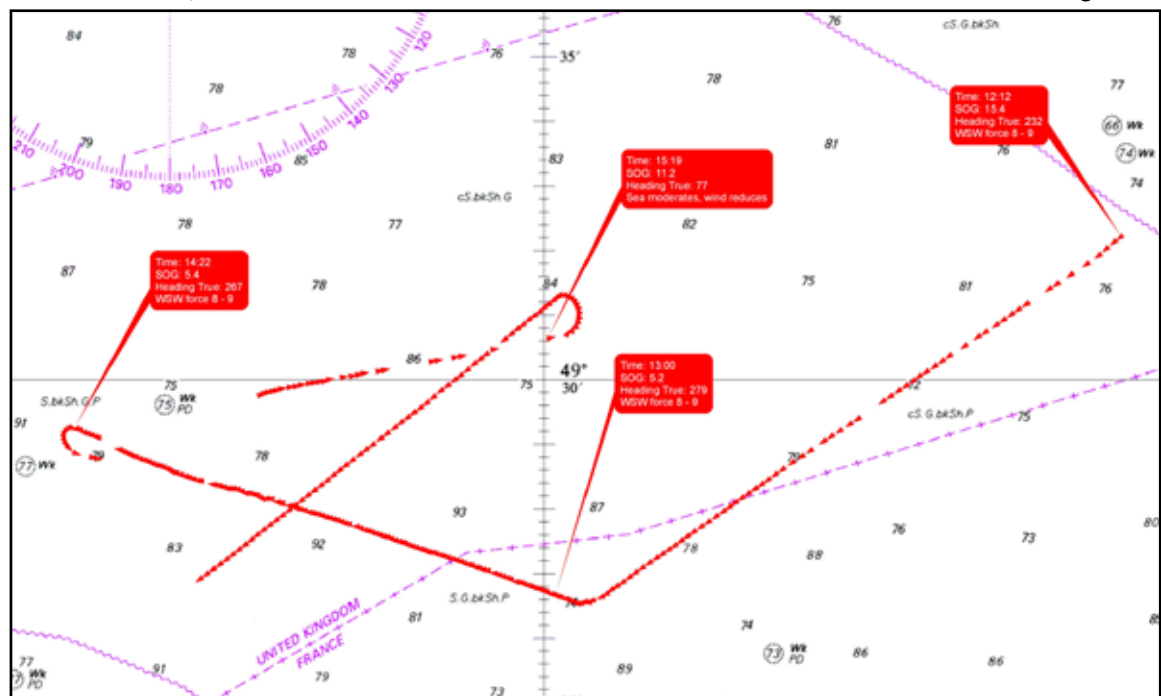
Figure 2

The master had continually assessed the deteriorating weather conditions and ship's movement throughout the forenoon watch. By 1200 the west-south-westerly wind had increased to force 8 to 9 and the sea remained rough with a 0.8 knot east-north-easterly tide running. However, the ship was recorded in the Deck Log as "pitching and rolling easily" and the master decided that it was safe to continue the passage at full ahead manoeuvring speed. At 1212 the ship's Automatic Identification System (AIS) recorded the vessel's speed over the ground (SOG) as 15.4 knots on a heading of 232° true (T). A copy of the AIS generated track is at **Figure 2**.

AIS tracks - 10 November 2008

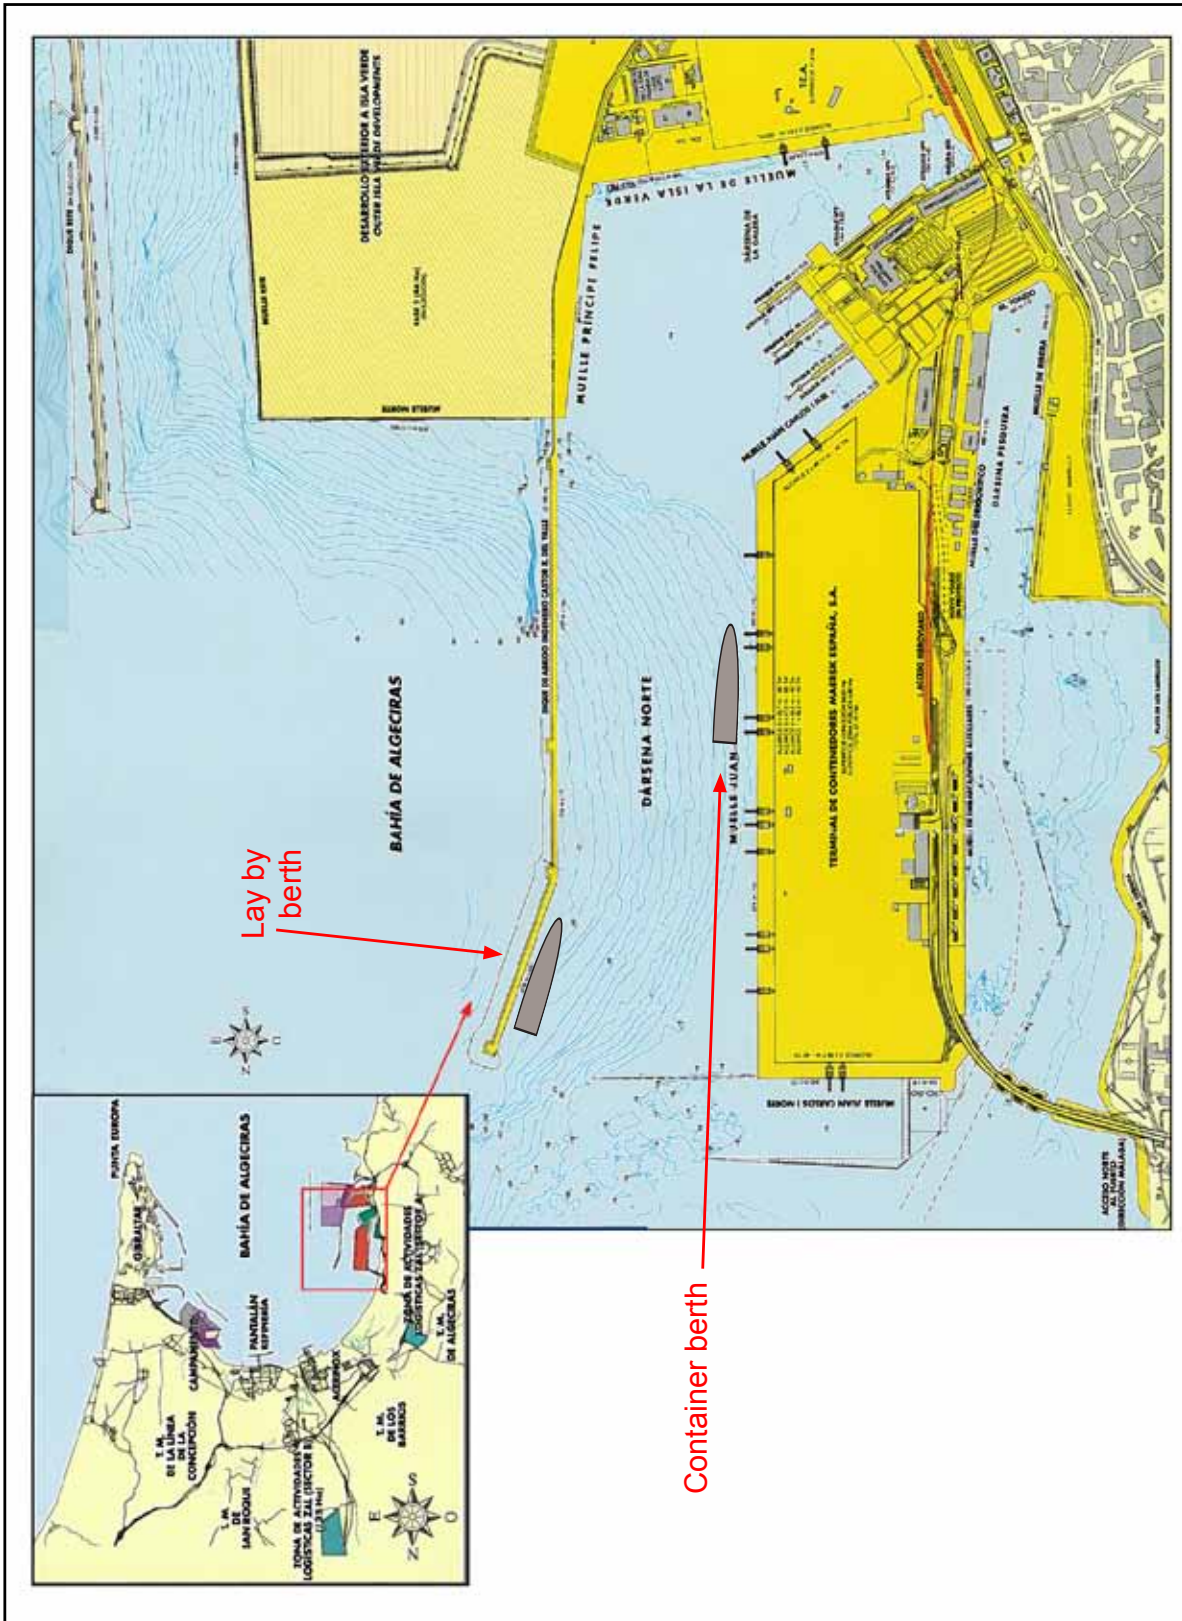
Figure 10

Layout of the Port of Algeciras

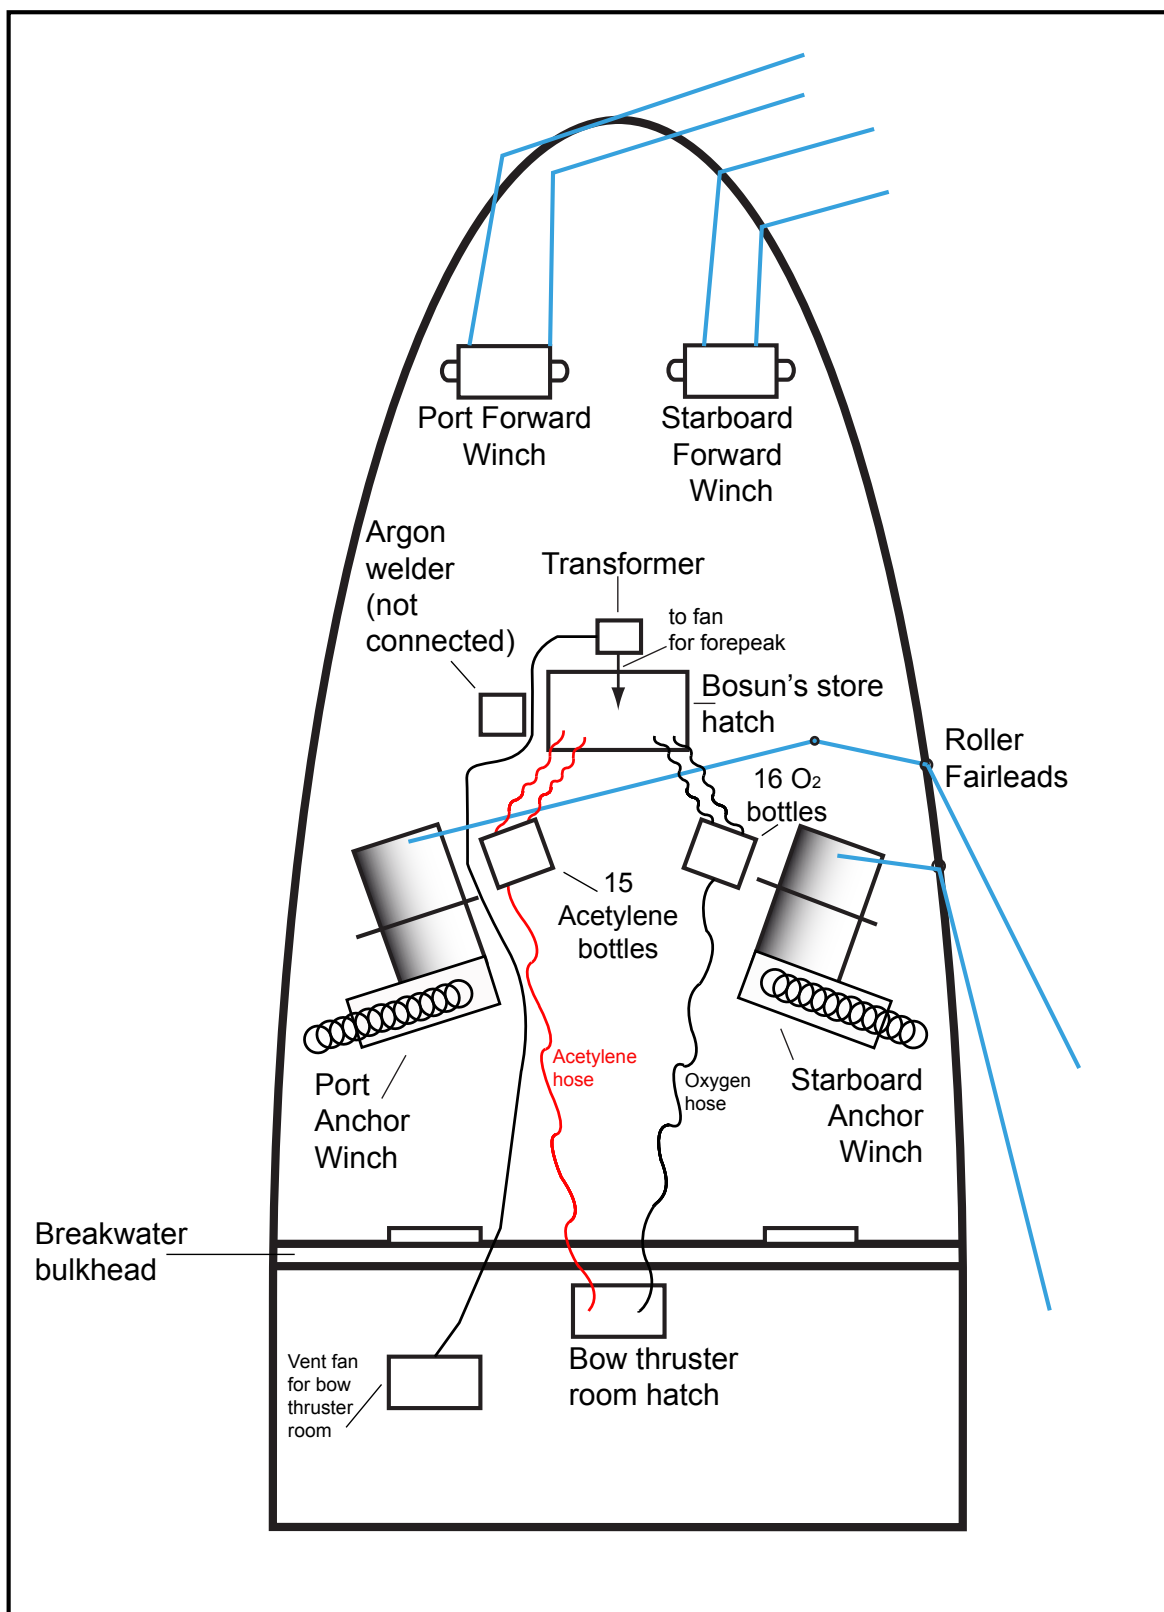
At about 0055 the burning stopped in both the forepeak and the bow thruster room. The blowtorch gas valves were shut, but the gas bottle valves were left open as the contractors started to grind off the rough, burnt edges of hull plating.

Diagrammatic layout of the contractor's equipment and forward mooring arrangements

Very soon afterwards the electrician/safety watchman left the forecastle area and went into the ship's accommodation to use the toilet facilities. He did not inform the foreman of his intentions, and contractors and their equipment were left without a safety oversight. On passing through the port access in the breakwater bulkhead the electrician/safety watchman noticed four, unidentified, stevedores about 25m aft of the gas bottle storage area. He was unsure if they were smoking at the time.

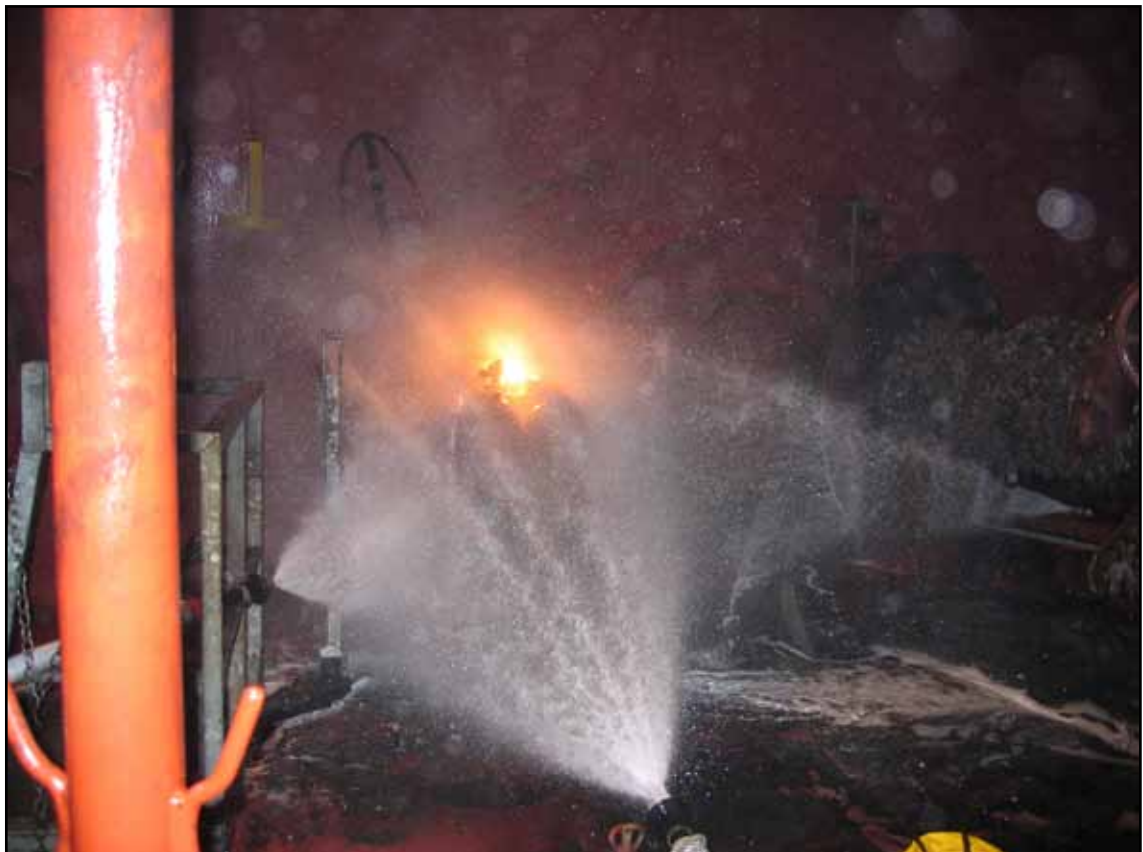
Figure 15

At 0252 the Head of Inspection and Survey recommended that the accessible acetylene bottles be dropped into the harbour to rapidly cool them down in view of the particular dangers associated with heated acetylene bottles. This was rejected by the OIC on pollution grounds. It was then decided to secure the fire-fighting hoses and direct the nozzles on to the acetylene and oxygen bottles and vacate the vicinity of the forecastle (**Figure 15**).

Hoses rigged to cool down the acetylene and oxygen bottles

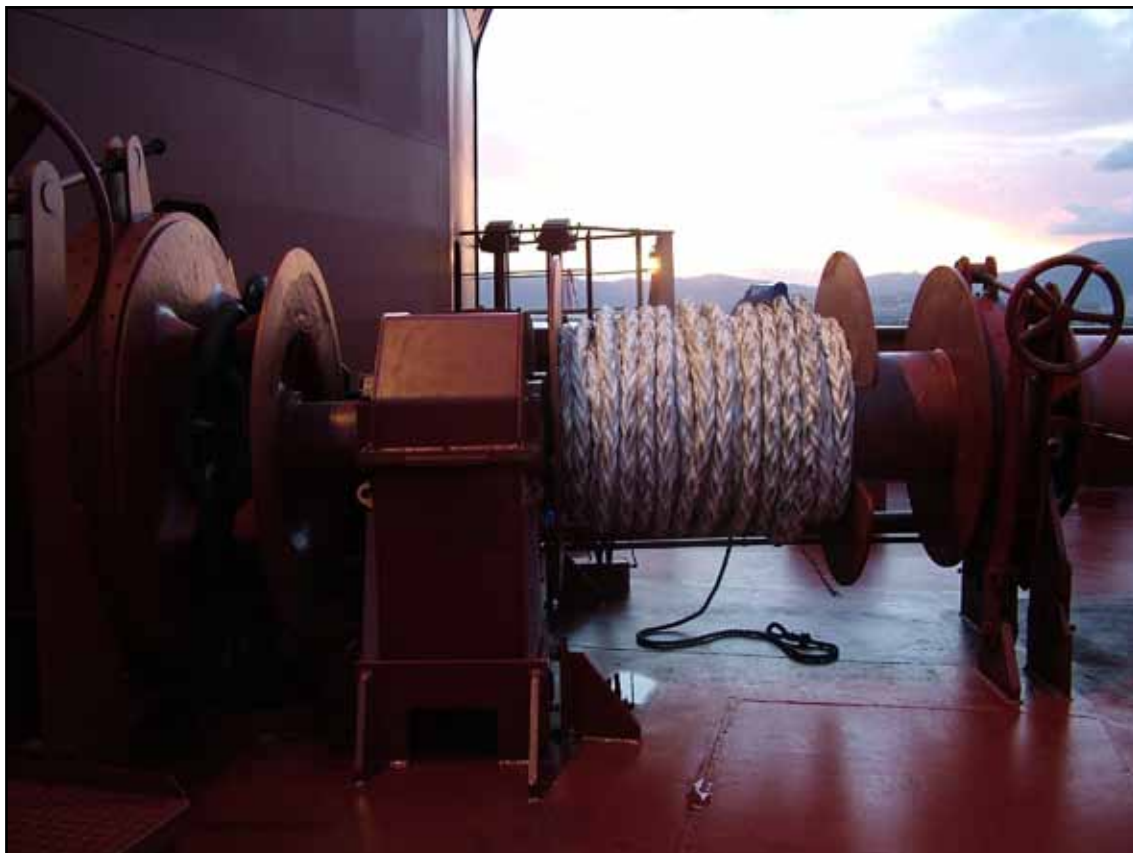
Figure 22

*Maersk Newport* was fitted with two, type 2 AMW 120/76 K3 R, twin drum windlass winches on the forecastle (**Figure 22**). The winches were designed and manufactured in 2008 by KGW Marine GmbH based in Schwerin in Germany.

General view of the port windlass winch

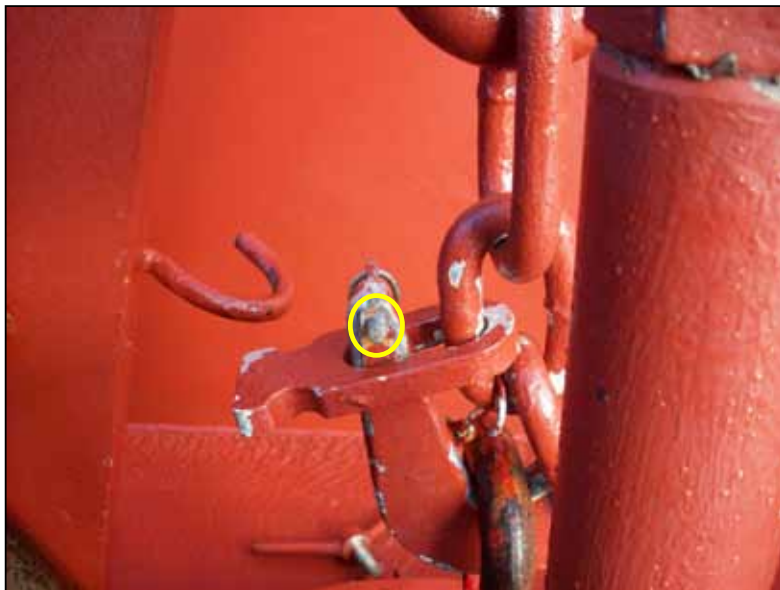
Figure 24

The forecastle team found that about  $\frac{1}{2}$  to  $\frac{3}{4}$  shackle of the port anchor cable had been released. The lashing chain Senhouse slip tapered securing pin had become detached from the slip and was hanging by its chain (**Figure 7**) and that the lashing chain was hanging loose. It was also found that the forward guillotine block was in the upright open position while the after guillotine block was in the horizontal closed position – **Figure 8**. Before the anchor cable was recovered, the chief officer checked the winch brake and managed to apply one full turn of the brake handwheel. After the port anchor was fully secured, checks were made to confirm that the starboard anchor was also fully secured.

Chain lashing Senhouse slip tapered securing pin

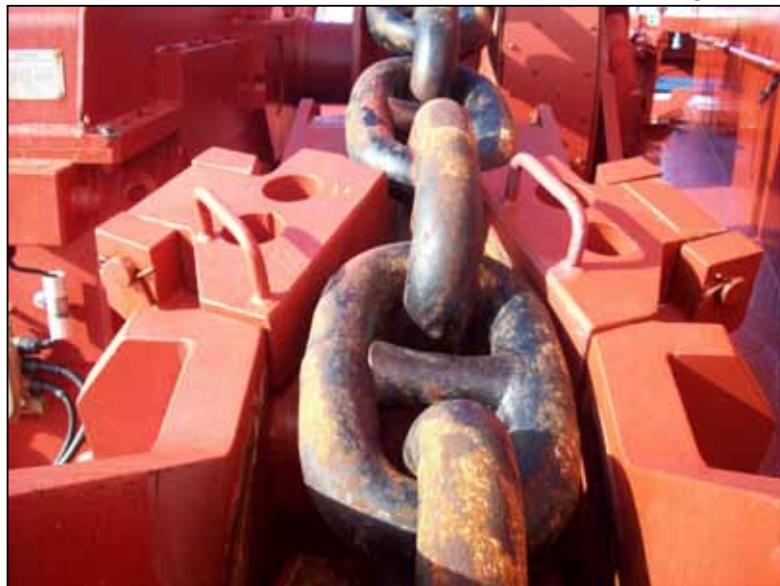
Figure 25

Both windlass winches were fitted with two heavy guillotine blocks (**Figure 25**) which could be lowered to the horizontal closed position when the anchor cable was fully secured. The purpose of the blocks was to take the load of the anchor cable when the ship was at anchor by allowing the face of one of the horizontal anchor chain links to rest against the face of the guillotine blocks.

Guillotine block arrangement

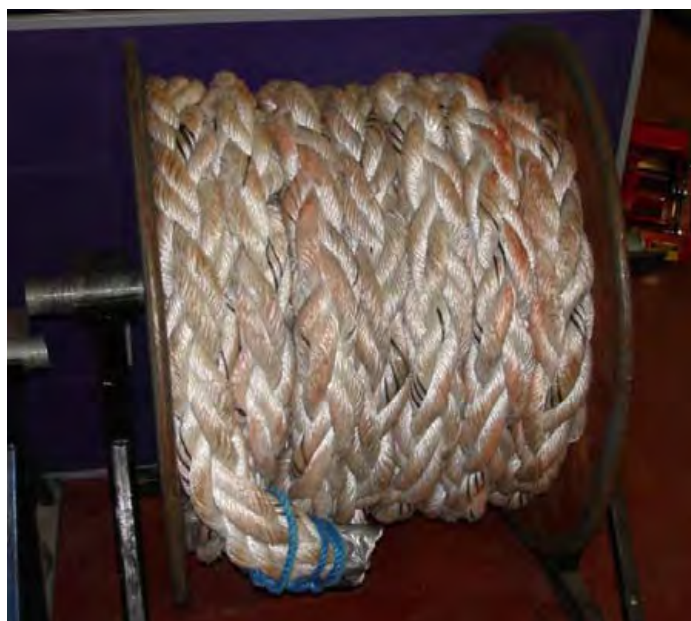
Description of sample(s): 8 strand braided polypropylene mooring rope, 80 mm Ø  
a) Wound 3 layers deep by 6/7 coils wide onto a steel flanged core  
(Figure 1)  
b) 80 cm length sample of rope taken from ~2 m back from failed  
end of line (herein after "Burn End")  
c) 80 cm length sample of rope taken from ~2 m back from eye end  
of line (herein after "Eye End")

Figure 1 – Rope sample wound on to steel flanged core.
