Operator: IBERIA
Aircraft type and model: Boeing B-727-256
Nationality: Spanish
Place of accident: Monte Oiz, 1.027 meters high
30 Km. SE of Bilbao Airport
43°13'42" N
2°35'24" W (M. Oiz)
Date and time: 19 February, 1985
08.27:04 hours

Aircraft Boeing B-727-256, registration EC-DDU, of IBERIA Airlines, performing scheduled flight IB-610 (Madrid-Bilbao), crashed into a metallic structure, base of television antennas, placed on Monte Oiz (1027 mts.).

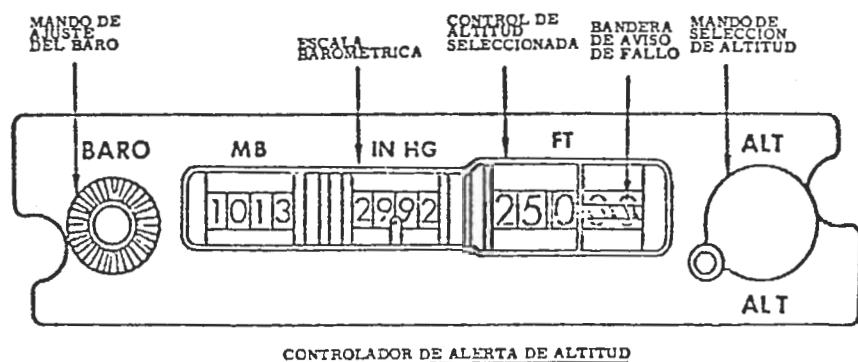
Fig. 2

The altitude warning system includes the following elements (Fig. 2):

1.- The Altitude Alert equipment was recovered from the aircraft remains; it was quite damaged by the impacts. On the altitude selection window, the ten thousand drum showed no digits (indicating a selection of under 10.000 feet), the thousand drum showed number 4 and the hundred drum showed number 3.

It was found that the ten thousand and thousand drums were blocked, they did not turn around its axis. It could be seen that the upper lid, as a result of the impacts, had been separated and was bent outward, and on its internal face it could be seen the print left by a cogged wheel belonging to the altitude

According to the FDR, CVR and the study of the remains it can be asserted that: nine seconds before leaving 5.000 feet there is a selection in the Altitude Alert system; the equipment was found with the thousand units blocked, showing number four; the hundred units was set at three and only allowed movement between two and three; the system's horn only sounds when the aircraft is at an altitude very close to 4.000 feet.

- g) Insist on the technical crews to place on the Altitude Alert system windows the altitudes which figure on the approach charts, always rounding to the higher hundred.
- h) Urge the appropriate aeronautical authority to assure periodic inspection systems for the specific zones that include protection surfaces, in order to avoid the appearance of obstacles that surpass the maximum permitted altitudes.
